Mode Cleaner suspension installation

Naoko Ohishi^A, T. Saito^B, K. Doi^C,
M. Nakano^C, K. Shiga^B, T. Narita^C, K. Hirai^B,
R. Takahashi^A, T. Sato^B, M. Ohkawa^B,
S. Kawamura^C, T. Uchiyama^C, Y. Aso^A, and E. Hirose^C
A: NAOJ, B: Niigata Univ., C: ICRR

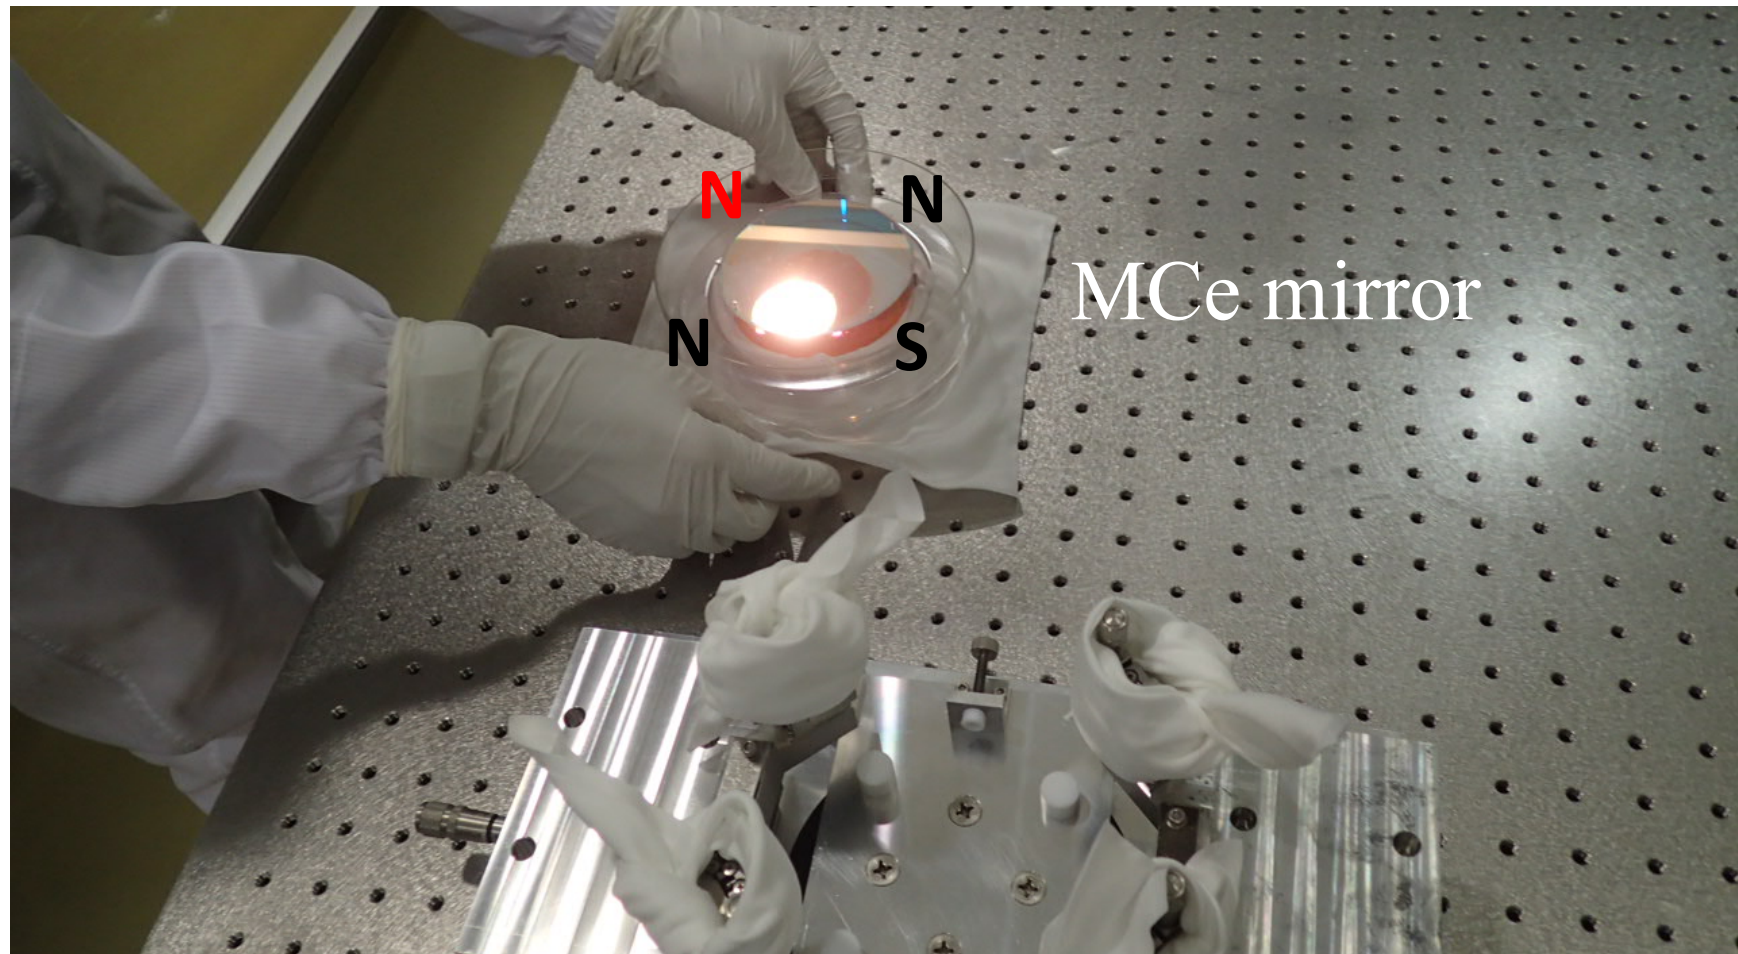
Glued a magnet in the wrong direction

We used magnetometer for MCI and MCo but didn't for MCE

- **Evaluation of magnetic field** (Michimura-san)
 - **NNNS is Permissible** in terms of displacement noise
 $5\text{e-}15\text{m/rHz}$ (NSNS) \rightarrow $3\text{e-}13\text{m/rHz}$ (NNNS)
 $< 1\text{e-}11\text{m/rHz @}10\text{Hz}$ requirement for
- **Adhesive removal test** (Hirose-san)
 - (Two Liquid Mixture Type Epoxy Resin Adhesive)
 - Adhesive can be removed by heating
 - Re-glueing test is necessary
 - There still remains the fear of damaging AR coating
- **Decision** about to repair/or not to repair the polarity
will be made at the next IOO meeting (Aug 31th)

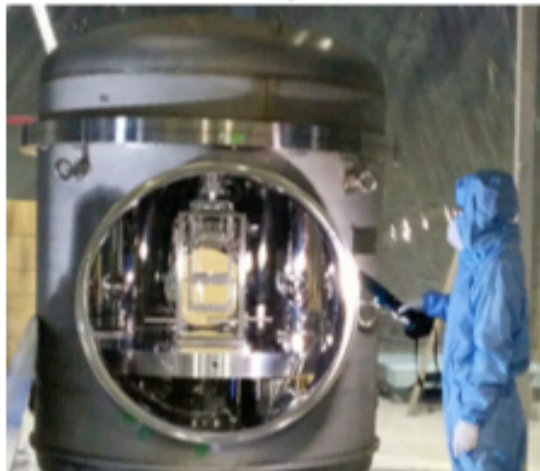
However, MCF Bread Board was partly blackened

- When the MCF breadboard was installed perhaps in Feb, we found it partly blackened
- Both MCE and MCF board were sent back to Hitz (日立造船) for cleansing in Mar
- Reinstallation
 - MCE: installation in May and leveling in Jun
 - MCF Aug 12th

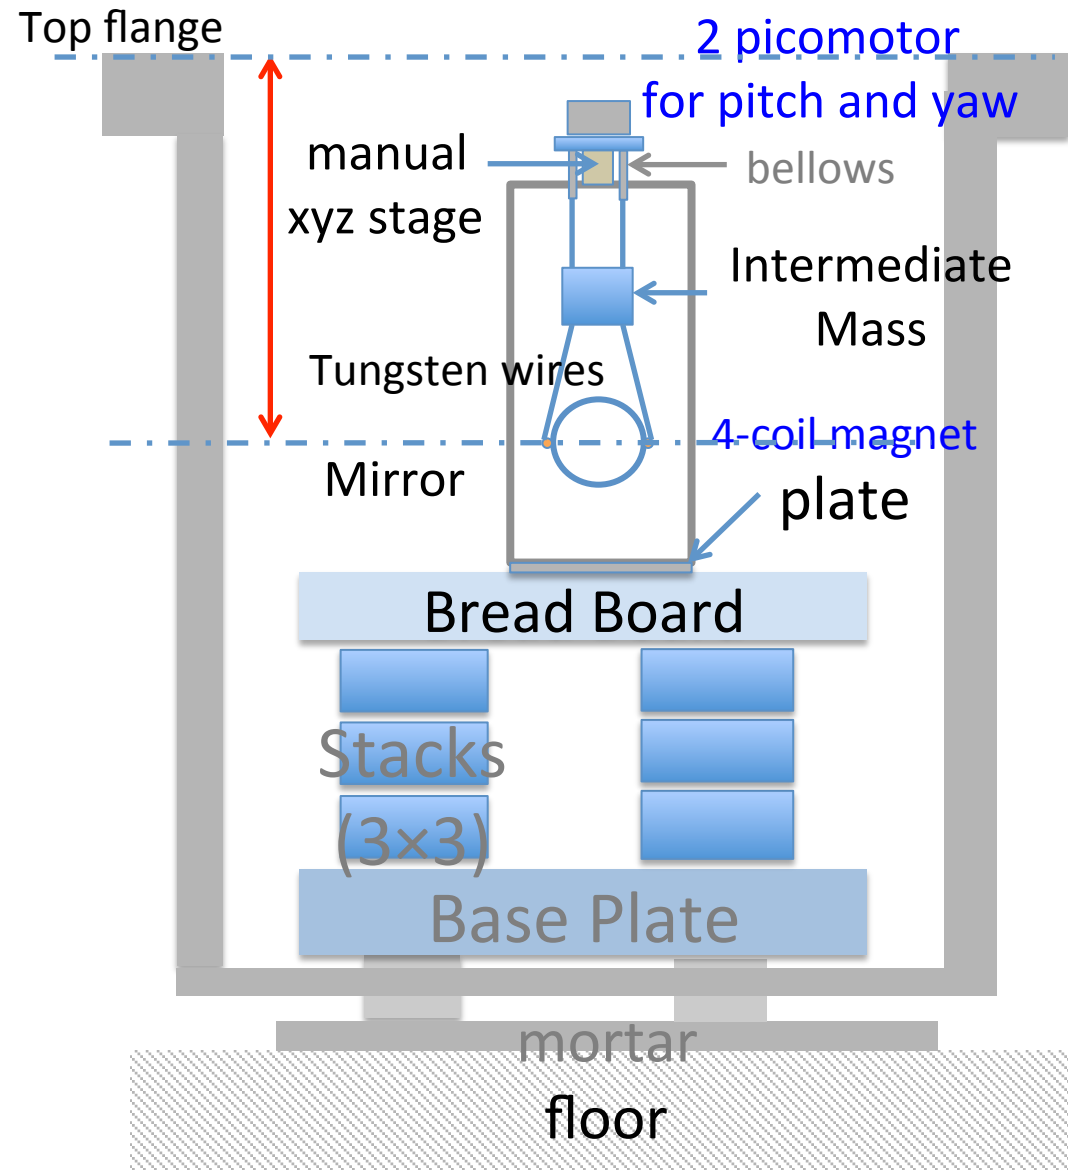
Position deviation of Breadboard

- **MCE**

+2mm in x-direction, +1mm in y-direction

Orientation error is less than 0.1 deg

- **MCF**

-2mm in x-direction, 4mm in y-direction

Orientation error is about 0.5 deg

Position and orientation deviation will be compensated by the plate under suspension

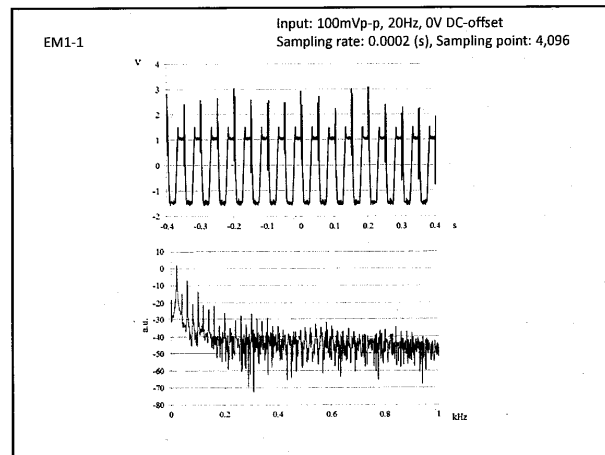
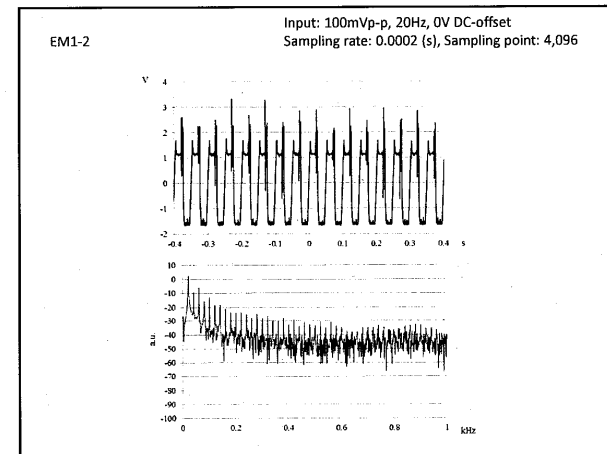
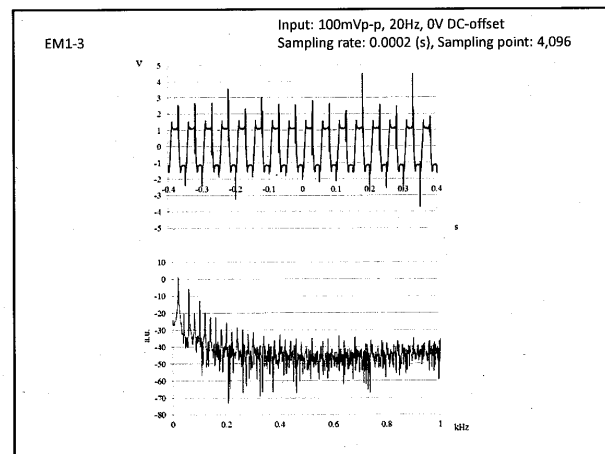
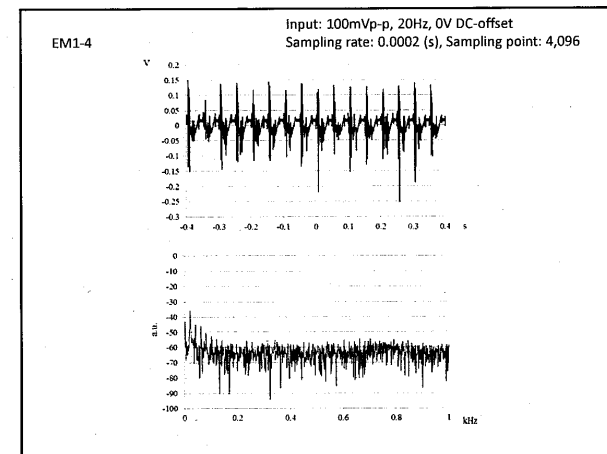
EM1: ch4 is strange

- Need to be discussed at the next IOO meeting.
- **Repair TAMA coil driver**
 - Current OP amp is already obsolete
 - OP amp replacement seem to be not enough
- **Use KAGRA coil driver**
 - KAGRA coil driver are already made (under test)
 - A kind of converter is necessary for handling differential signal output of KAGRA coil driver
- In either case, it takes a few weeks, I think.

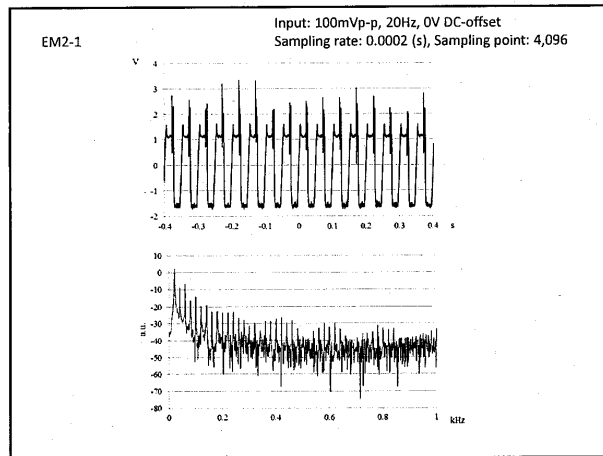
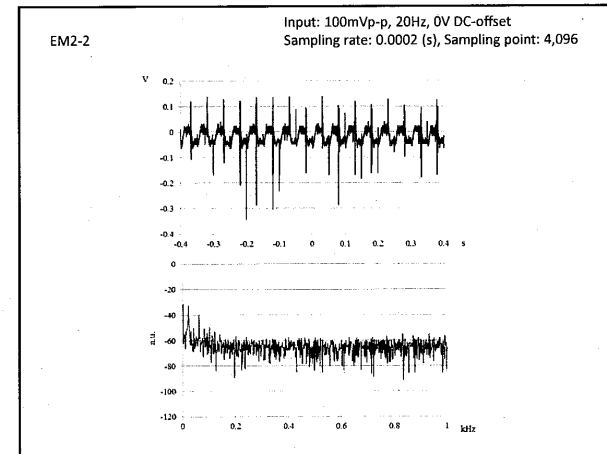
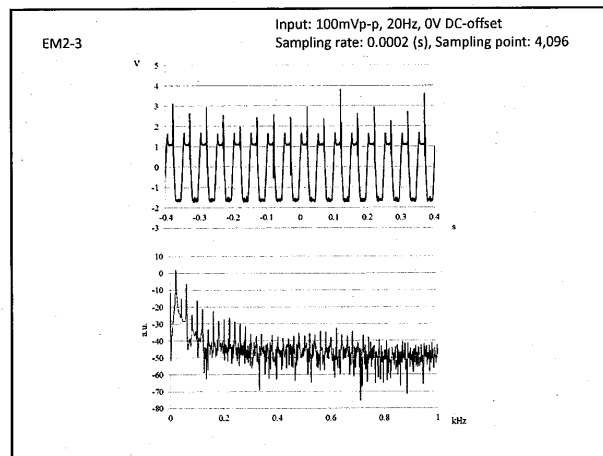
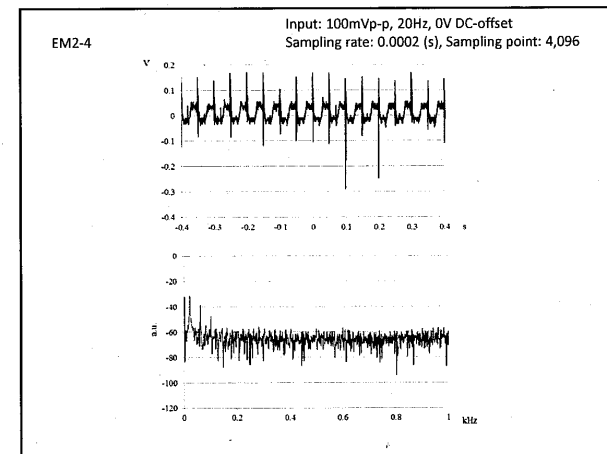
EM2: ch2 and ch4 are bad

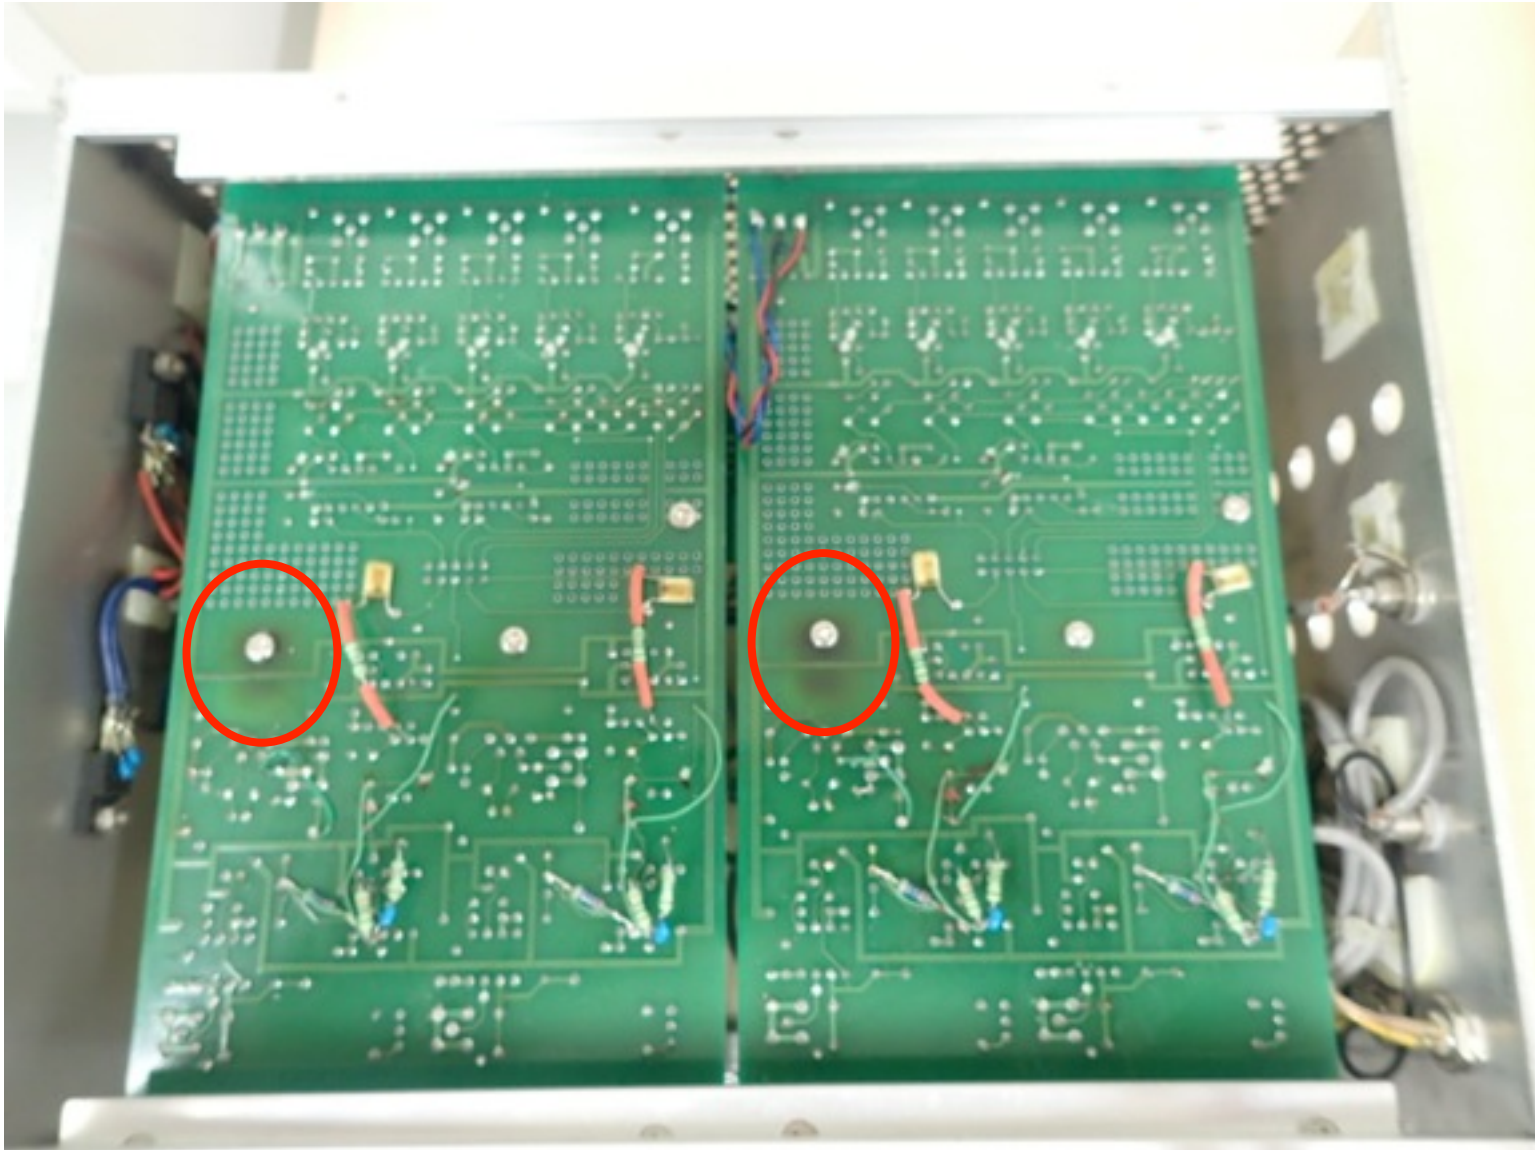
NM1: circuit board burned
