Mode Cleaner suspension installation

Naoko Ohishi^A, T. Saito^B, K. Doi^C,
M. Nakano^C, K. Shiga^B, T. Narita^C, K. Hirai^B,
R. Takahashi^A, T. Sato^B, M. Ohkawa^B,
S. Kawamura^C, T. Uchiyama^C, Y. Aso^A, and E. Hirose^C
A: NAOJ, B: Niigata Univ., C: ICRR

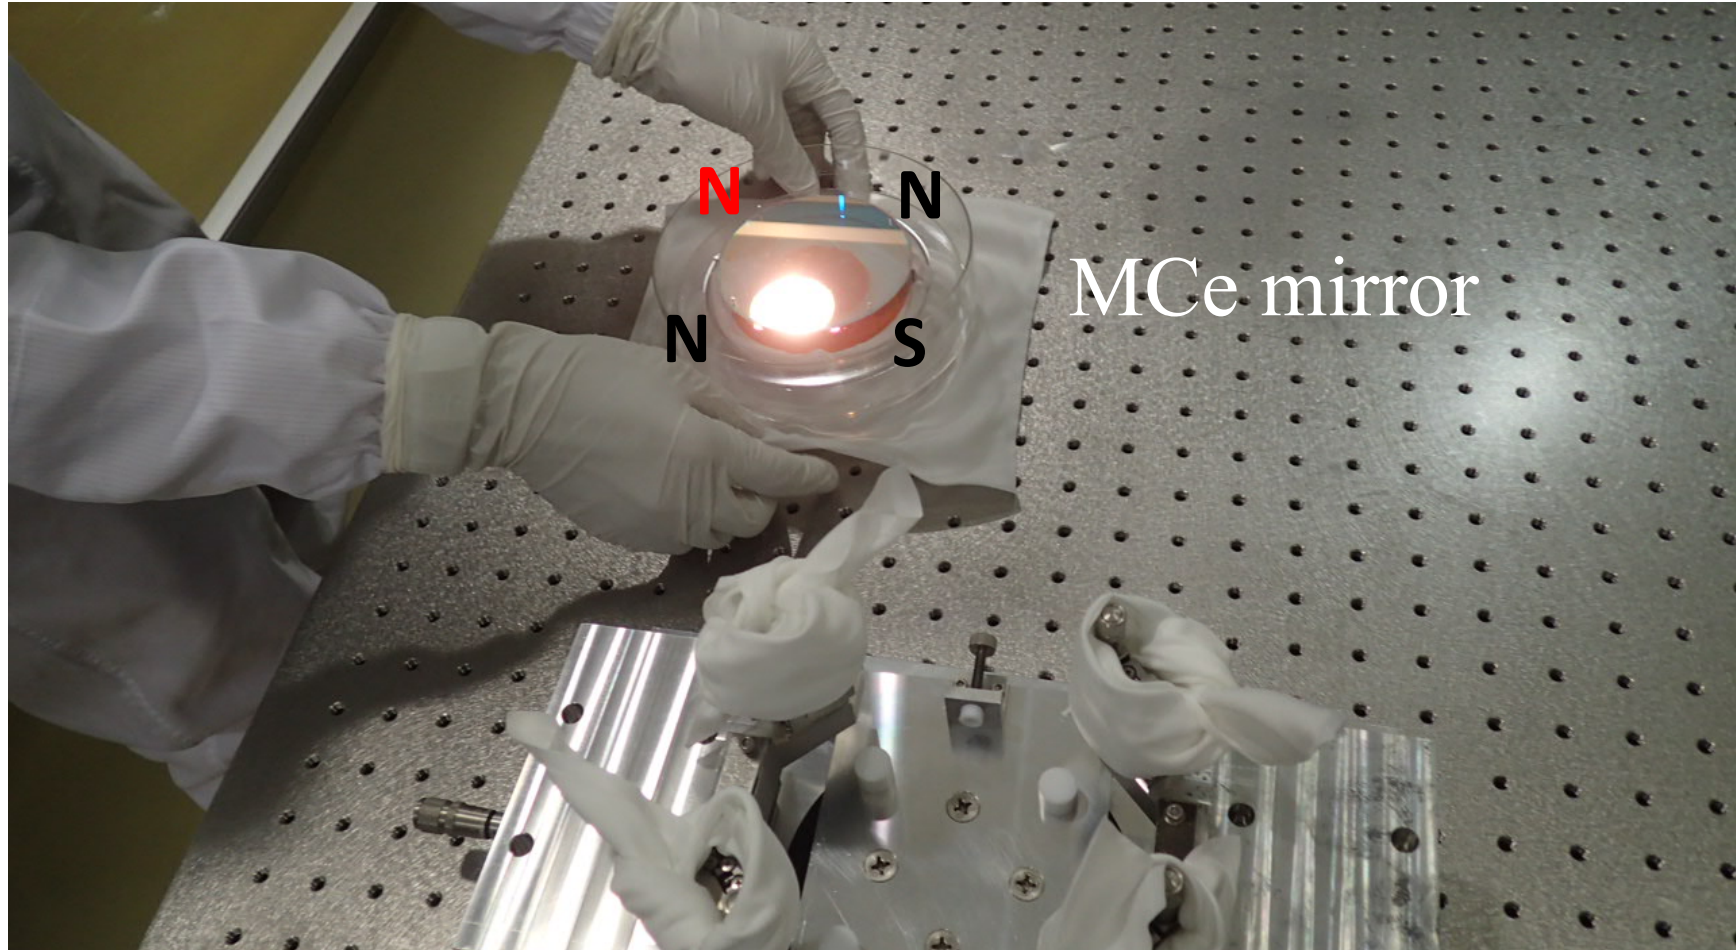
Glued a magnet in the wrong direction

We used magnetometer for MCI and MCo but didn't for MCE

- **Evaluation of magnetic field (Michimura-san)**
 - **NNNS is Permissible** in terms of displacement noise
 $5e-15\text{m/rHz}$ (NSNS) \rightarrow $3e-13\text{m/rHz}$ (NNNS)
 $< 1e-11\text{m/rHz @10Hz}$ requirement for
- **Adhesive removal test (Hirose-san)**
(Two Liquid Mixture Type Epoxy Resin Adhesive)
 - Adhesive can be removed by heating
 - Re-glueing test is necessary
 - There still remains the fear of damaging AR coating
- **Decision** about to repair/or not to repair the polarity will be made at the next IOO meeting (Aug 31th)

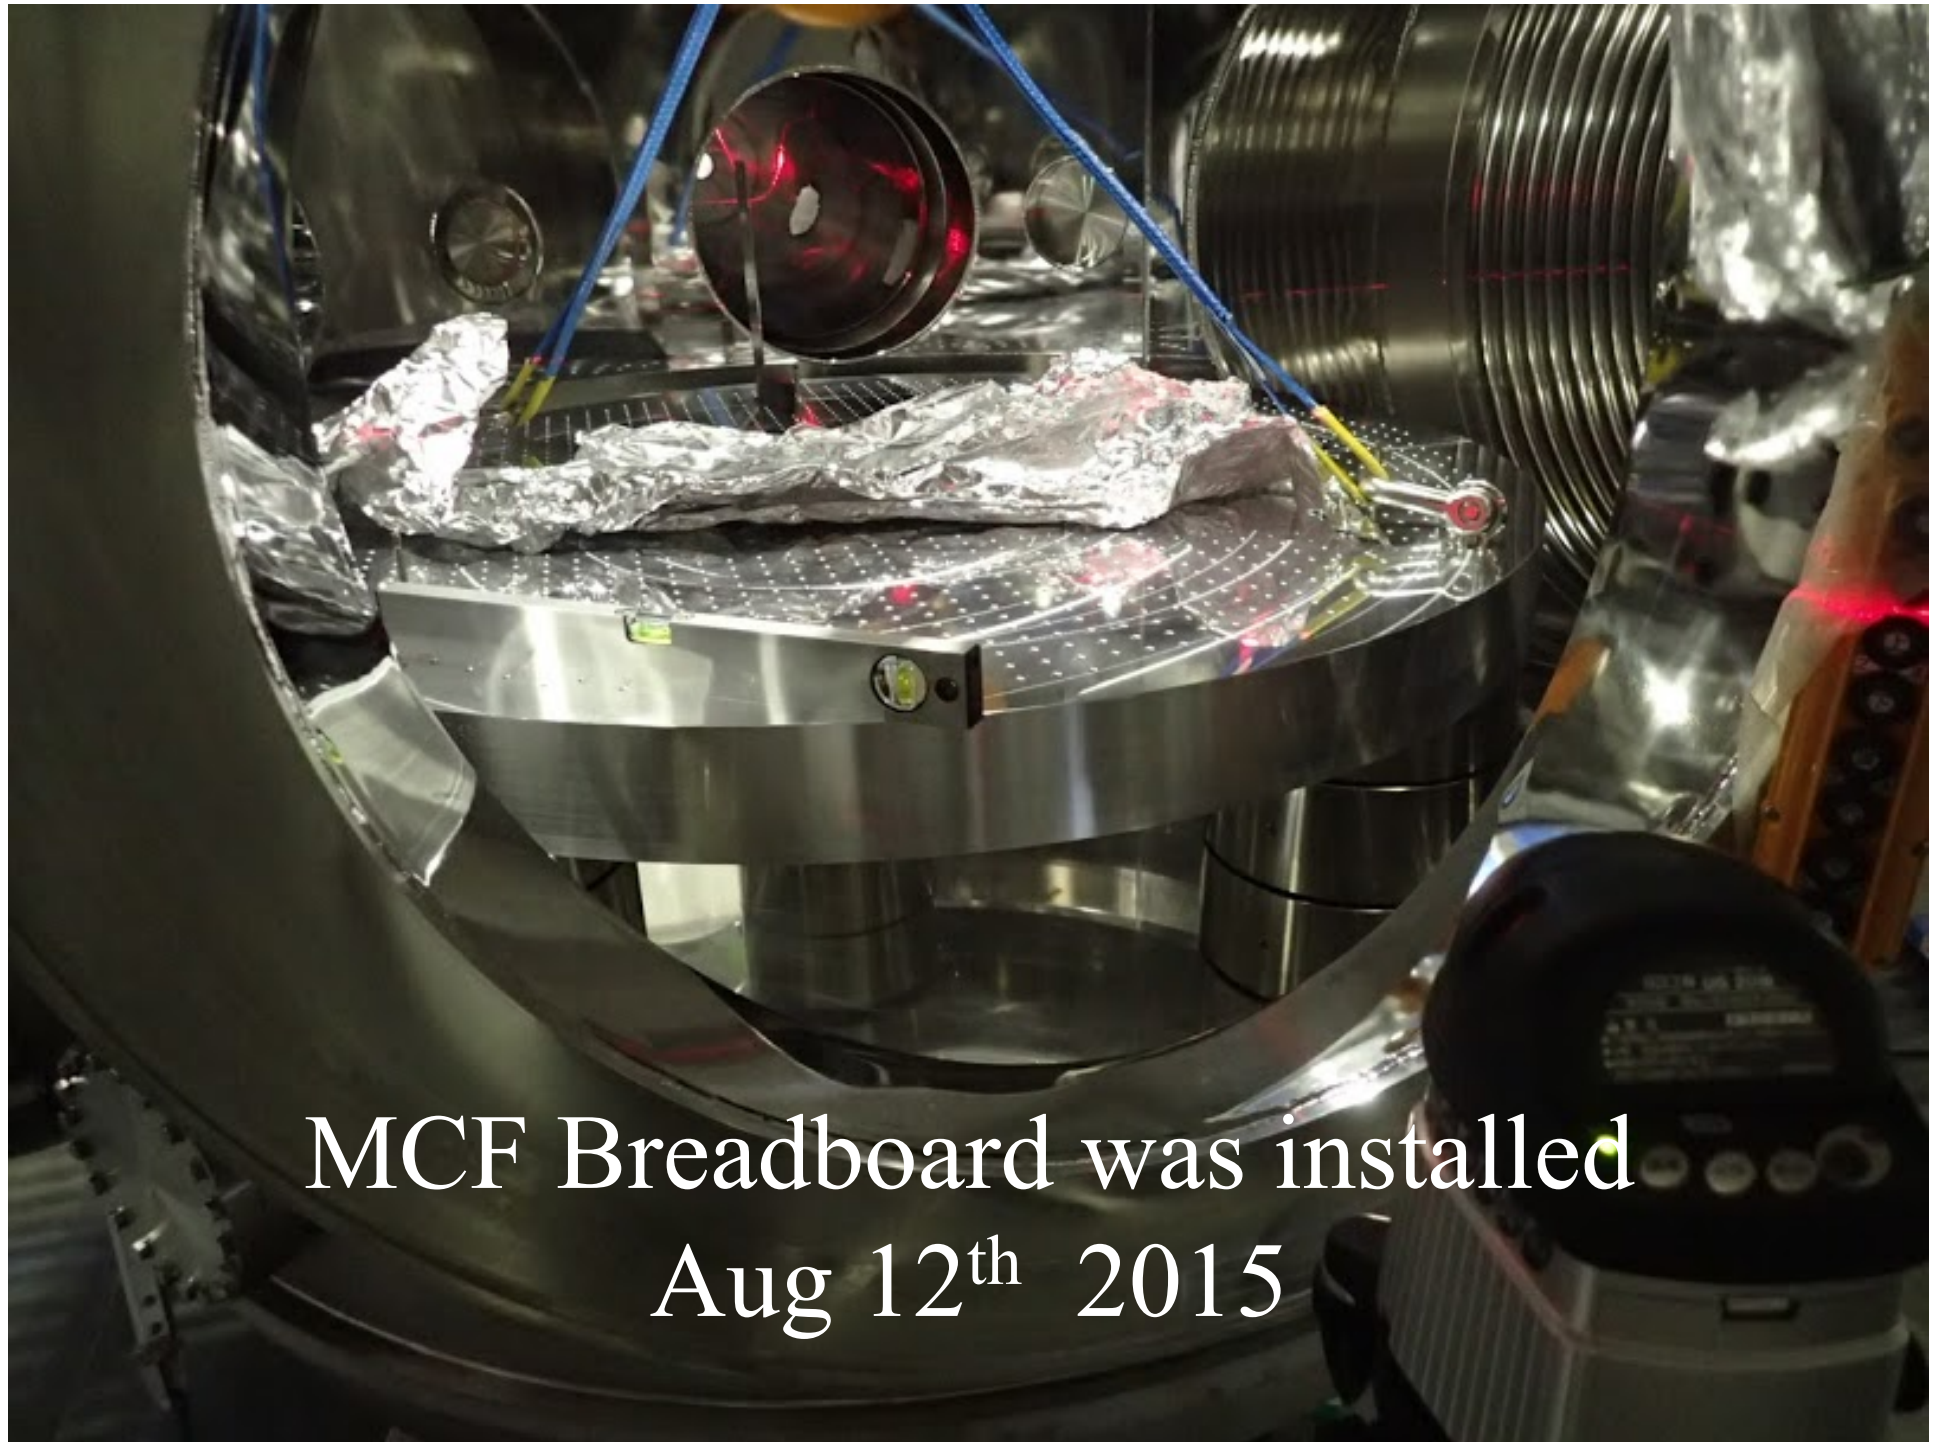
MCF Breadboard was installed
Aug 12th 2015

However, MCF Bread Board was partly blackened

- When the MCF breadboard was installed perhaps in Feb, we found it partly blackened
- Both MCE and MCF board were sent back to Hitz (日立造船) for cleansing in Mar
- Reinstallation
 - MCE: installation in May and leveling in Jun
 - MCF Aug 12th

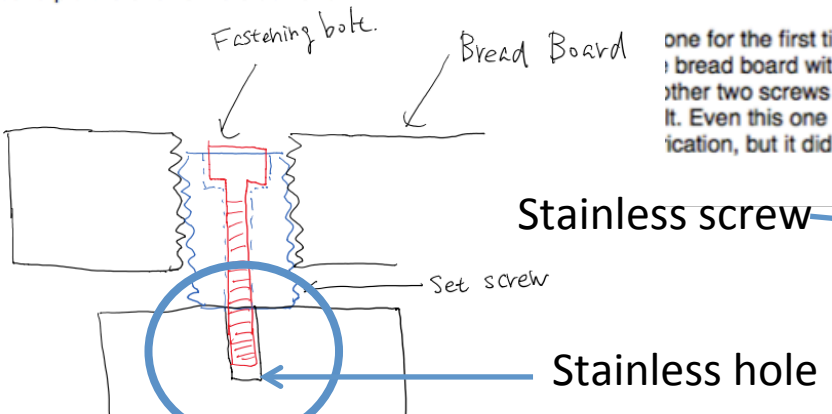
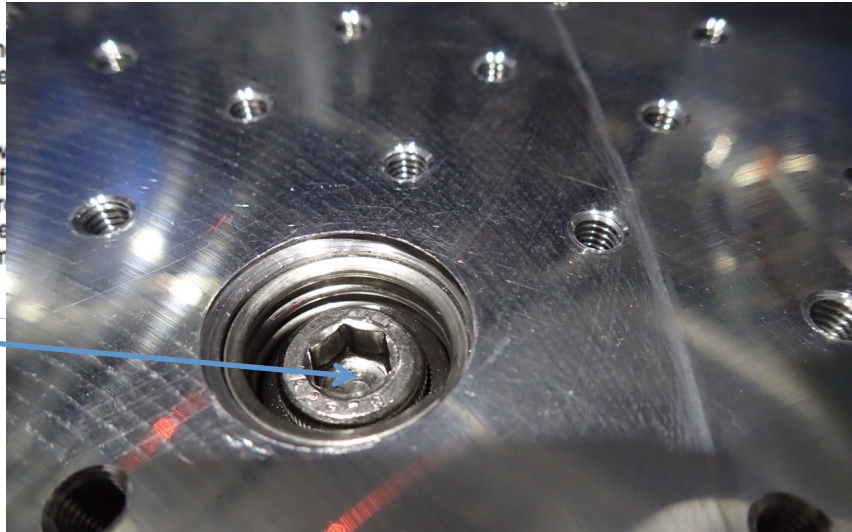
One of the MCF bread board screws is stuck in the middle

After the bread board leveling, when we were fastening the bread board to the stack, one of the three screws got stuck in the middle.

The structure of the fastening part is shown in the attached PDF. The set screw used to adjust the height of the bread board with the crane. After the leveling, we successfully fastened two screws. However, the third one got stuck at 1 - 2mm before the set screw. The second picture shows the stuck one.

one for the first time, we felt it was difficult to fasten the bread board with the crane. After the leveling, the other two screws were easy to fasten. However, this one was hard. When we tried to fasten it, it did not help. From

Use **silver-plated** bolts on stainless holes and fasten carefully

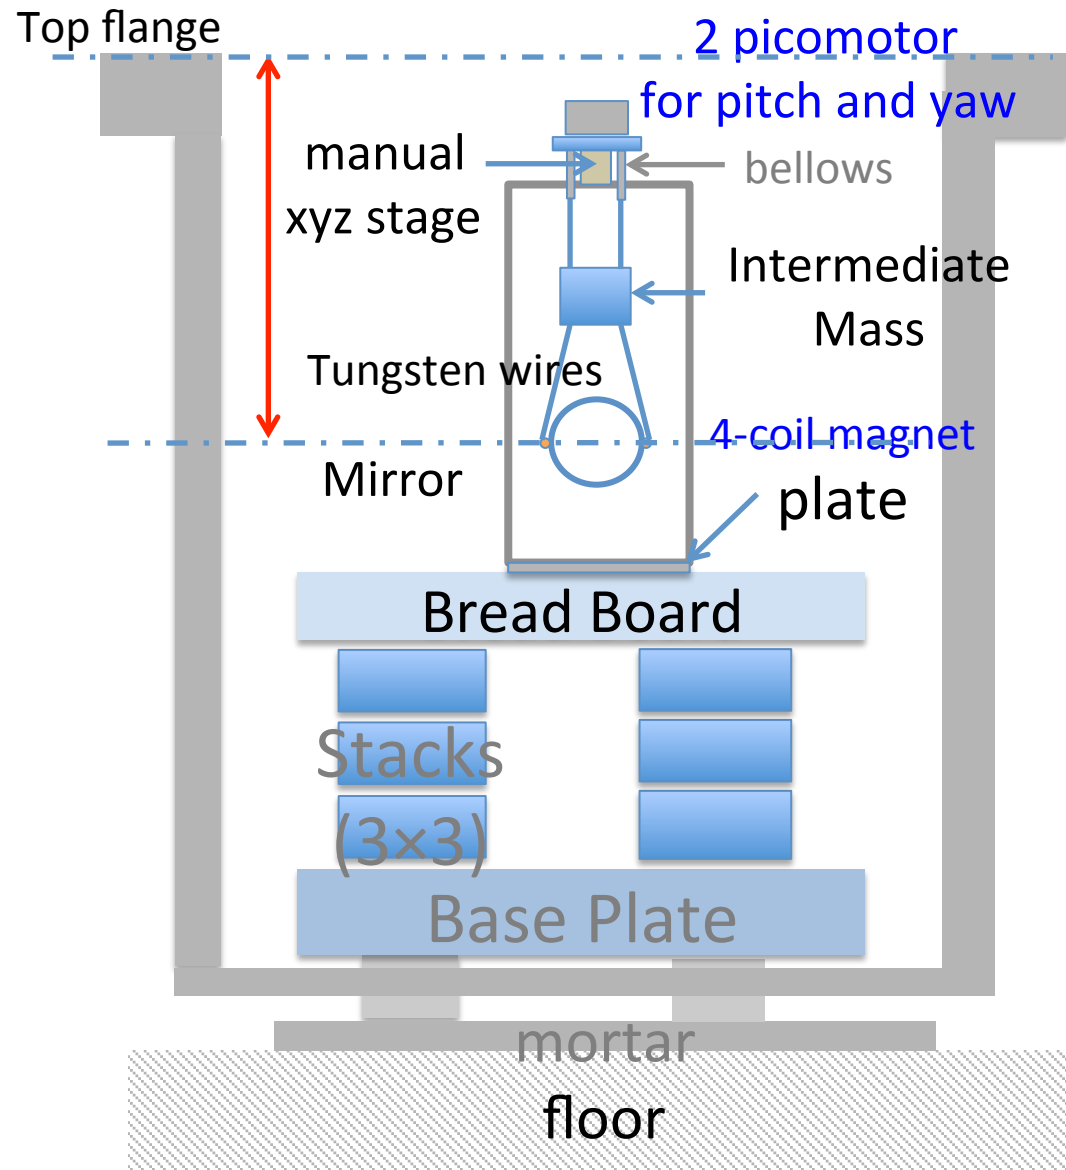
- **MCE**

- +2mm in x-direction, +1mm in y-direction

- Orientation error is less than 0.1 deg

- **MCF**

- 2mm in x-direction, 4mm in y-direction

- Orientation error is about 0.5 deg

Position and orientation deviation will be compensated by the plate under suspension

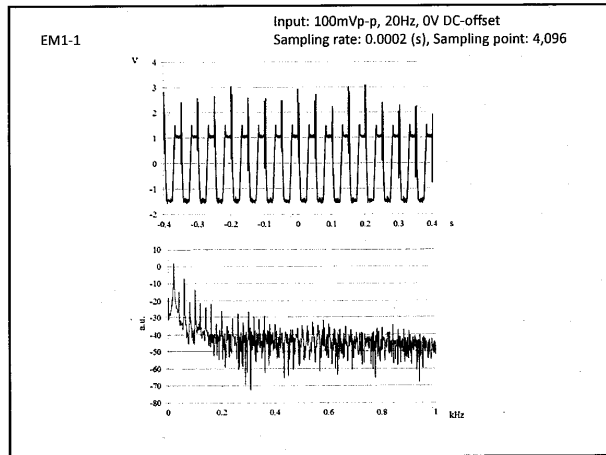
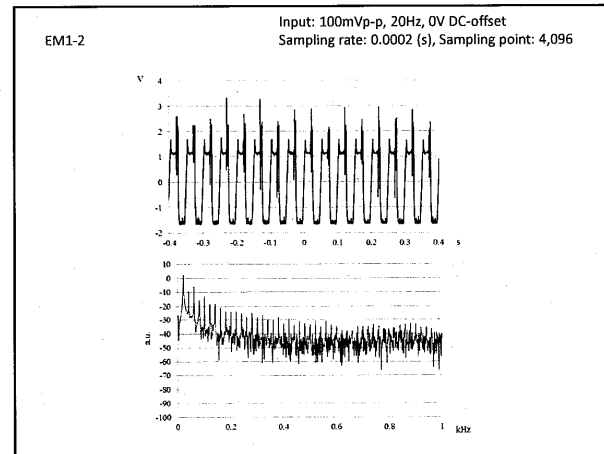
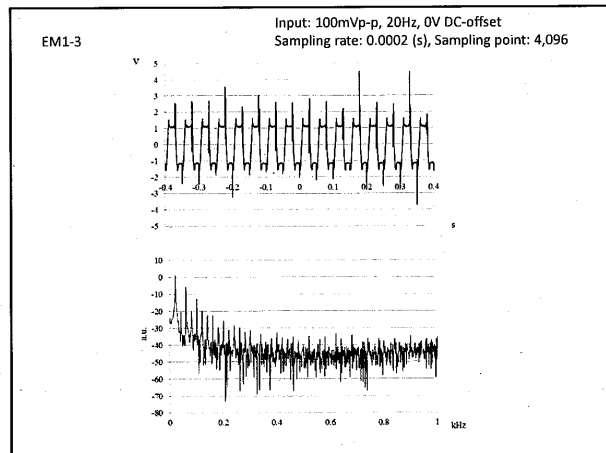
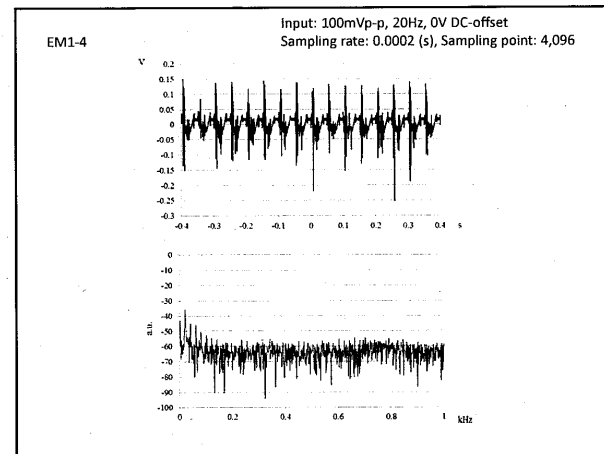
EM1: ch4 is strange

- Need to be discussed at the next IOO meeting.
- **Repair TAMA coil driver**
 - Current OP amp is already obsolete
 - OP amp replacement seem to be not enough
- **Use KAGRA coil driver**
 - KAGRA coil driver are already made (under test)
 - A kind of converter is necessary for handling differential signal output of KAGRA coil driver
- In either case, it takes a few weeks, I think.

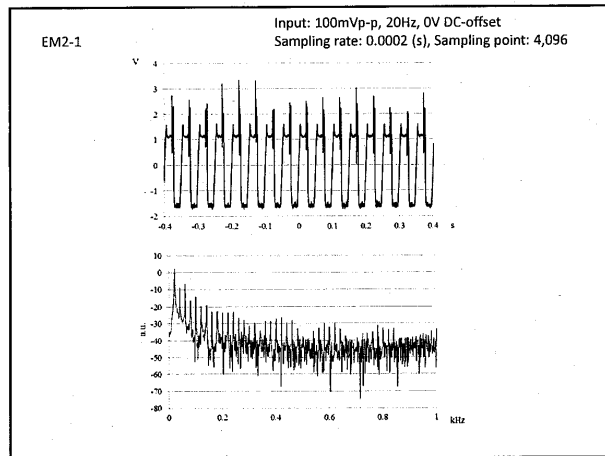
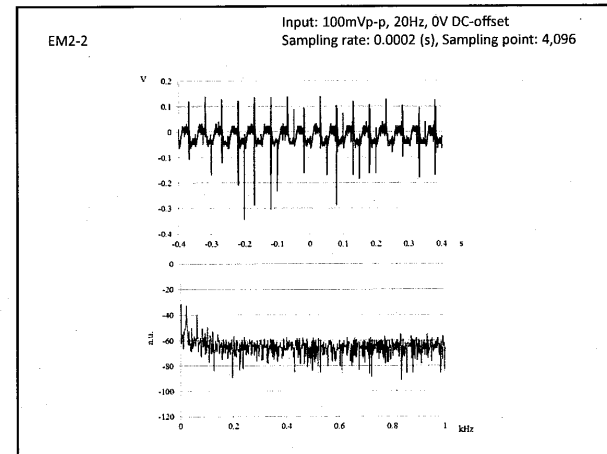
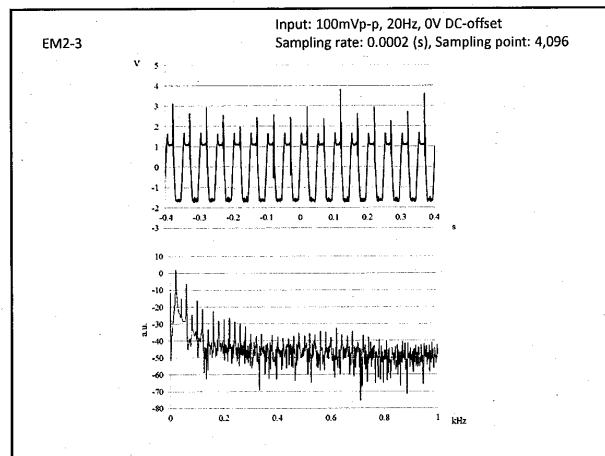
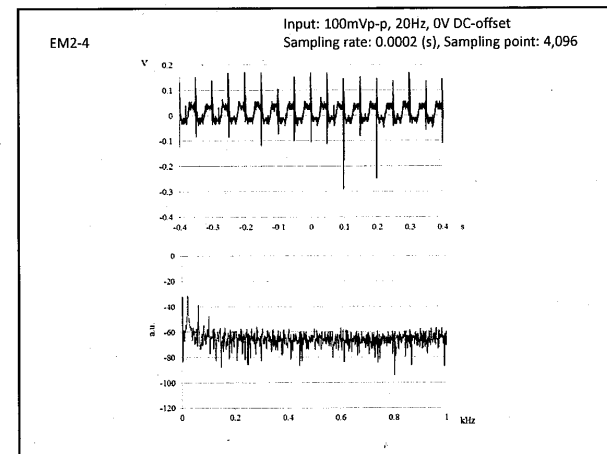
EM2: ch2 and ch4 are bad
