# **Current Status of Interferometer Alignment**

K. Izumi for commissioning teams  
2018 Feb. 6th

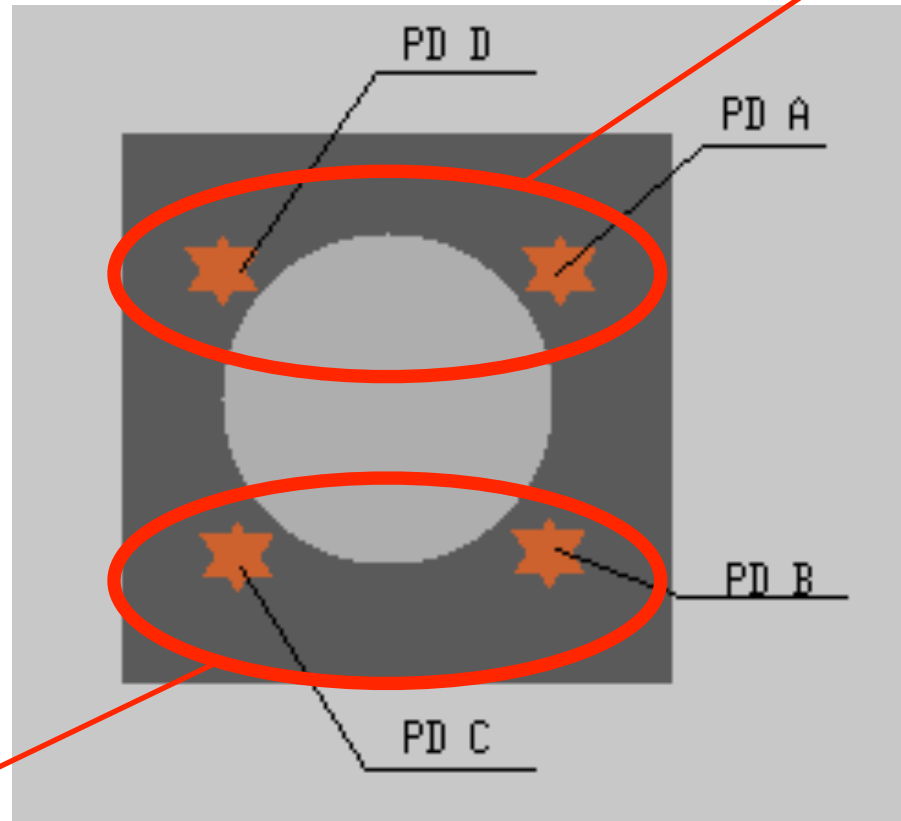
# Baffle PDs

no response  
to the  
interferometer  
beam

good!!

**Note: all the PDs were tested in air and determined to be functional**

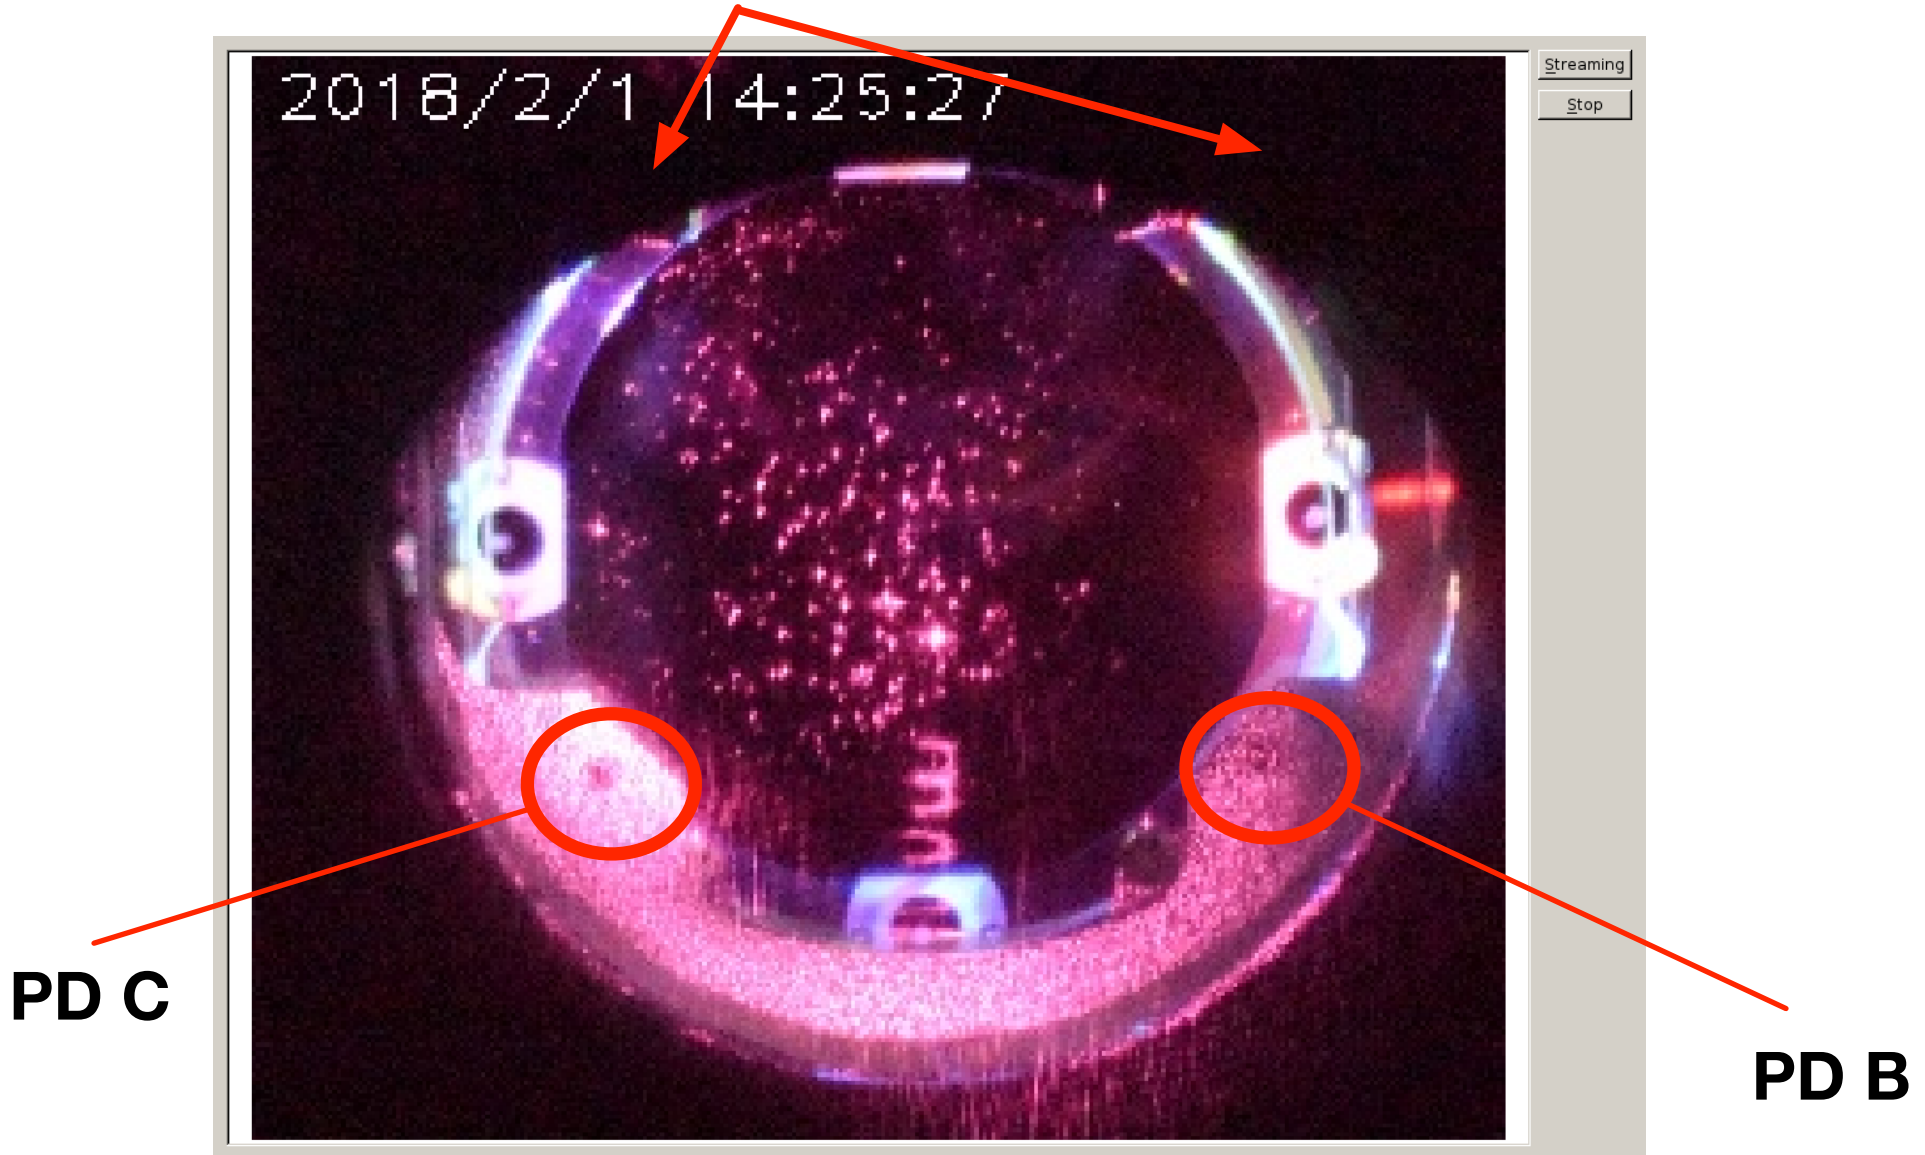
# PDs A and D are occulted?

=> The interferometer beam is occulted for the two non-responding PDs?

It looks like this black aperture occults the beam.

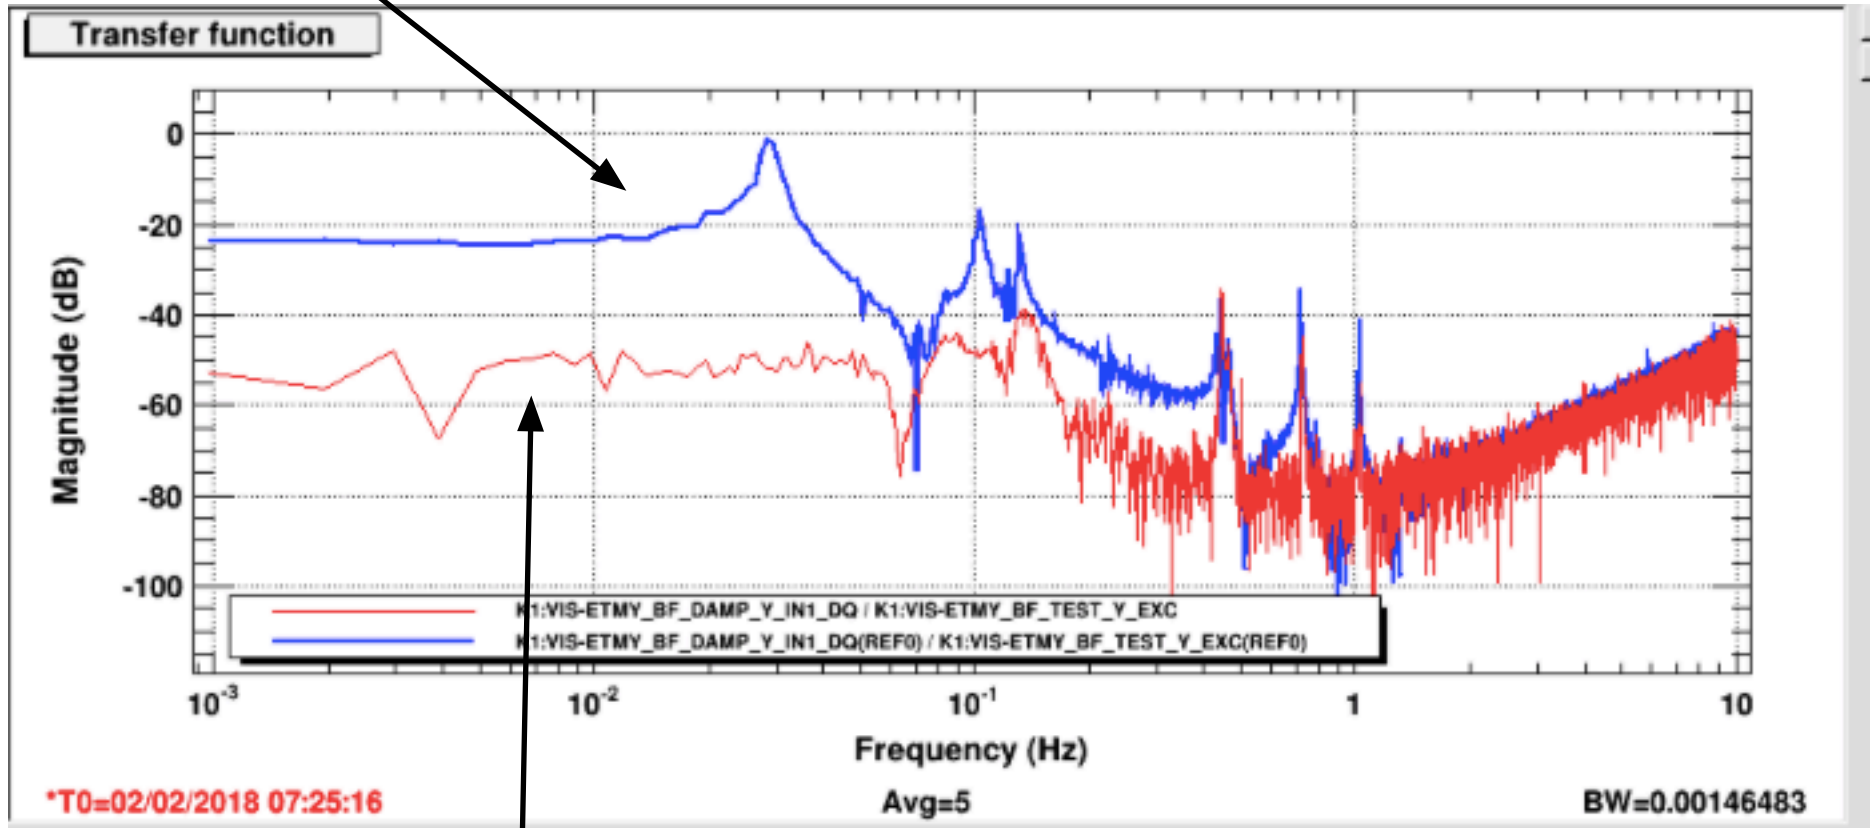
# Corrupted TF

✓ **The BF yaw transfer function was corrupted.**

=> In particular, the DC stiffness increased a lot, making the DC level lower by more than a factor of ten.

Jan.13th  
good

Feb. 2nd  
bad

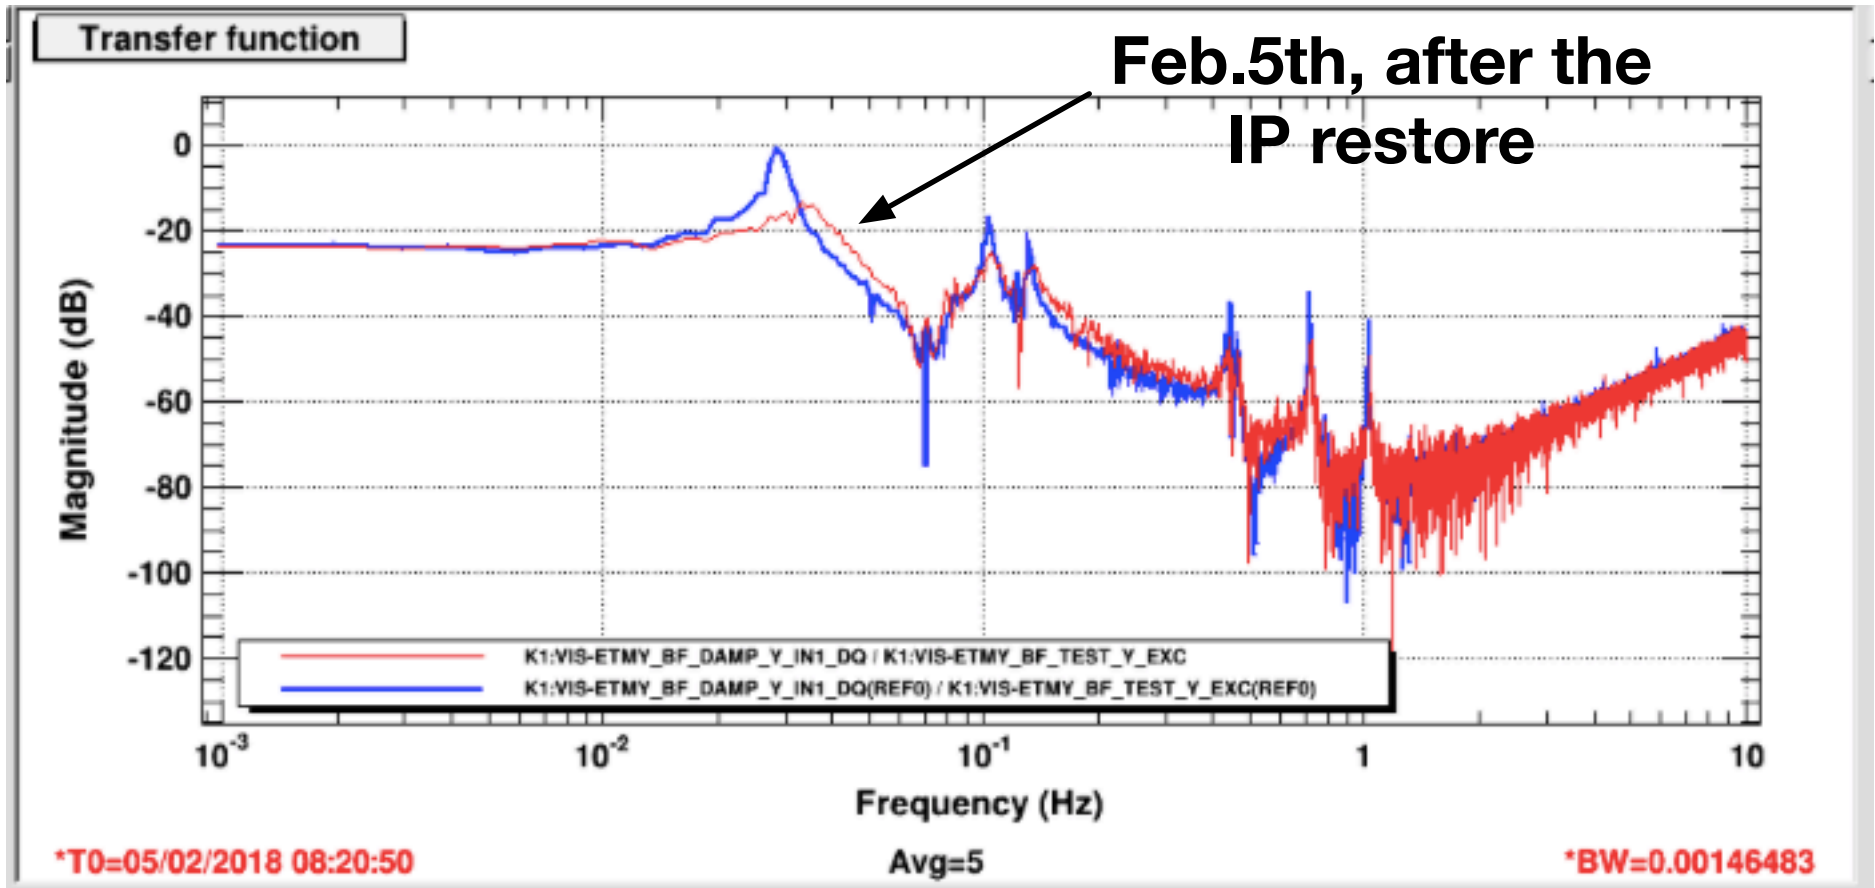
# After restoring the IPs

=> Moving IPs somehow alleviated the issue.

Much better although it seems still rubbing somewhere.
