Session: errors not to be made again  
*The beauty of hindsight:* a discussion of mis-steps in

# KAGRA

**Tomo Akutsu**

For the KAGRA collaboration

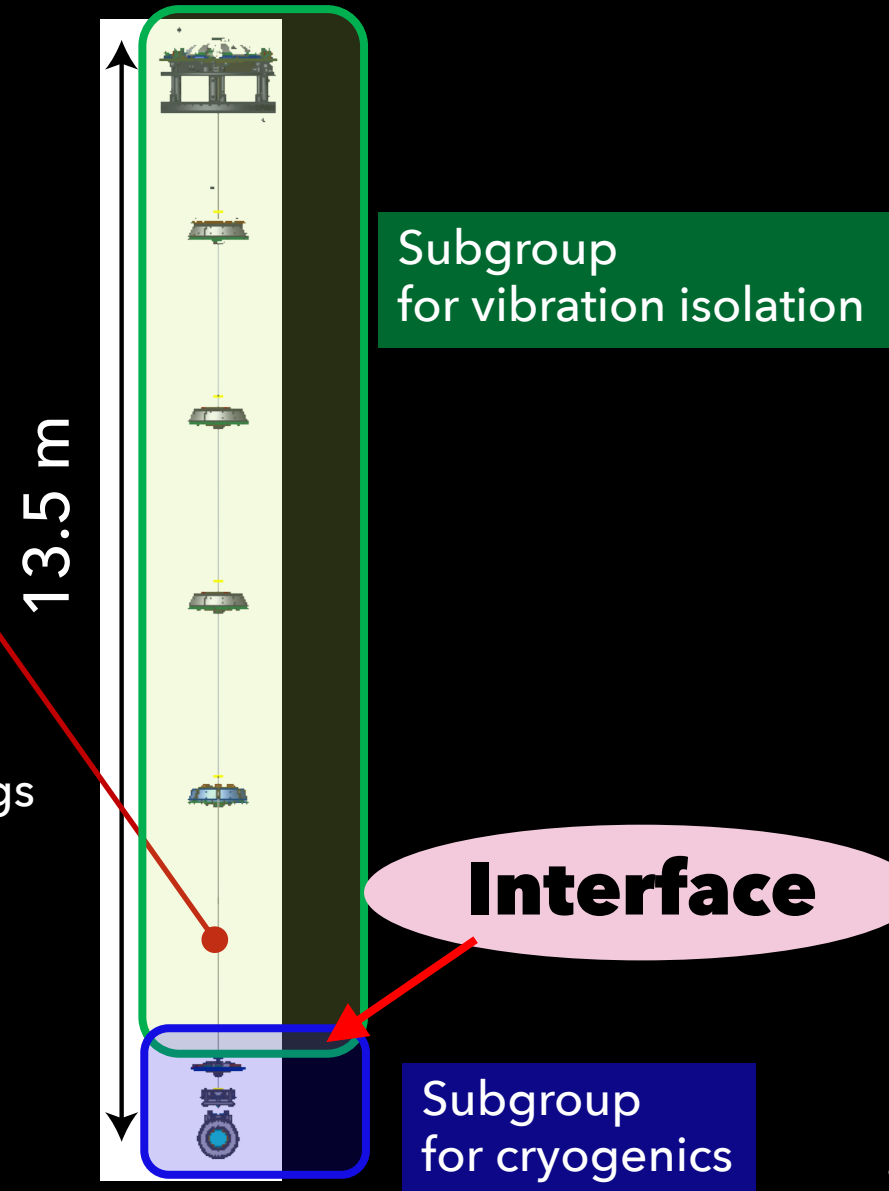
An example: we *finally* realized this on 18<sup>th</sup> May 2017 at the final timing of their integration.

Too long wire (~10 cm)

- We used different versions of the drawings each other.
- No system engineers.
- No interface control documents.

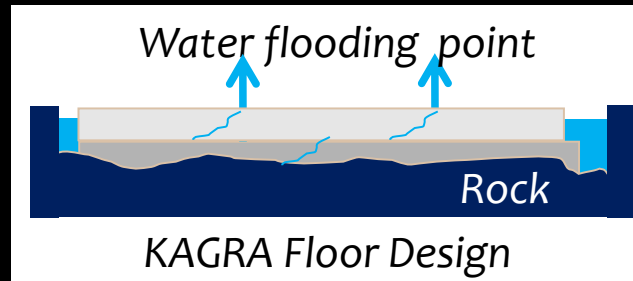
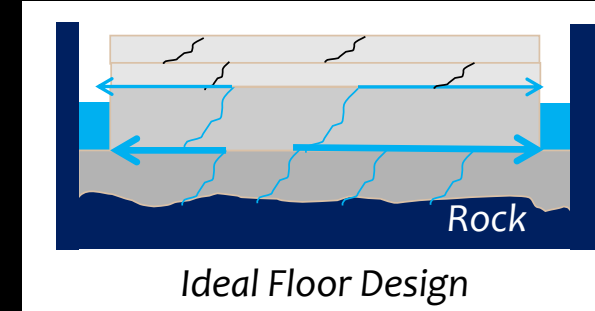
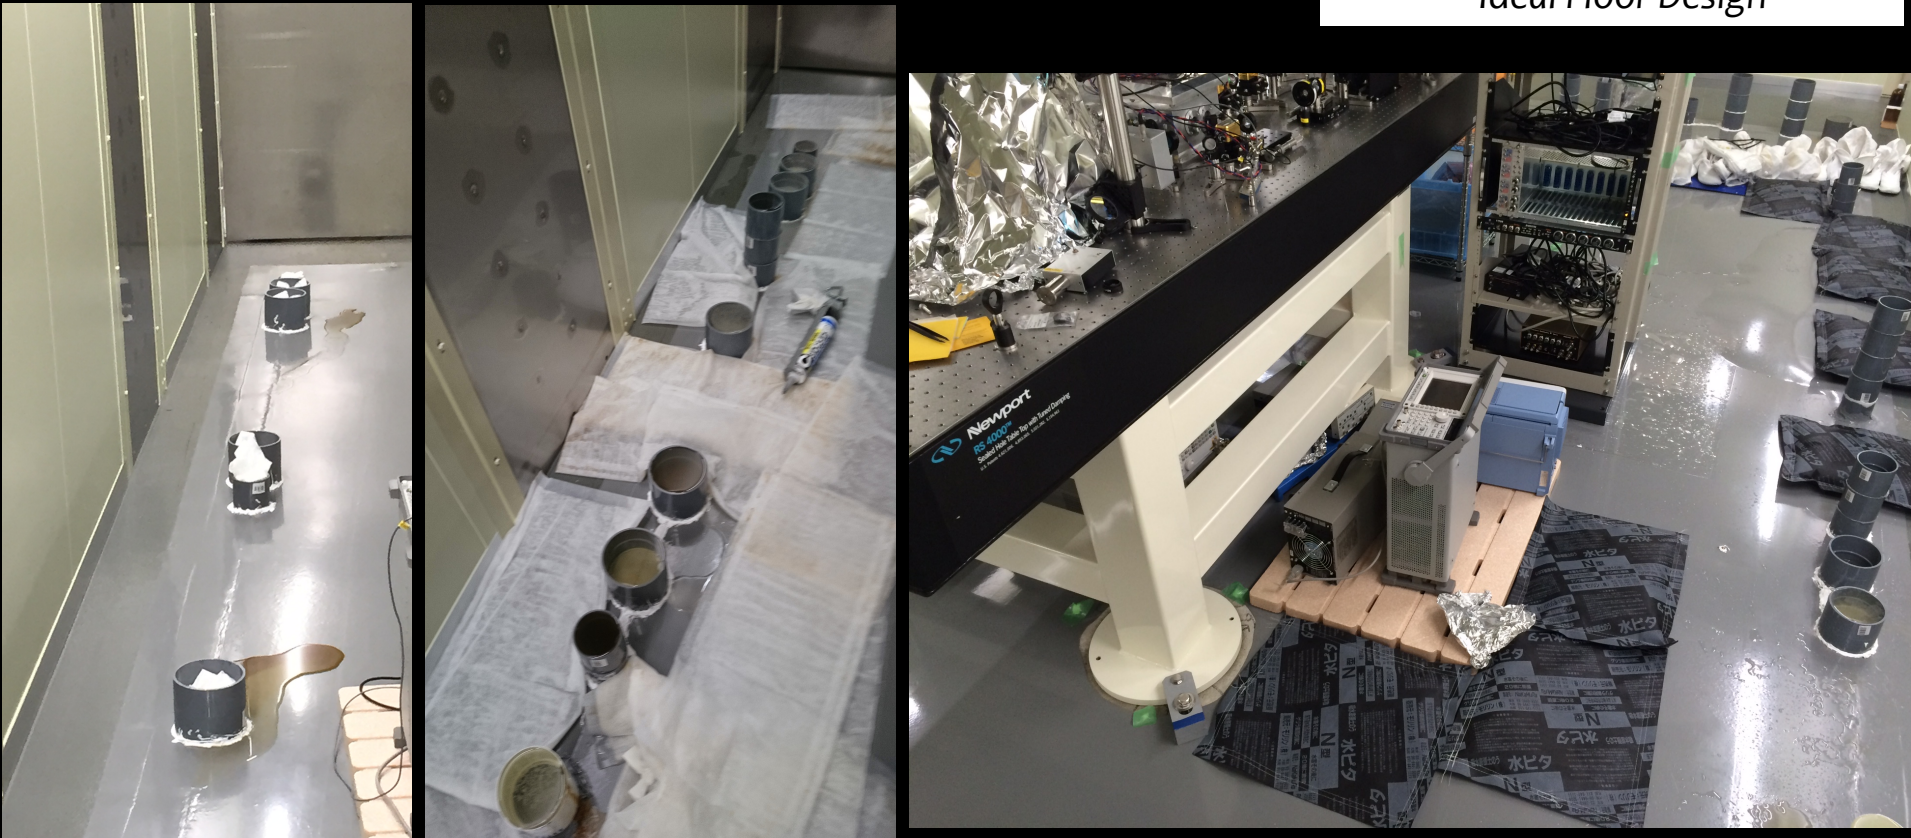
# Groundwater in the PSL clean room

- Note: you can find groundwater and rain everywhere in the tunnel!
- This is just an example of the (endless) fights from Dec 2014 to Apr 2015.

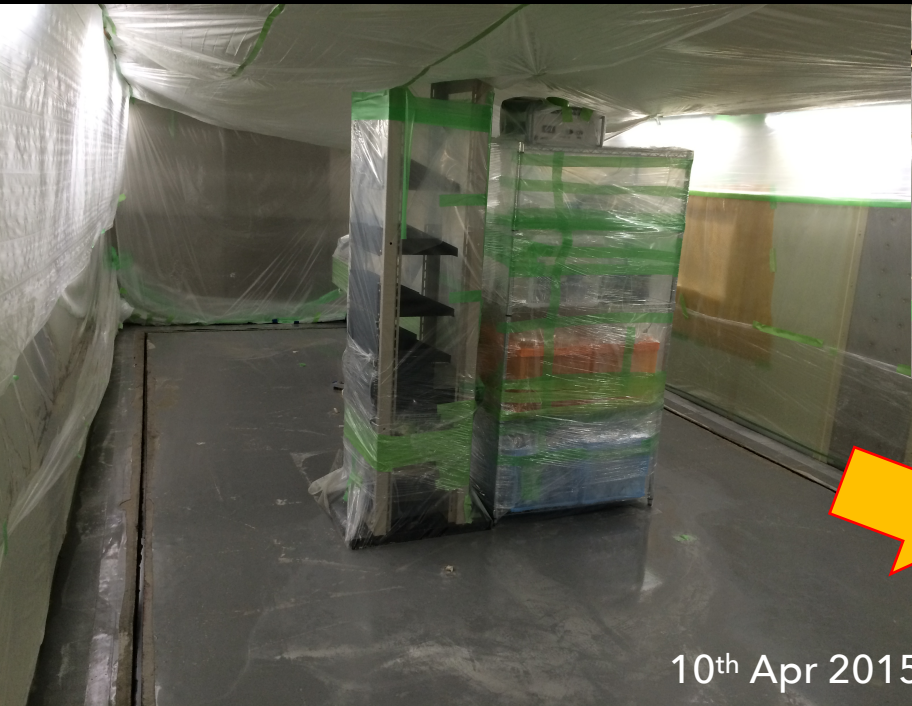
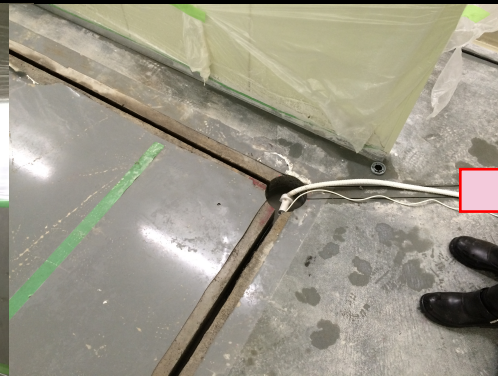
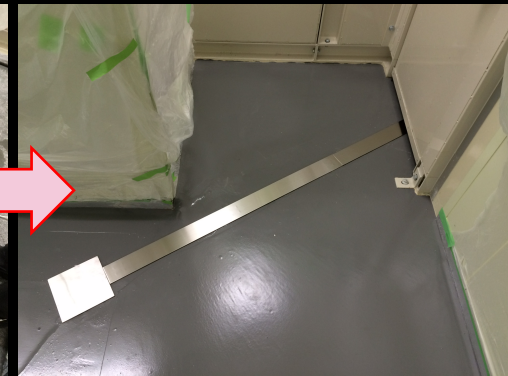
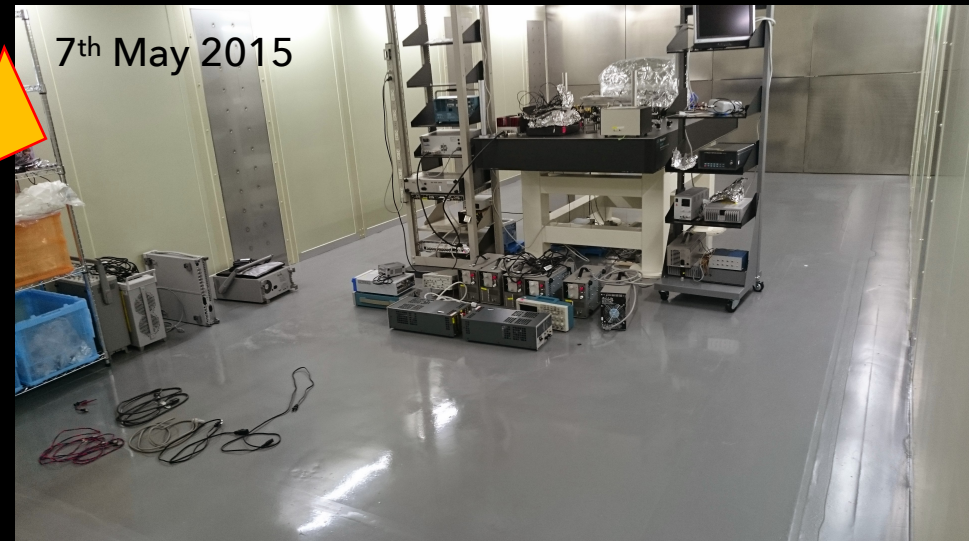
# Groundwater in the PSL clean room

Built new drainages

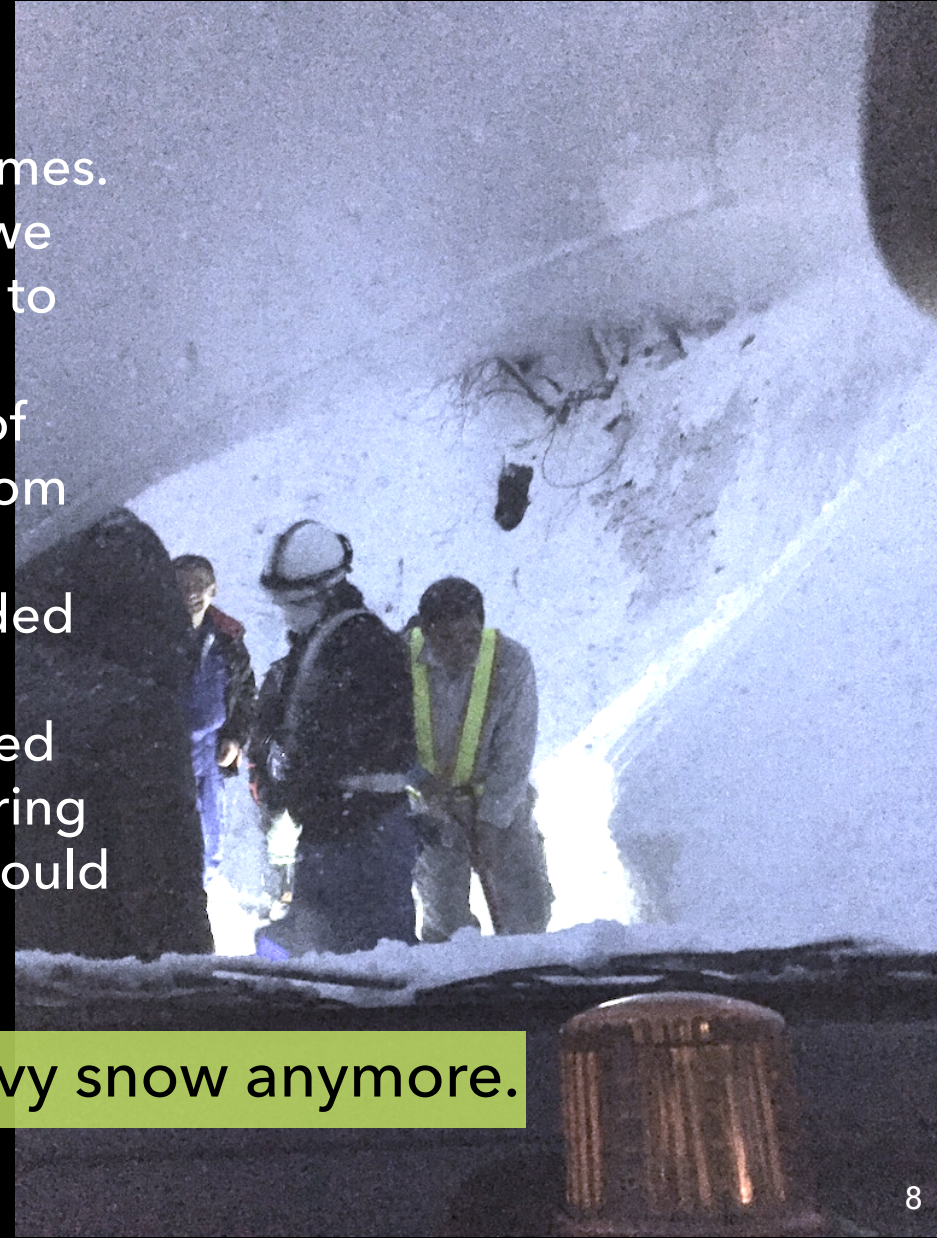
- E-cars are useful in the tunnel; no fumes.
- On the day, due to heavy snowing, we stopped the works earlier, and tried to drive back from the tunnel.
- The car was trapped in a heavy fall of snow, and small avalanches came from the right.
- We tried to dig out the car, but needed to wait for arrival of a snowplow.
- In the car, the heater should be turned off to keep the battery of the car during the waiting; otherwise the battery would be running out in the low temp.

We don't use electric cars in heavy snow anymore.

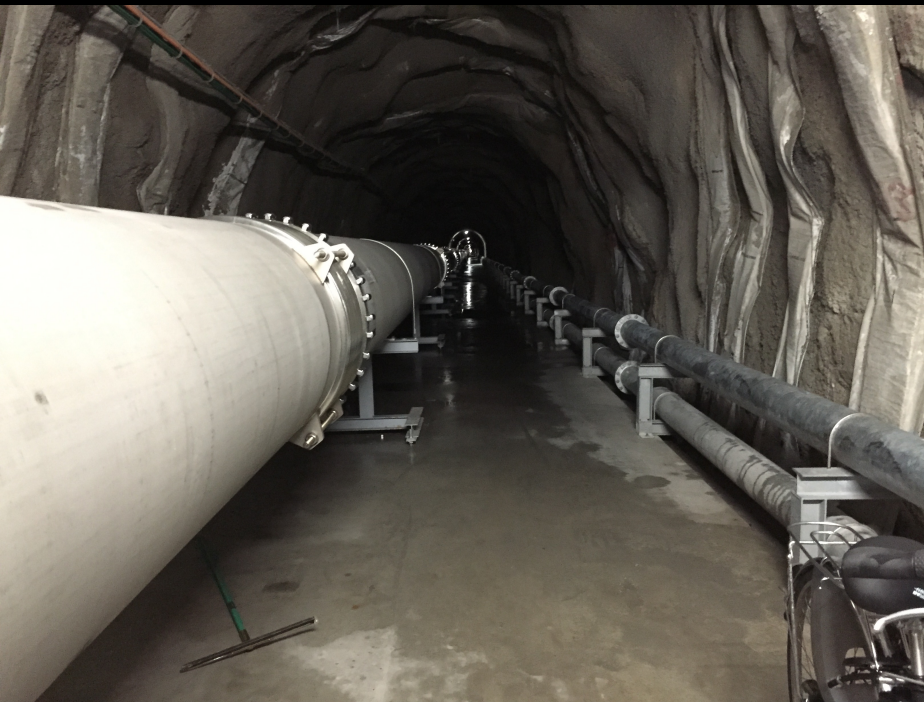
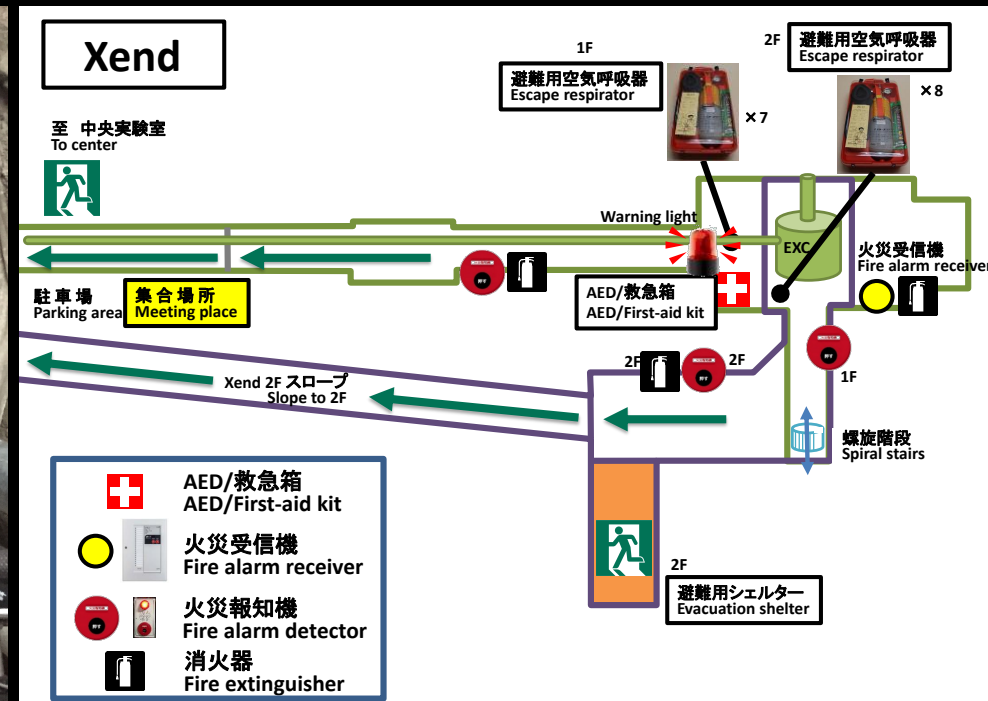
- The tunnel has a dead-end at the end of the X-arm; not escapable.
- The number of portable air tanks (respirators) are limited.
- The volume of the tank would not be sufficient for 3-km running; usable for only 10-min walking, 5-min running. (ref: I take 12 mins by E-assisted bike + walk.)

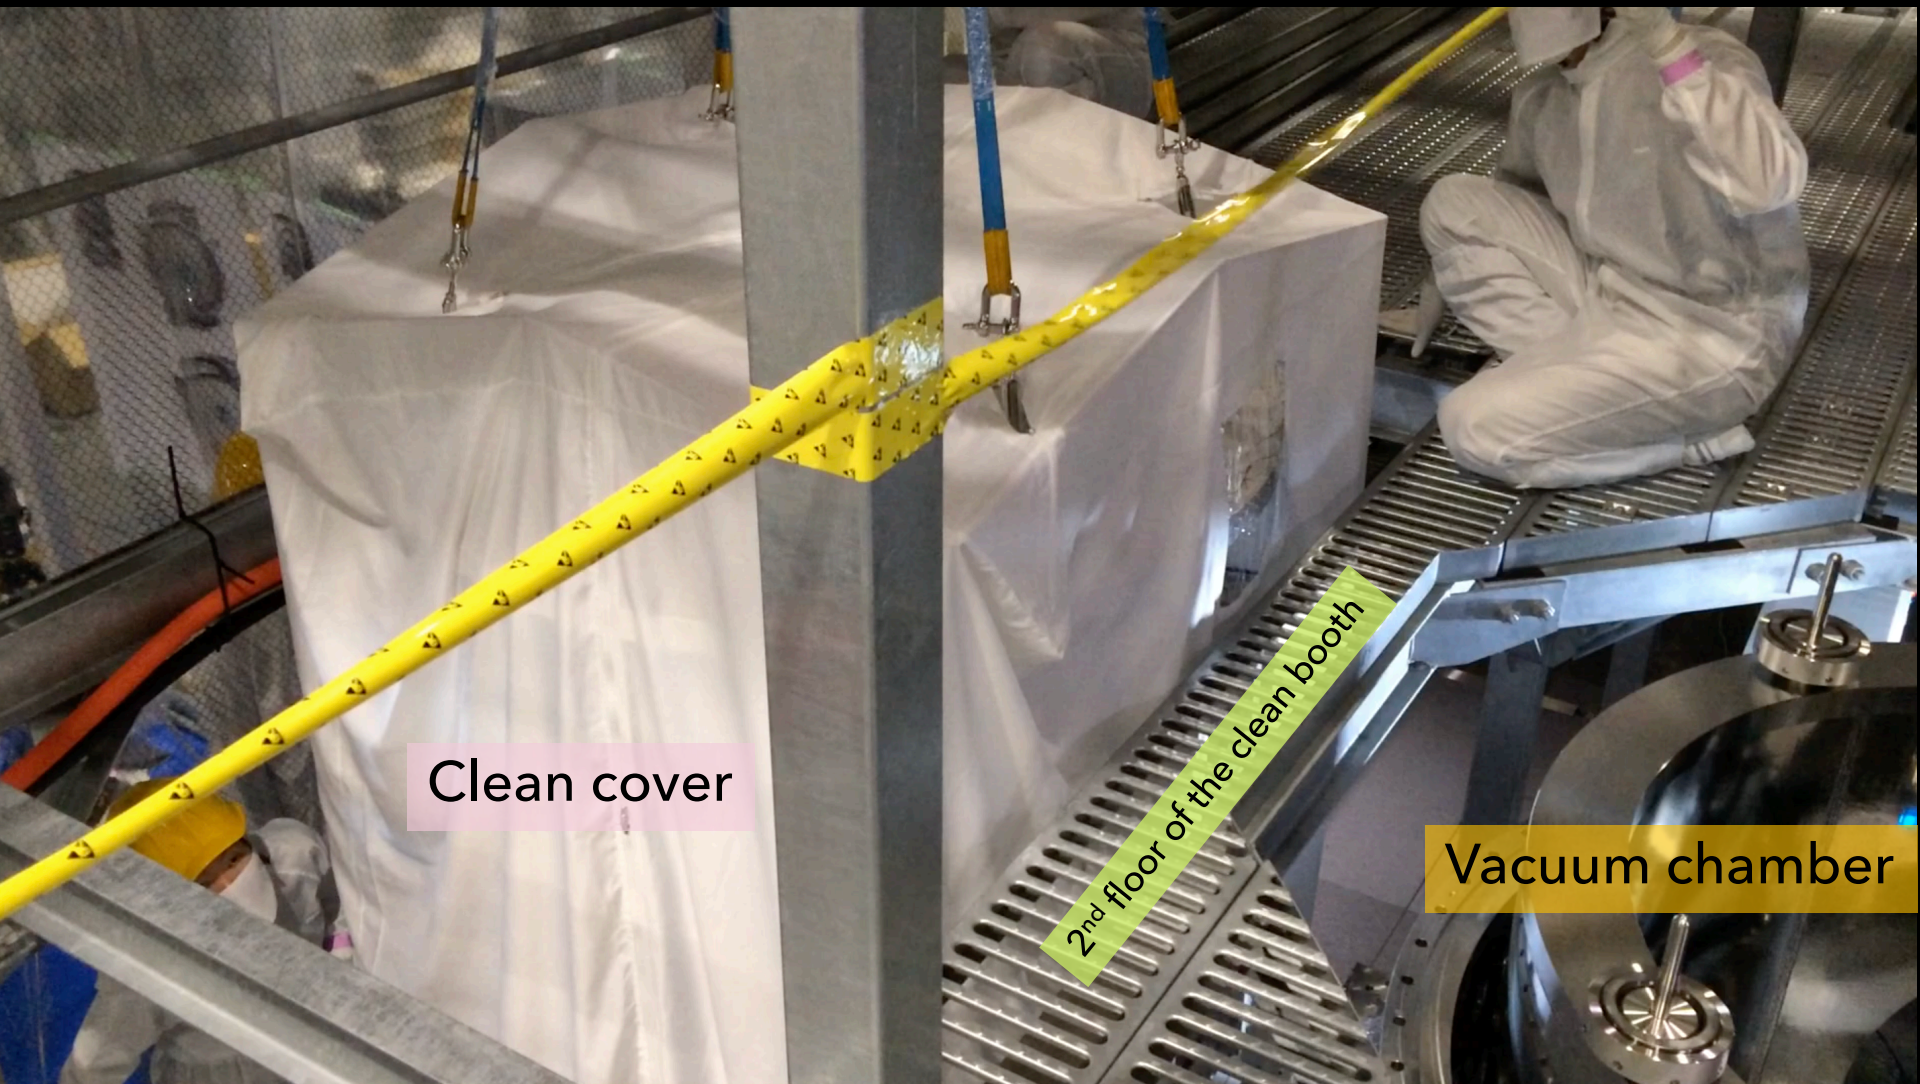
At the installation test of a suspension with a spare mirror for PR3 on 10<sup>th</sup> Dec 2015

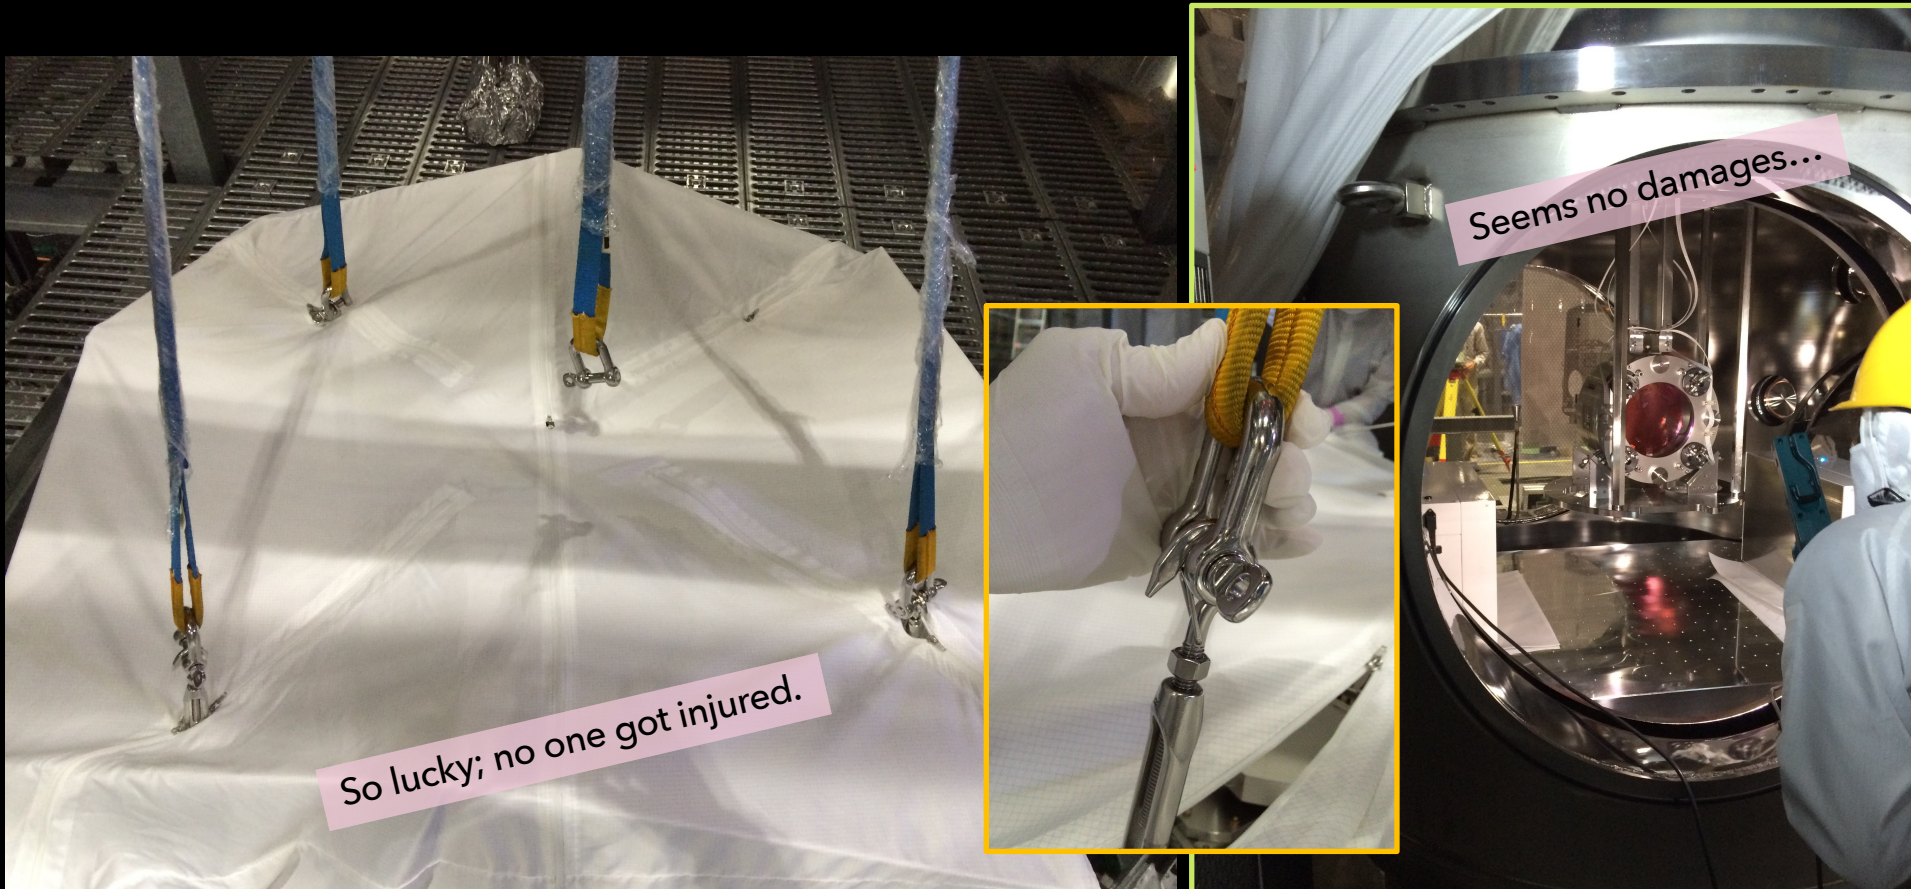
- One of the four turnbuckles (to balance the load) suddenly unhooked during the crane work.
- The load fell ~ 1 cm and arrived (crashed!) onto the target position!

- **Mystery:** neither the turnbuckle nor the shackle seemed broken; a bad hooking from the first!?
- If so, the clean cover hid the bad hooking?? → Now we don't use such turnbuckles for these works.
- Plus, actually a pair of hook points were connected by a single sling. If the turnbuckle would have unhooked at the higher position, the paired point would lose the tension at once, and the load would swing, and caused severe injuries... again, we were so lucky. → "One hook for one sling".

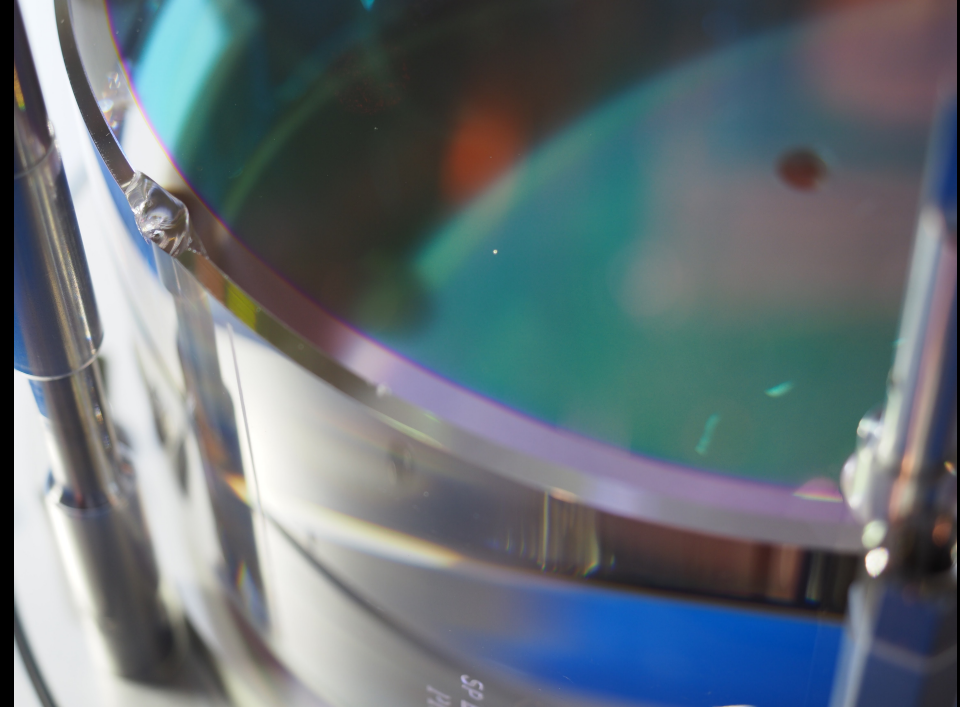
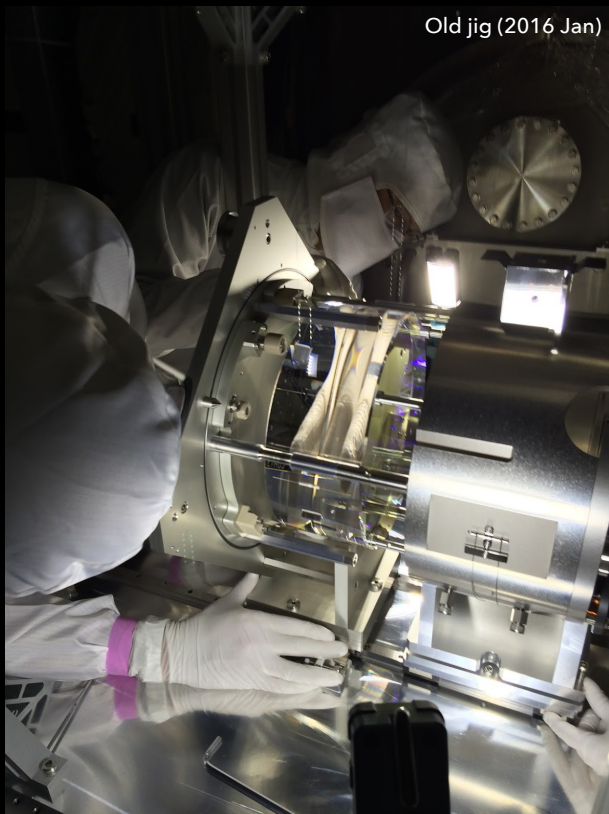
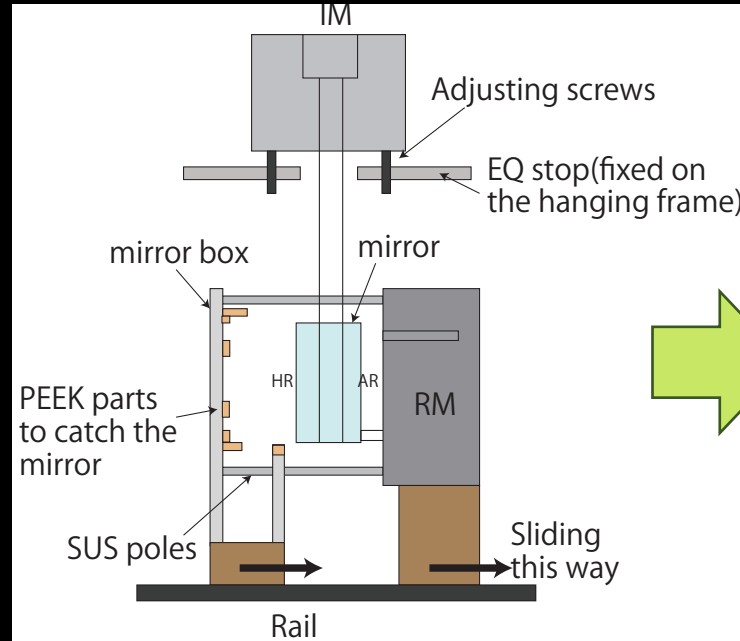
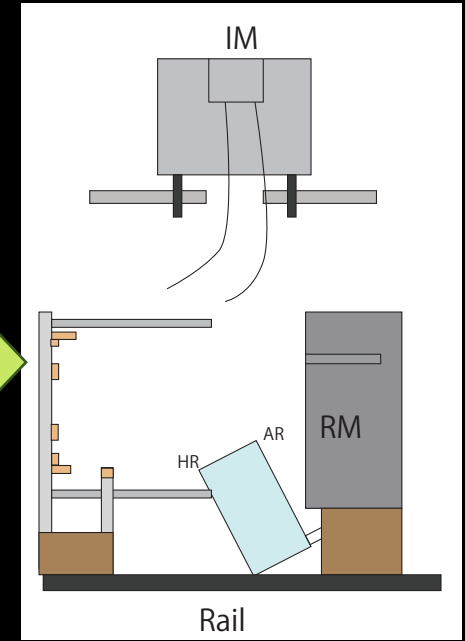
Happened when the workers tried to detach the PR3 mirror from the suspension for the upgrade from iKAGRA to bKAGRA.

→ We stopped, and took time to modify/re-consider the jig and the procedure.

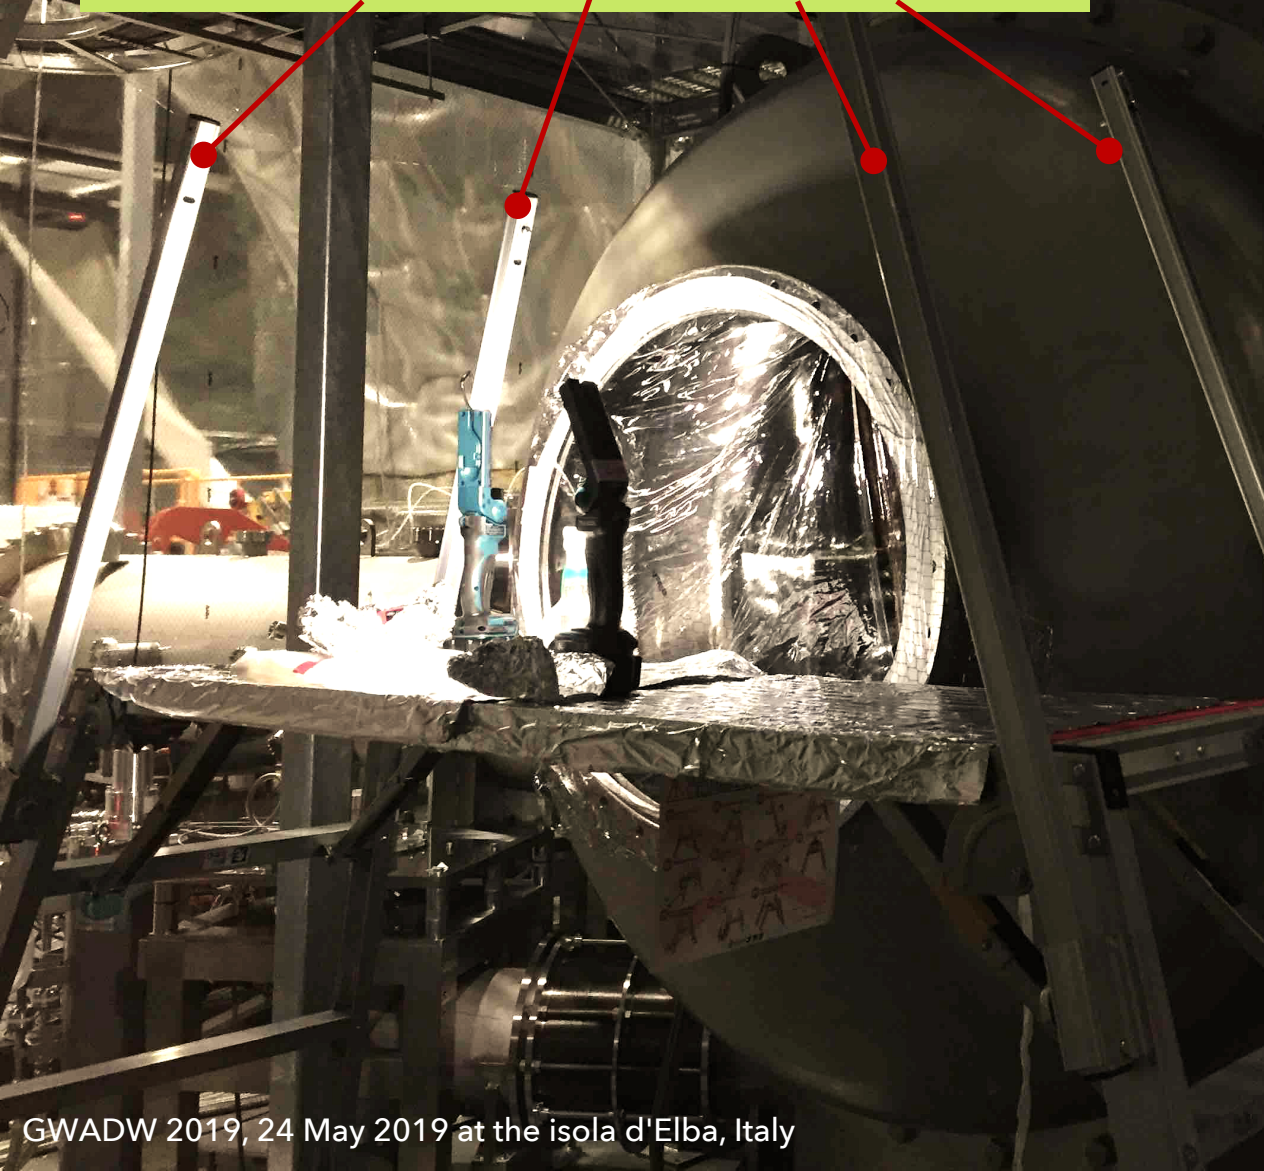
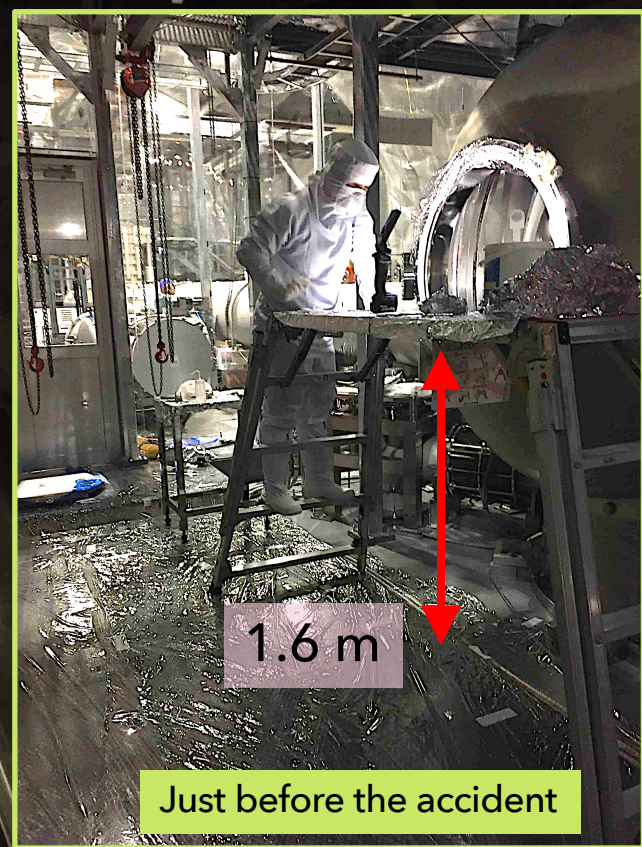
So lucky: the worker did not get injured at all.

Just before the accident

Those handles must be extended as written in the manual.

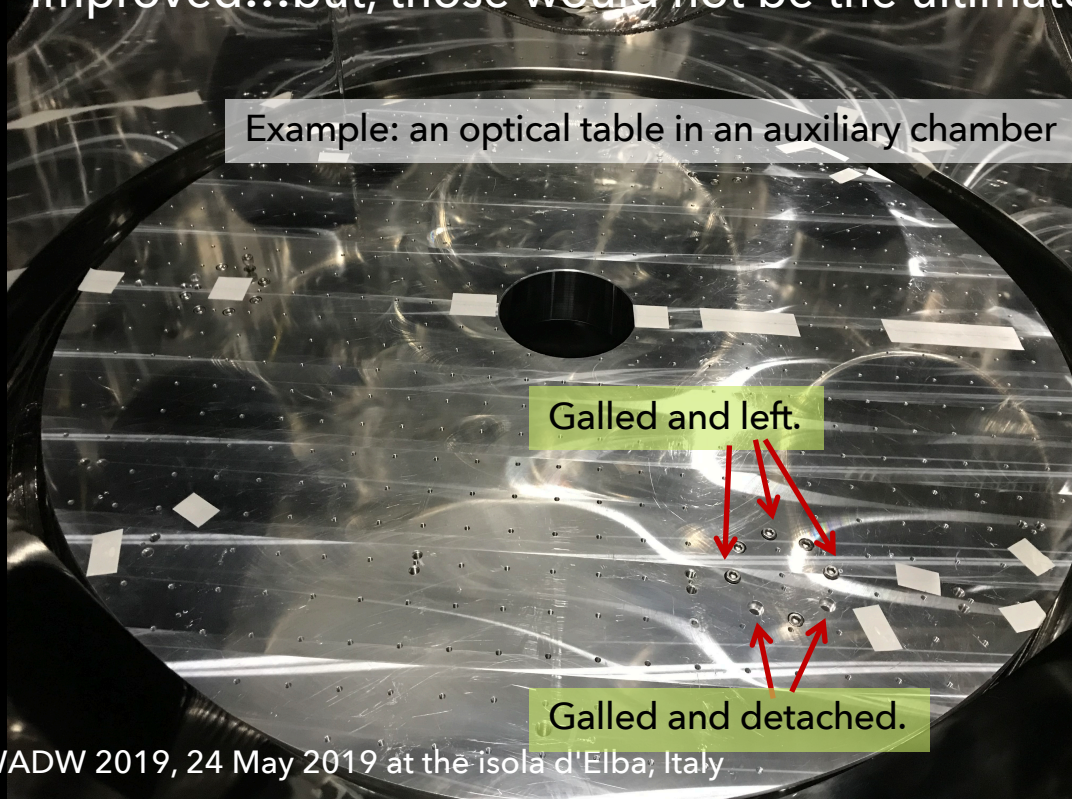
- Stuffs made of the same material (metal) adhere each other easily.
- Typical: washed SUS parts with screw holes used in vacuum chambers

Example: an optical table in an auxiliary chamber

Galled and left.

Galled and detached.

- Screw policy <https://gwdoc.icrr.u-tokyo.ac.jp/cgi-bin/DocDB/ShowDocument?docid=5107>
- For the SUS parts, SDC clean bolts or chemical washed BUMAX109 should be used.
- Improved...but, those would not be the ultimate answers; keep investigations.

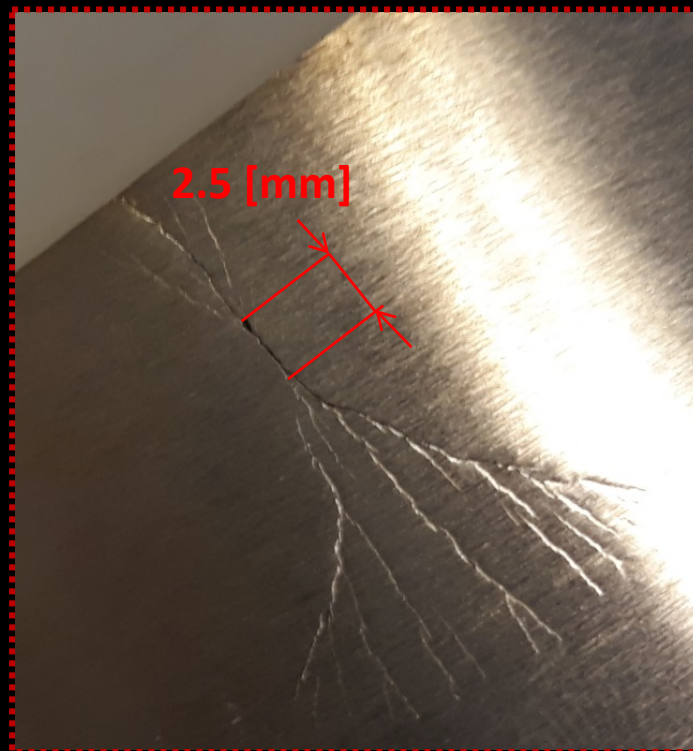
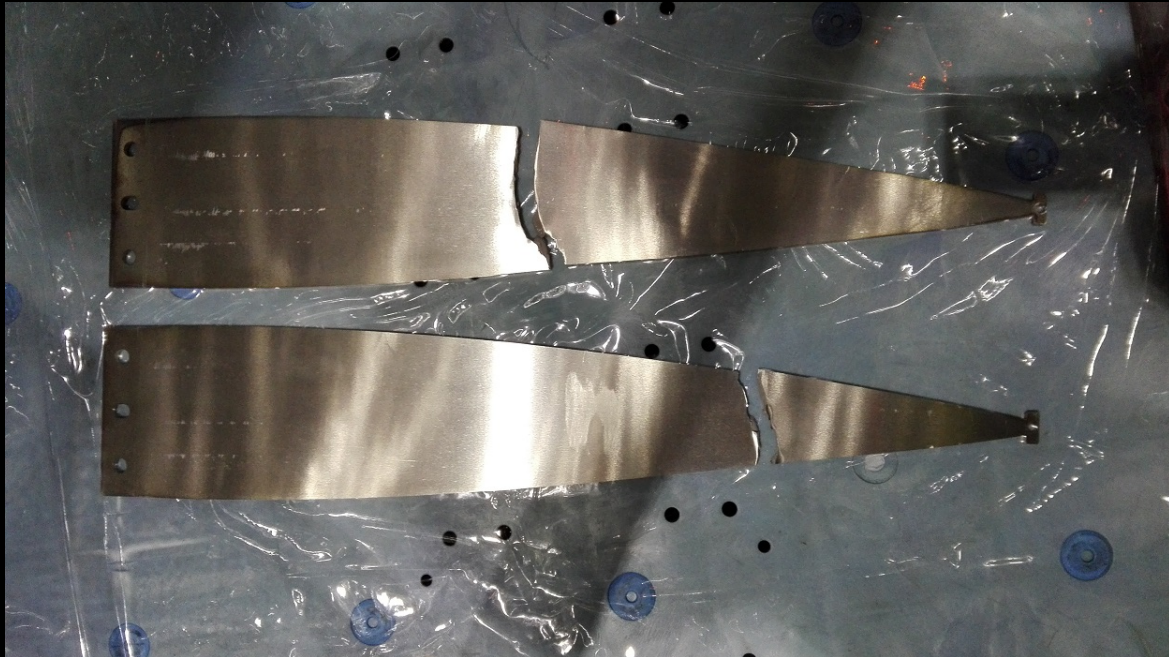
- Some of thick blade springs for top GAS filters were broken or cracked.
- Imported and stocked for a long time...
- The process and why they broke have been investigated and reported.
- Replaced with new ones (in the new process) made in Japan.

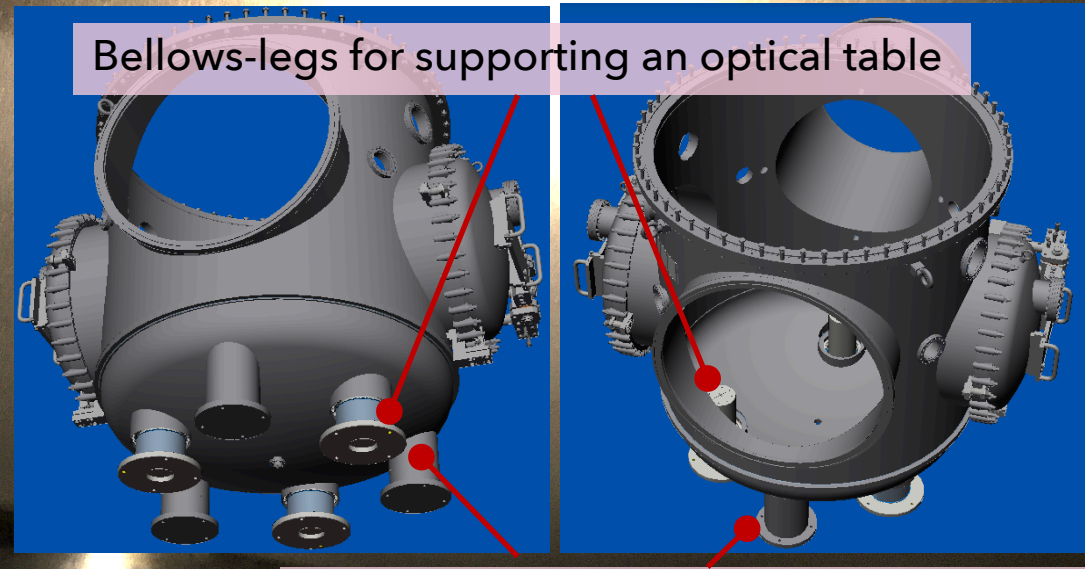
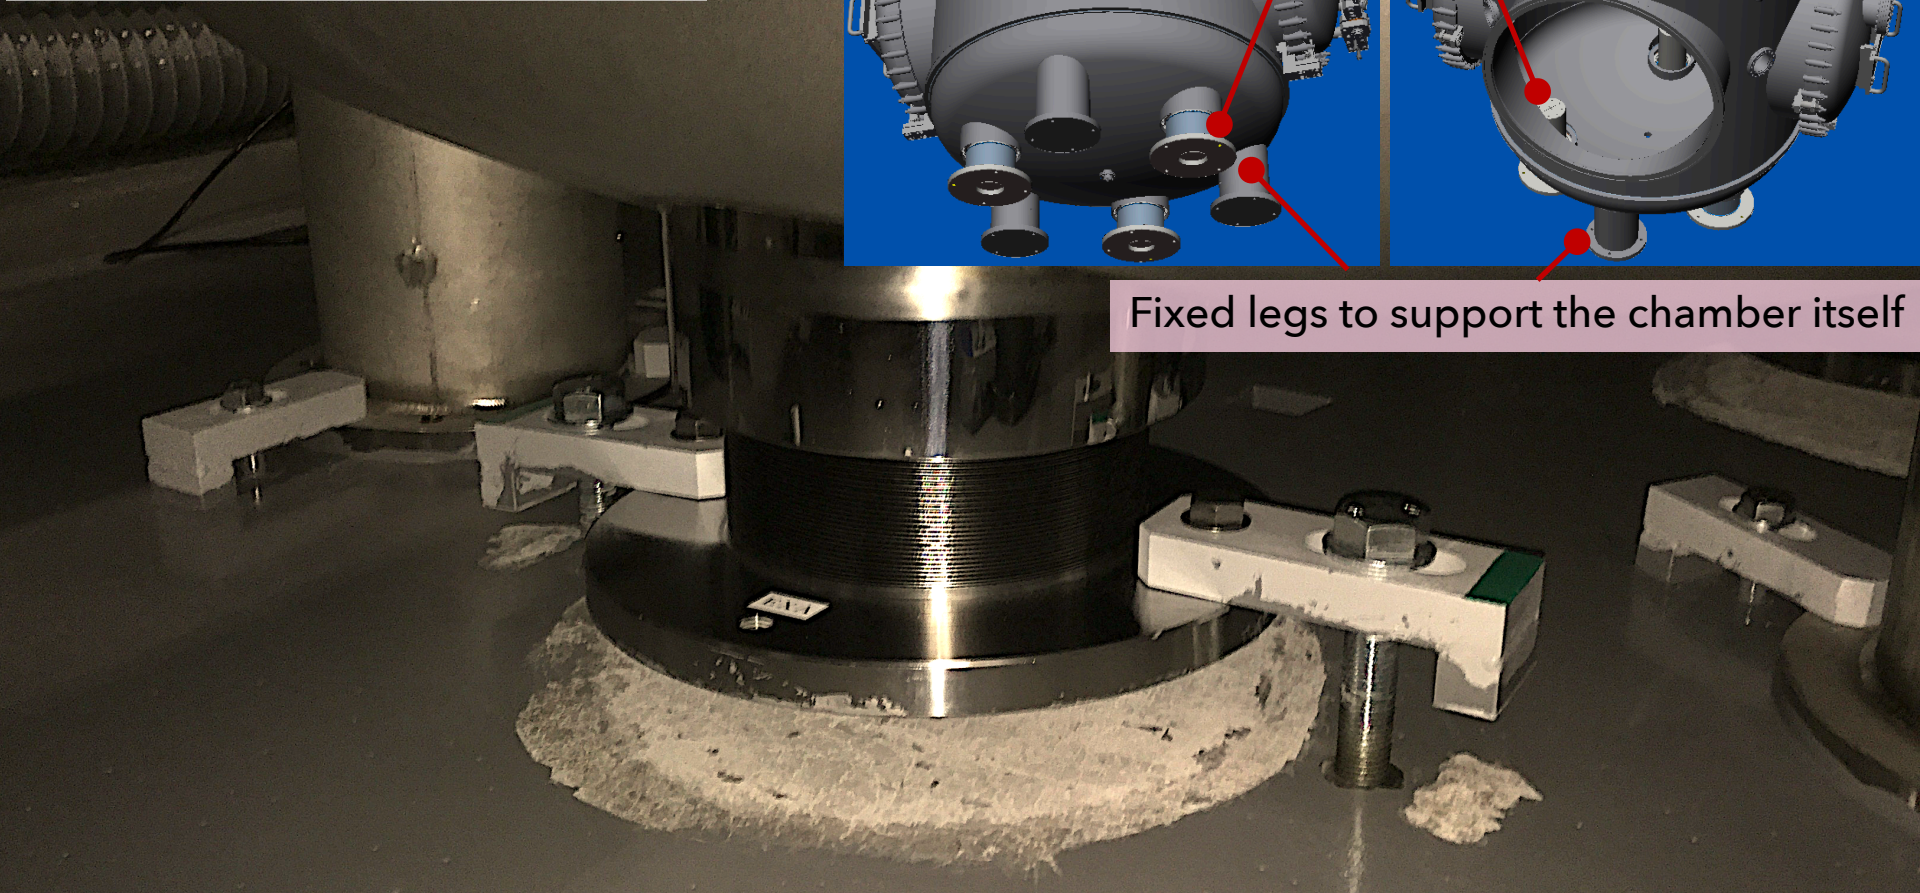
The optical table in the chamber was also floated.  
A freely suspended (iKAGRA-)ETM was on the optical table... → no damages

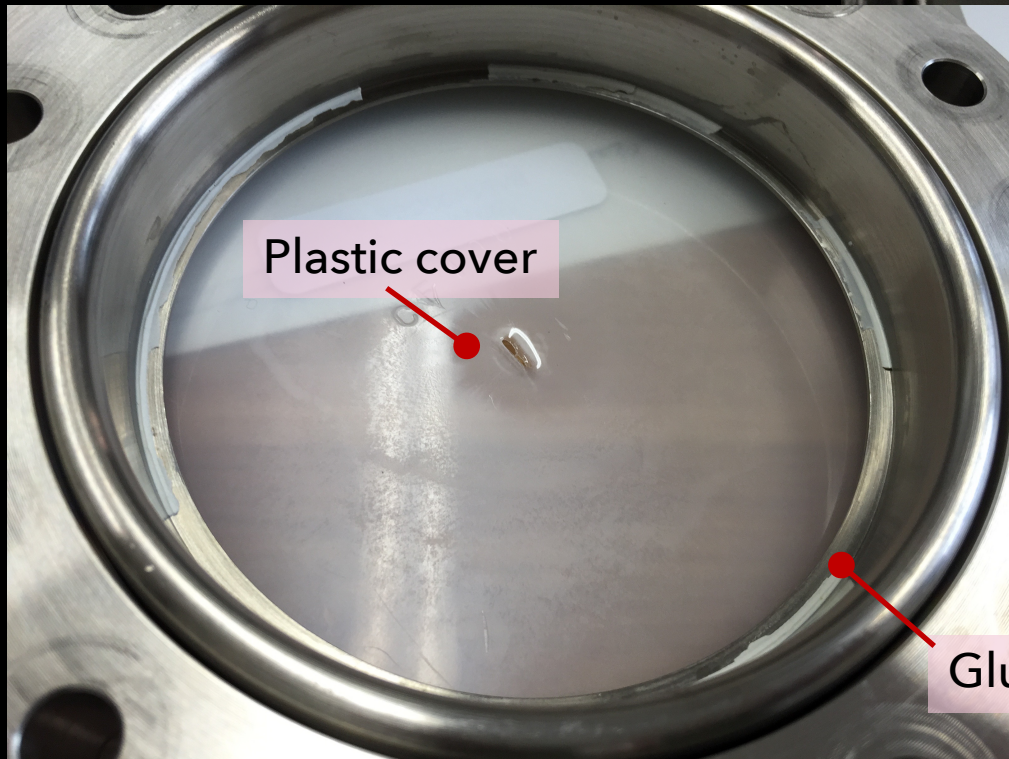
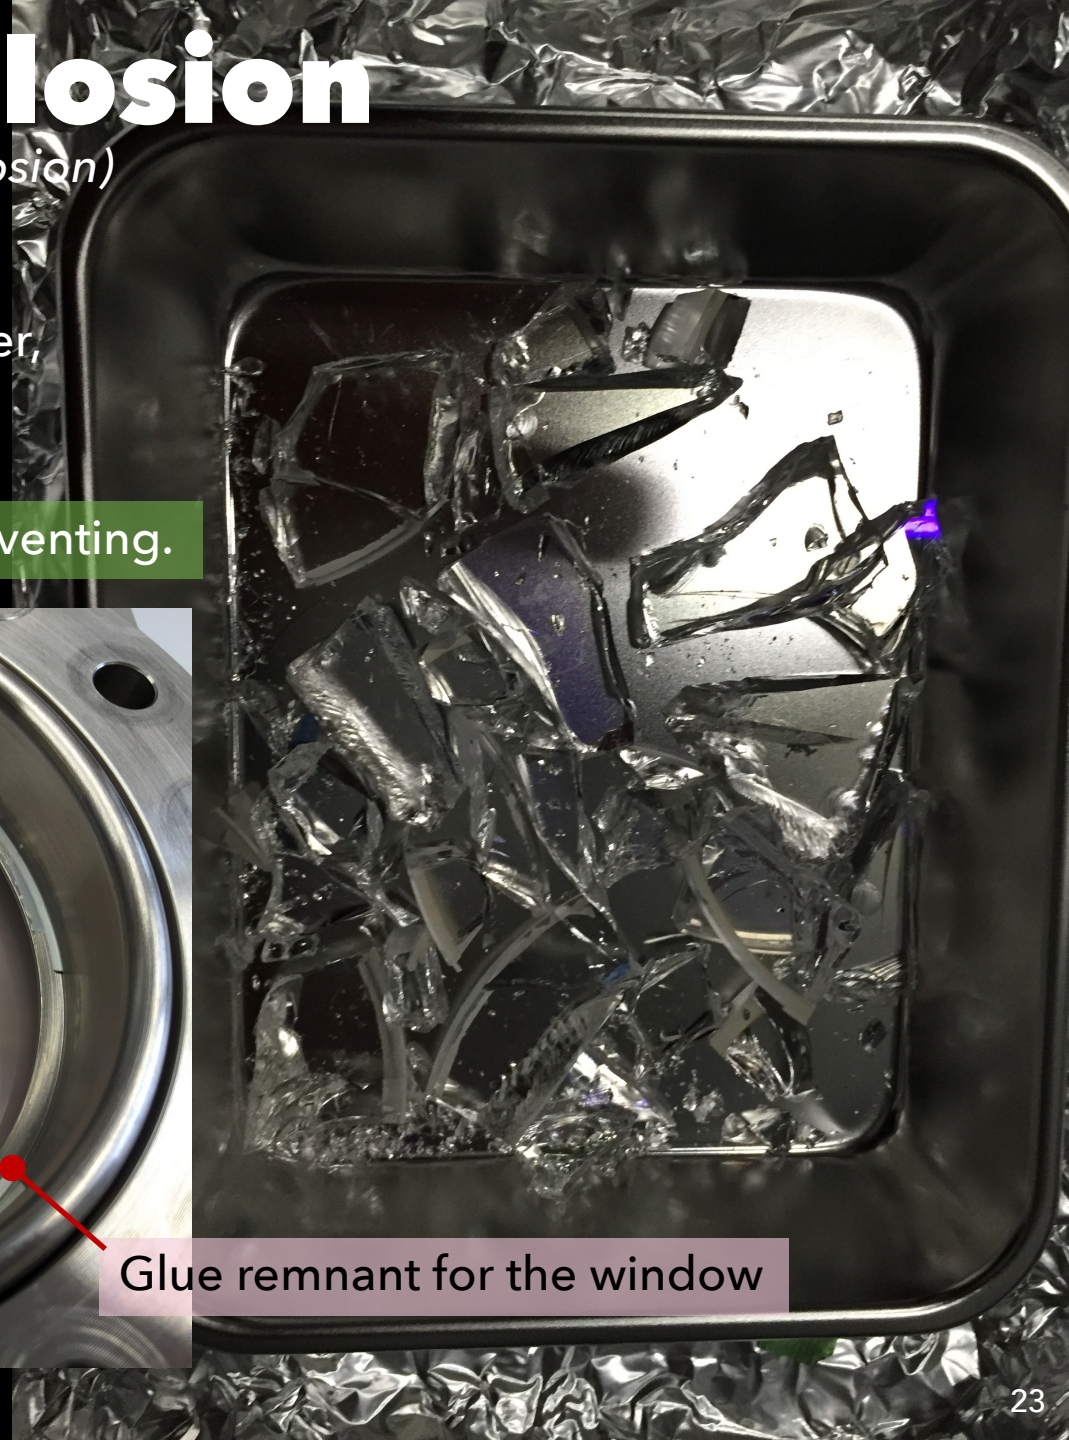
- We were hurry to vent the chamber, as the inside had levitated.
- No safety valves for over-pressure

Now we attach a safety valve-ish for venting.

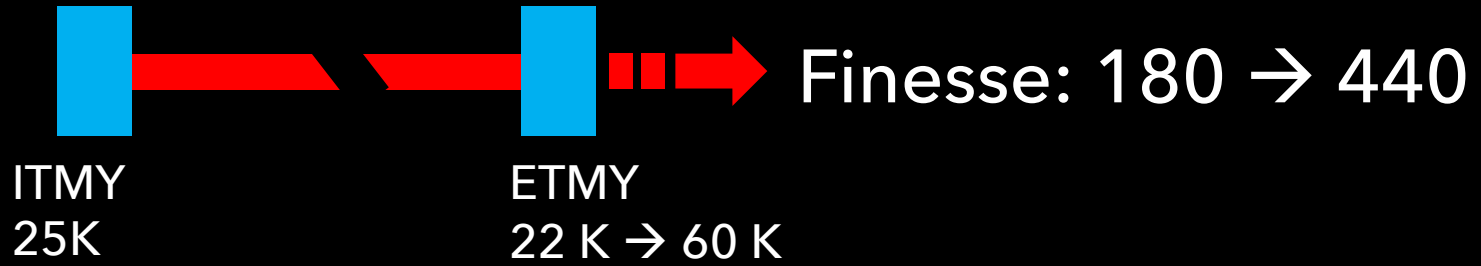
We found the finesse of the cryogenic Y-arm cavity was too low... suspected icing on the mirror(s), so started to heat up.

- In the chamber, it has been  $\sim 10^{-5}$  Pa
- If the reducing finesse is due to the icing, what made them?  $N_2$  and/or  $H_2O$ ?  $\rightarrow$  comparing the pressure monitors and temperature varying; adding mass spectrometers...
- What else?...
