Session: errors not to be made again  
*The beauty of hindsight:* a discussion of mis-steps in

# KAGRA

**Tomo Akutsu**

For the KAGRA collaboration

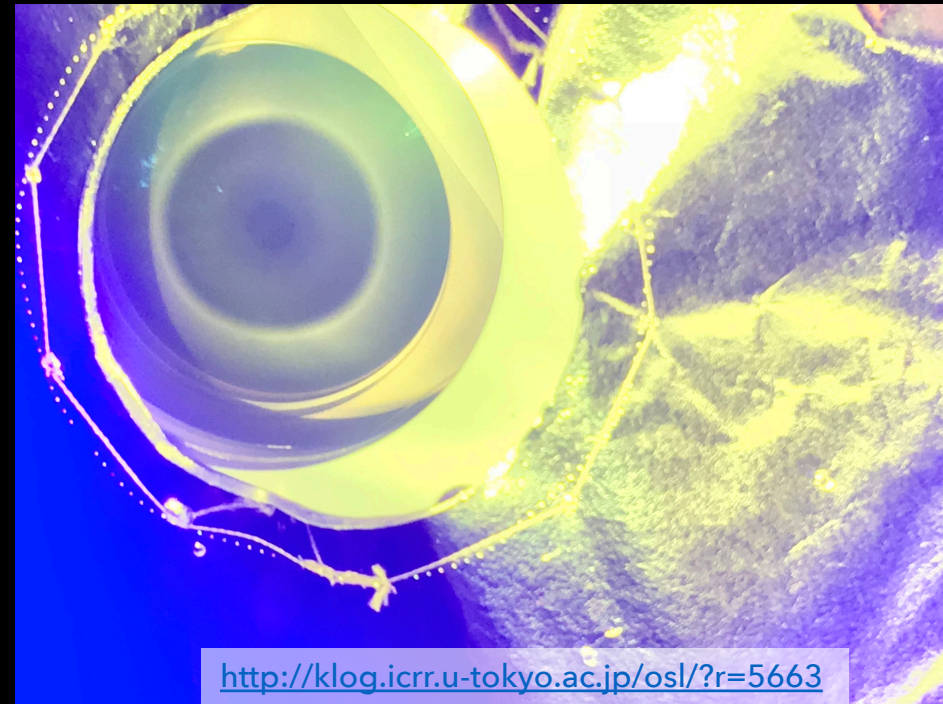
Actually, icing was already observed for viewport windows for oplevs the other day.  $\rightarrow$

Photo of a frosted window for oplev (31<sup>st</sup> Jul 2018)
