Mode Cleaner suspension installation

Naoko Ohishi^A, T. Saito^B, K. Doi^C, M. Nakano^C, K. Shiga^B, T. Narita^C, K. Hirai^B, R. Takahashi^A, T. Sato^B, M. Ohkawa^B, S. Kawamura^C, T. Uchiyama^C, Y. Aso^A, and E. Hirose^C A: NAOJ, B: Niigata Univ., C: ICRR

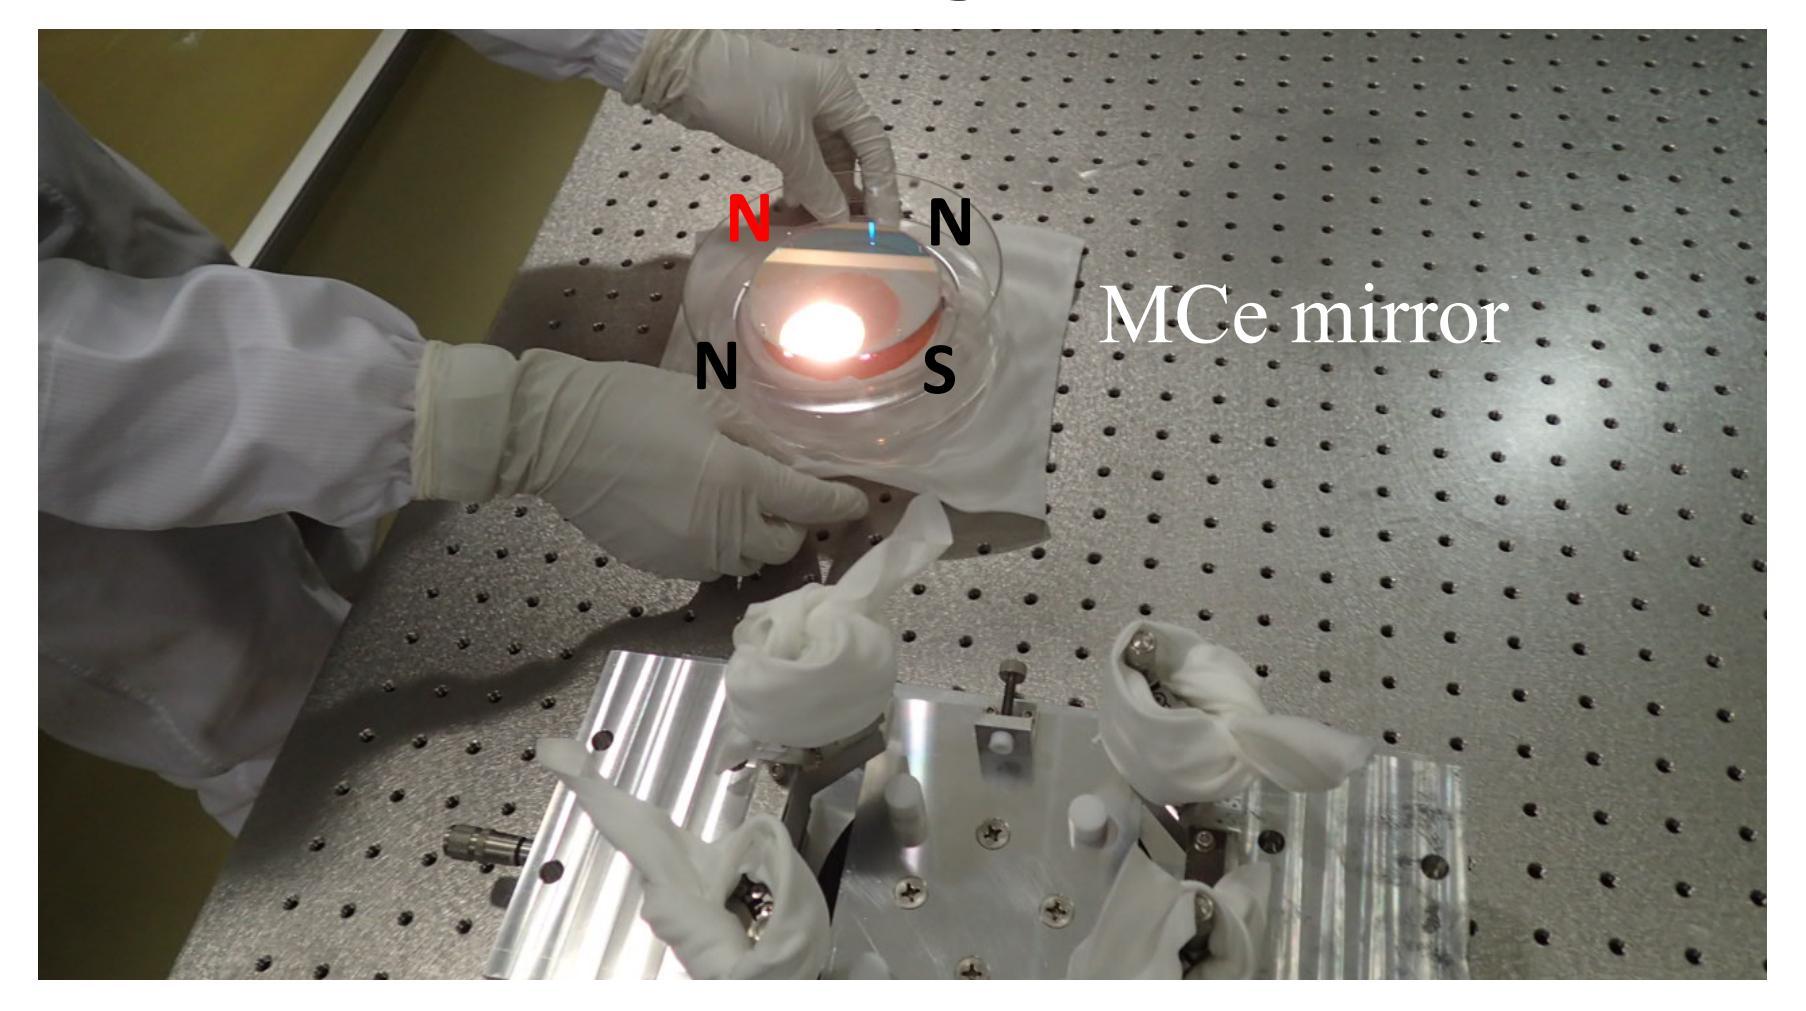
Glued a magnet in the wrong direction

We used magnetometer for MCi and MCo but didn't for MCe

- Evaluation of magnetic field (Michimura-san)
 - NNNS is Permissible in terms of displacement noise
 5e-15m/rHz (NSNS) → 3e-13m/rHz (NNNS)
 < 1e-11m/rHz @10Hz requirement for
- Adhesive removal test (Hirose-san)
 - (Two Liquid Mixture Type Epoxy Resin Adhesive)
 - Adhesive can be removed by heating
 - Re-glueing test is necessary
 - There still remains the fear of damaging AR coating
- **Decision** about to repair/or not to repair the polarity will be made at the next IOO meeting (Aug 31th)

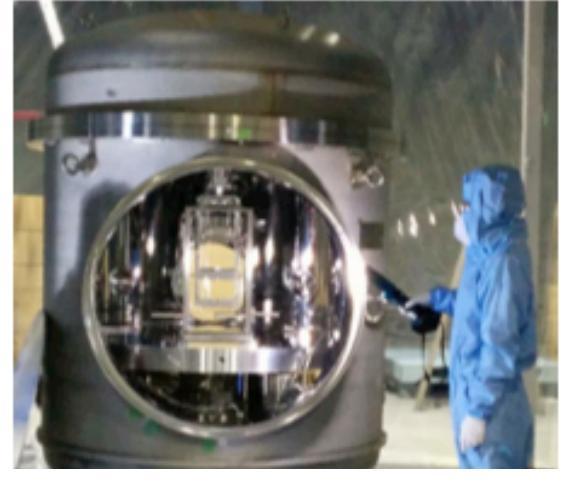
However, MCF Bread Board was partly blackened

- When the MCF breadboard was installed perhaps in Feb, we found it partly blackened
- Both MCE and MCF board were sent back to Hitz (日立造船) for cleansing in Mar
- Reinstallation
 - MCE: installation in May and leveling in Jun
 - MCF Aug 12th

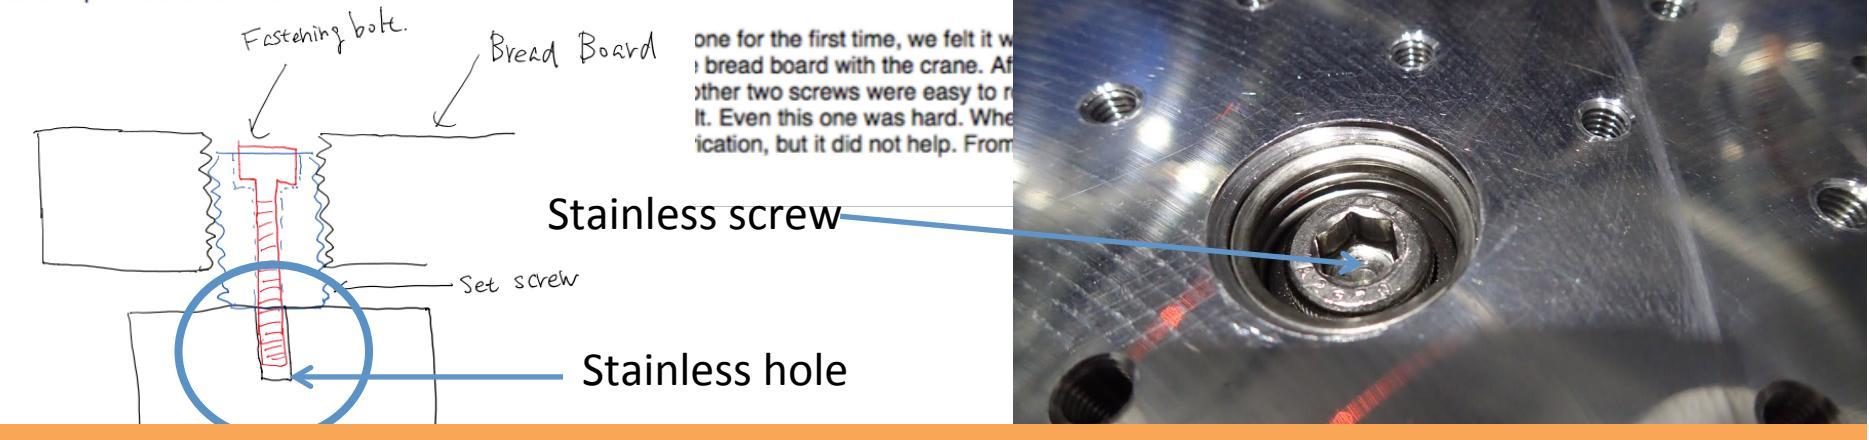
• Galling of Stainless screw

One of the MCF bread board screws is stuck in the middle

After the bread board leveling, when we were fastening the bread board to the stack, one of the three screws got stuck in the middle.

The structure of the fastening part is shown in the attached PDF. The set screw used to adjust the h the set screw. We successfully fastened two screws. However, the third one got stuck at 1 - 2mm be second picture shows the stuck one.

Use silver-plated bolts on stainless holes and fasten carefully

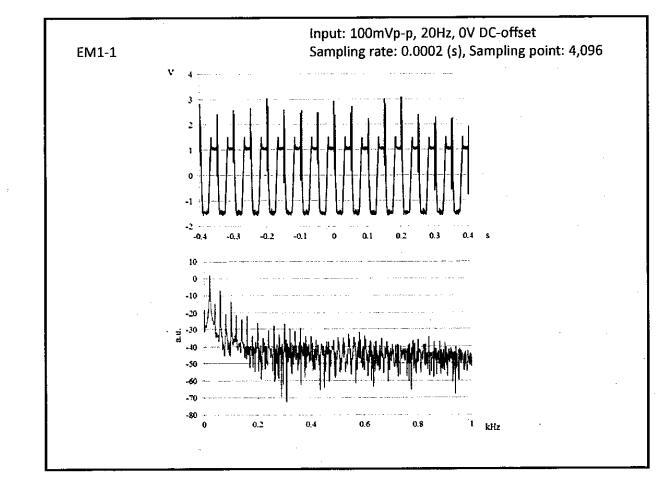
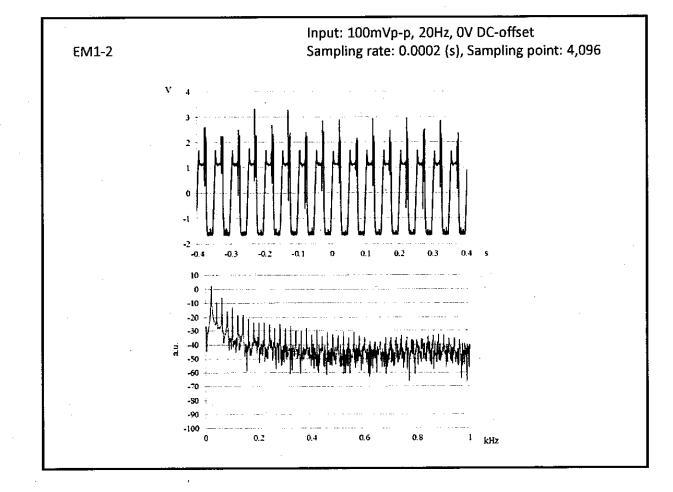
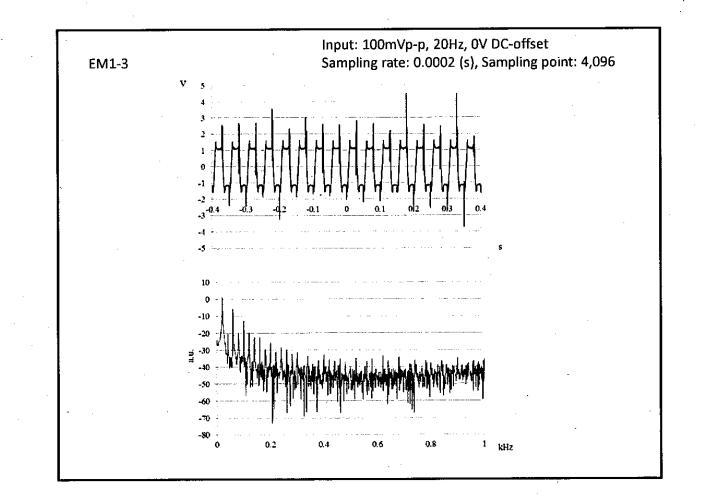
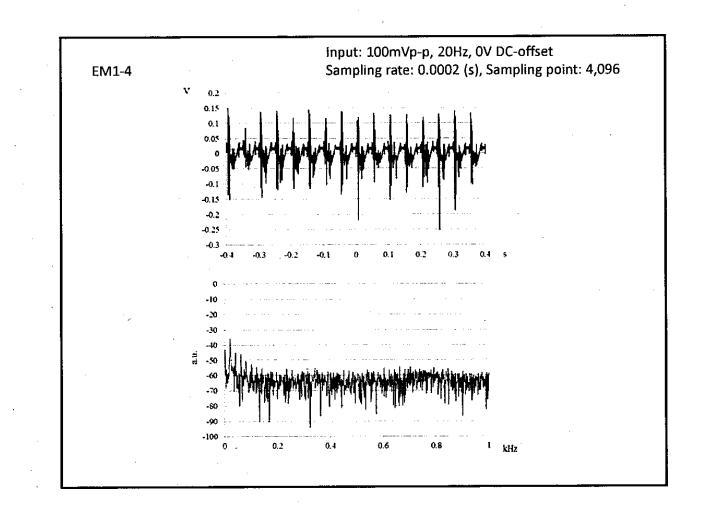
EM1: ch4 is strange

- Need to be discussed at the next IOO meeting.
- Repair TAMA coil driver
 - Current OP amp is already obsolete
 - OP amp replacement seem to be not enough
- Use KAGRA coil driver
 - KAGRA coil driver are already made (under test)
 - A kind of converter is necessary for handling differential signal output of KAGRA coil driver
- In either case, it takes a few weeks, I think.

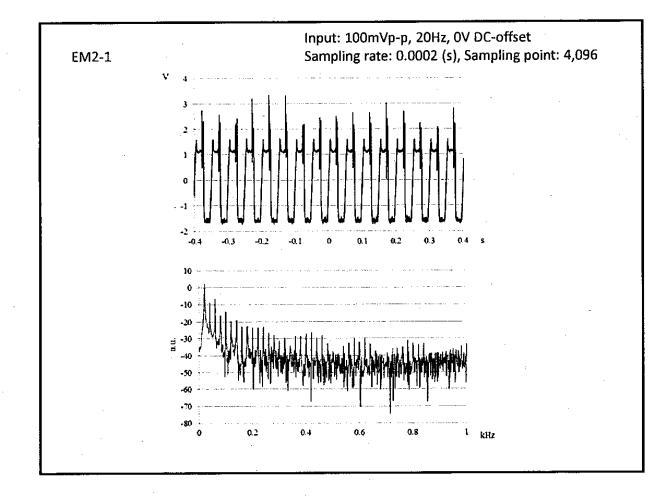
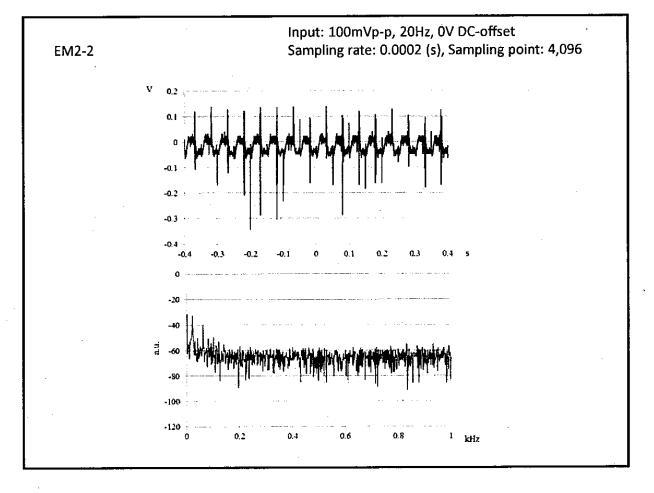
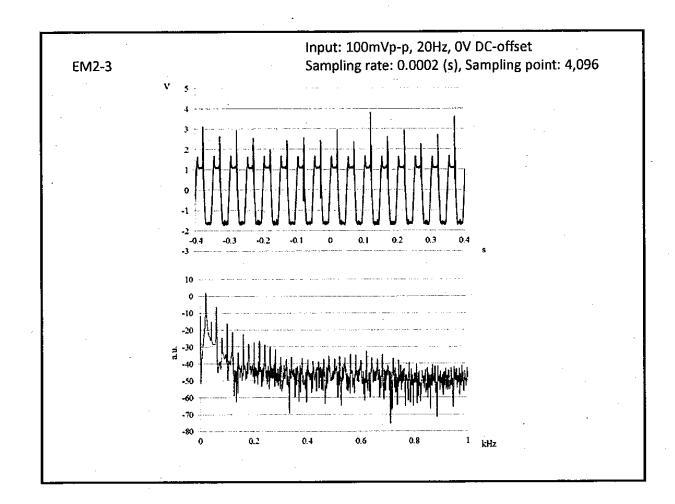
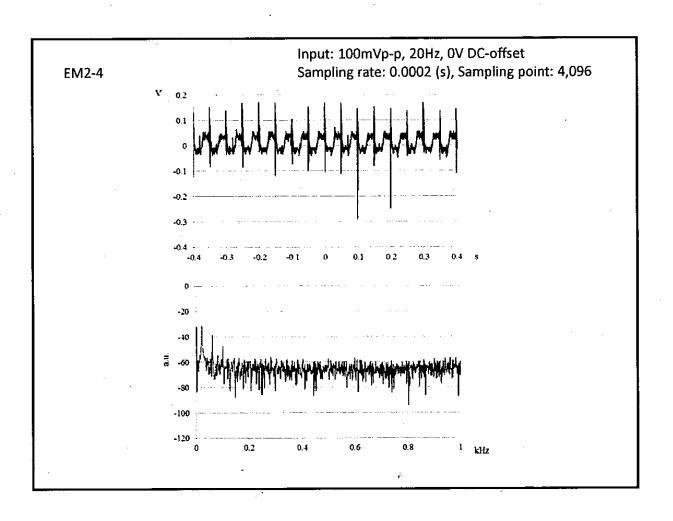
EM2: ch2 and ch4 are bad

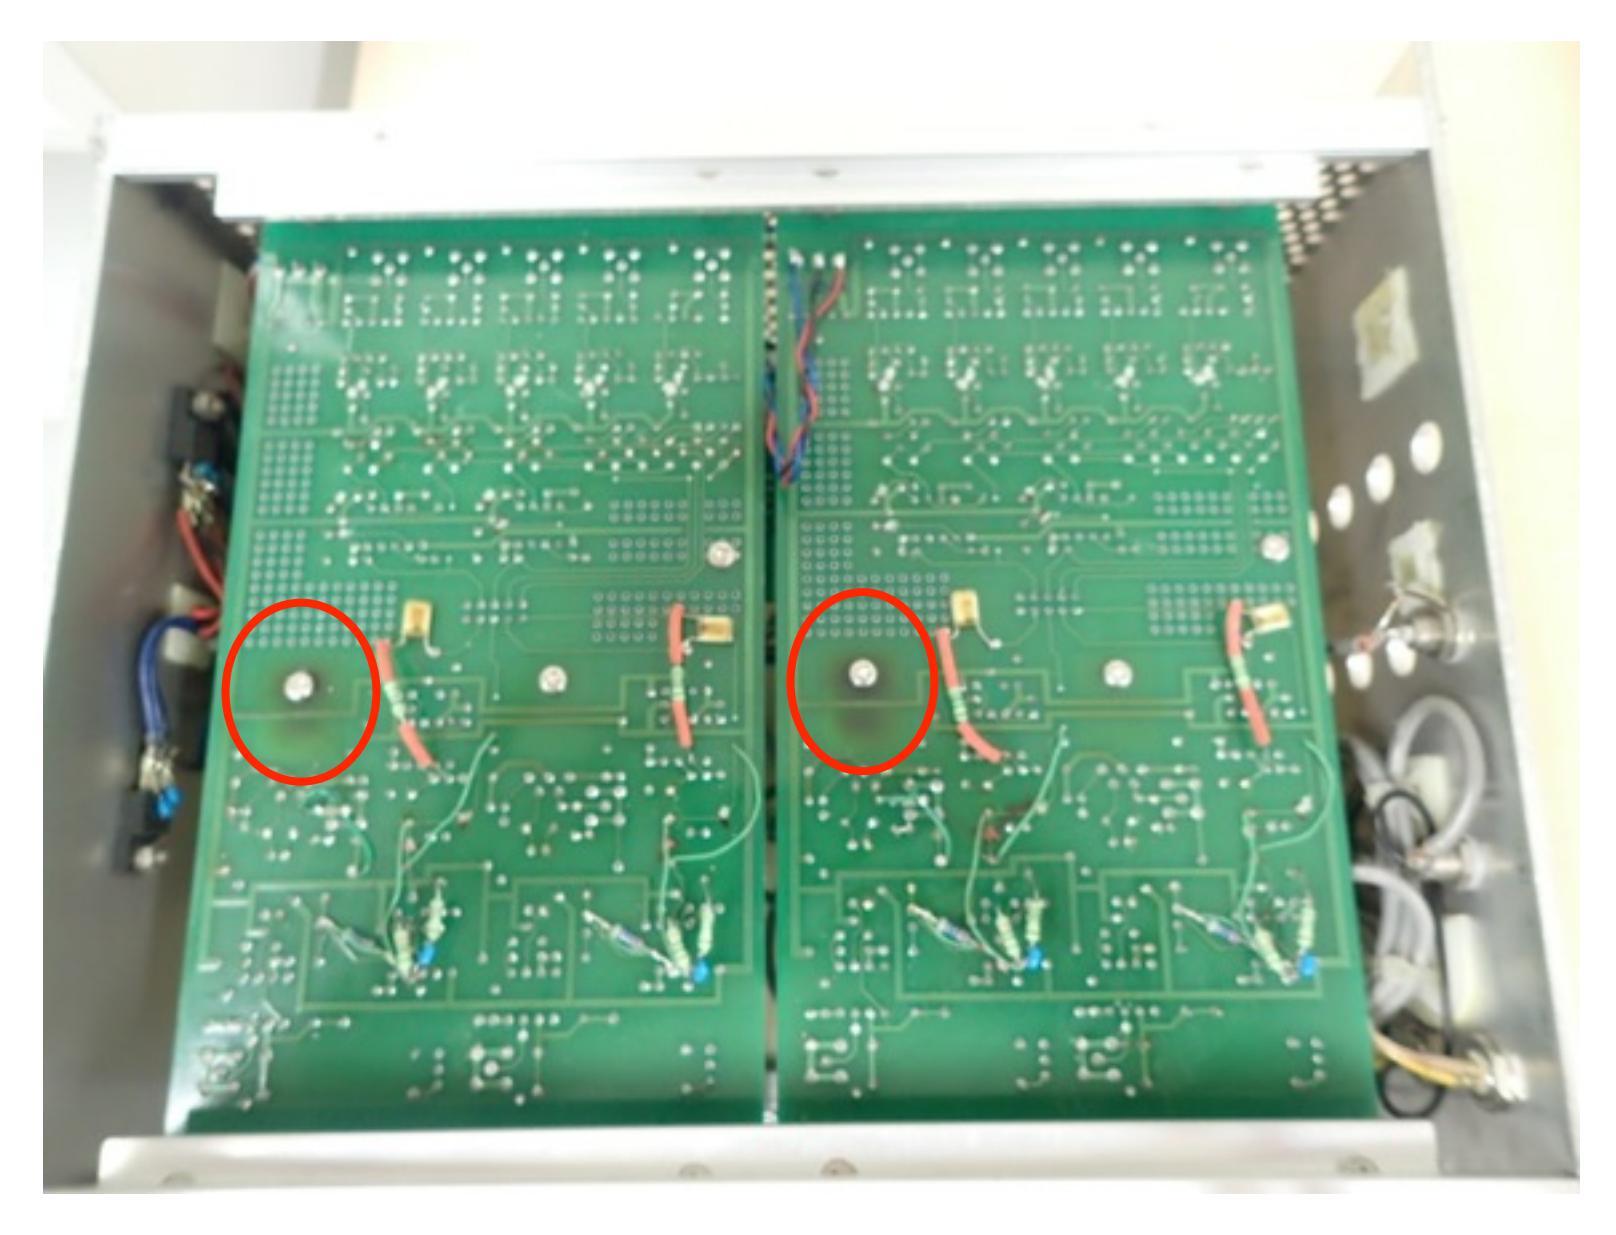
NM1: circuit board burned
