Health check: at ITMY tower part in June 2019.

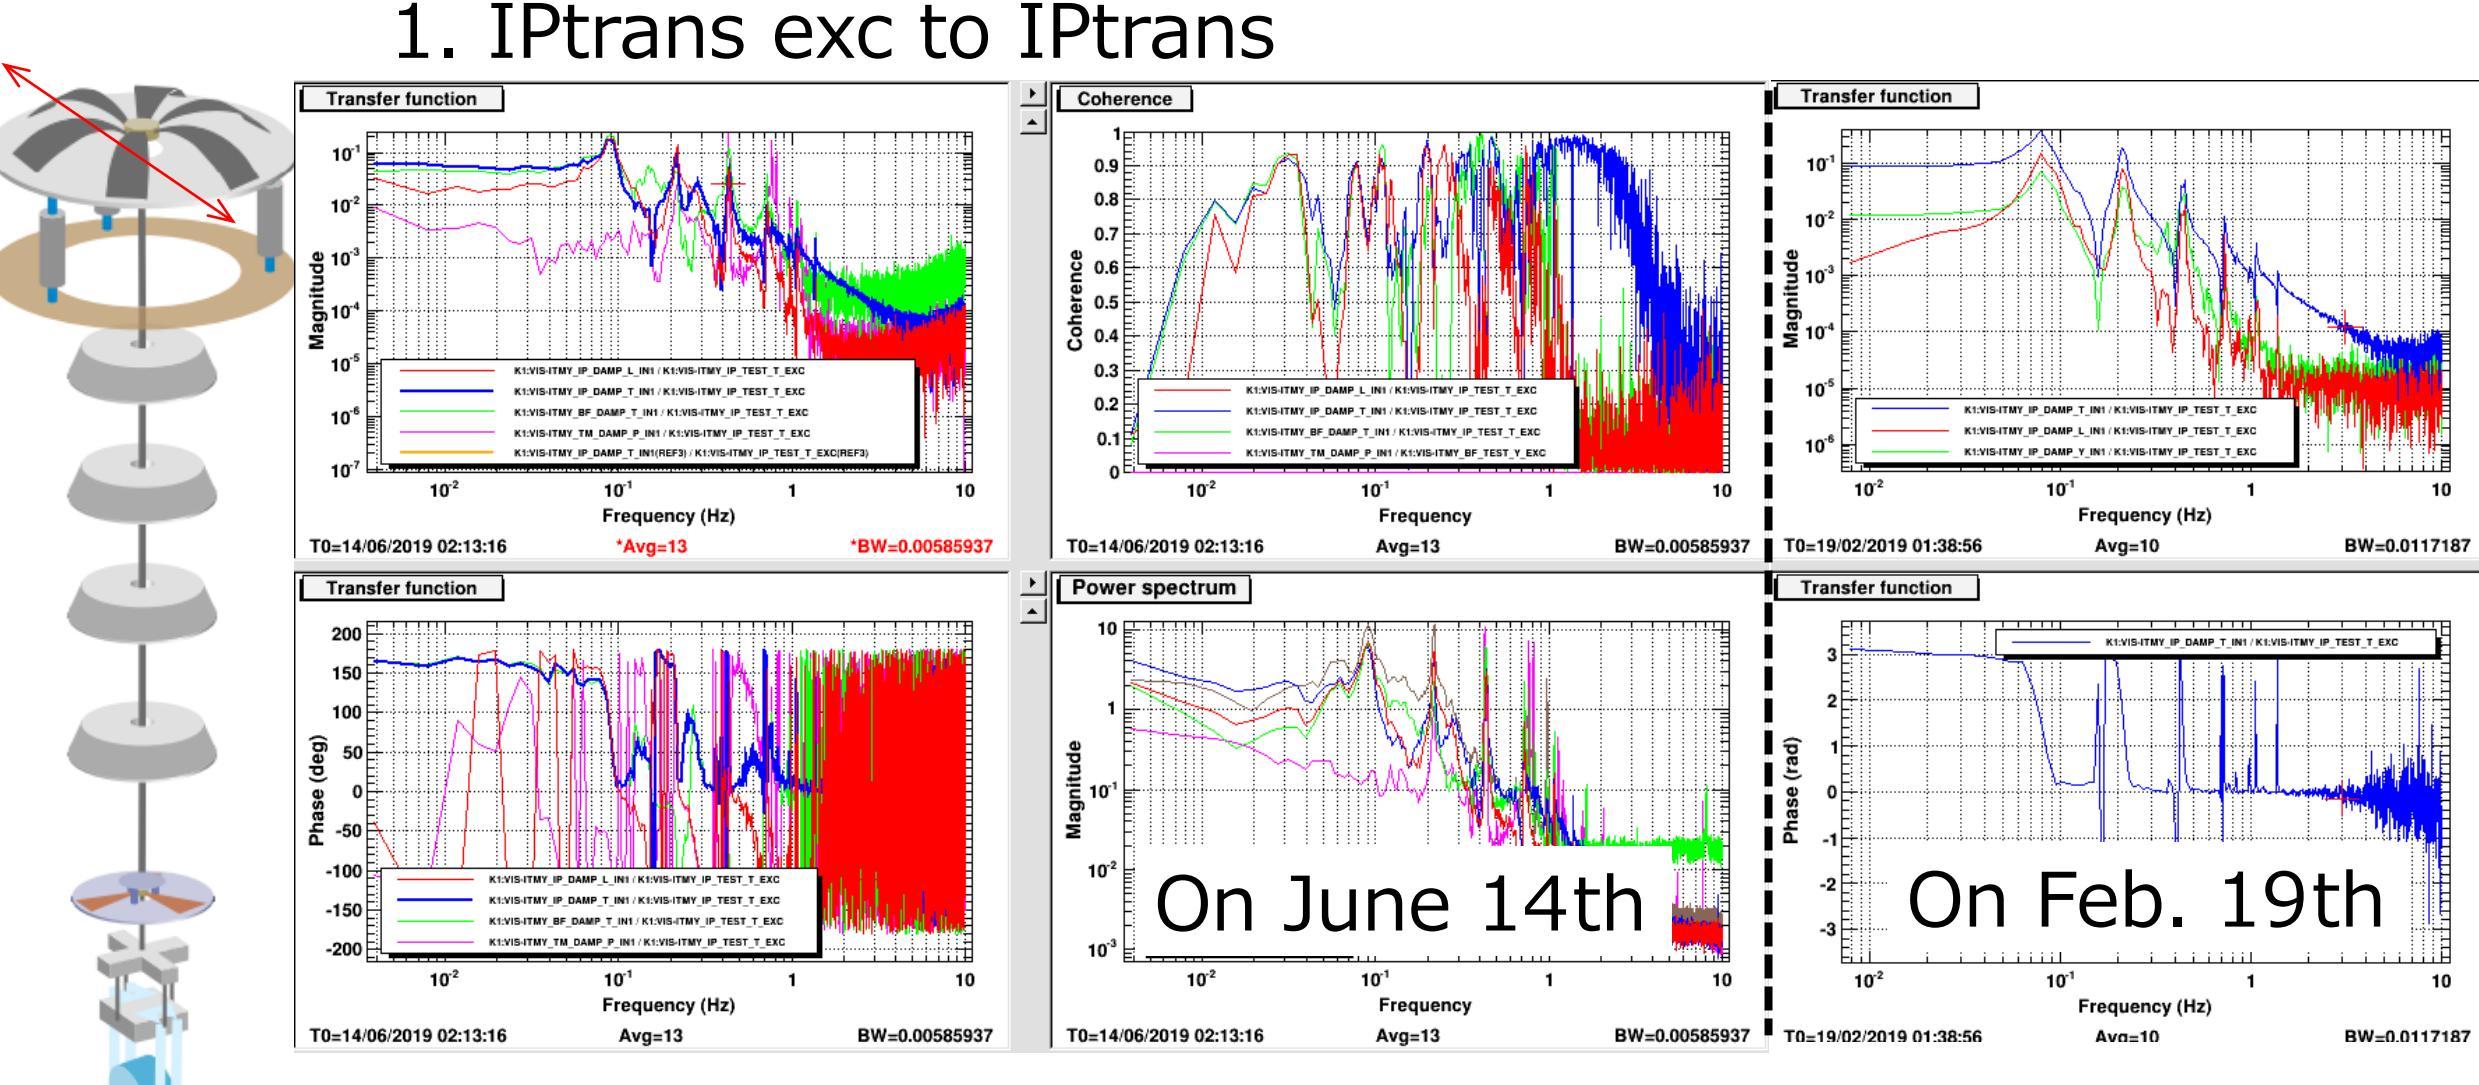
The issue: mechanical transfer functions looked weird.

\rightarrow Suspension is softly touching to frame?

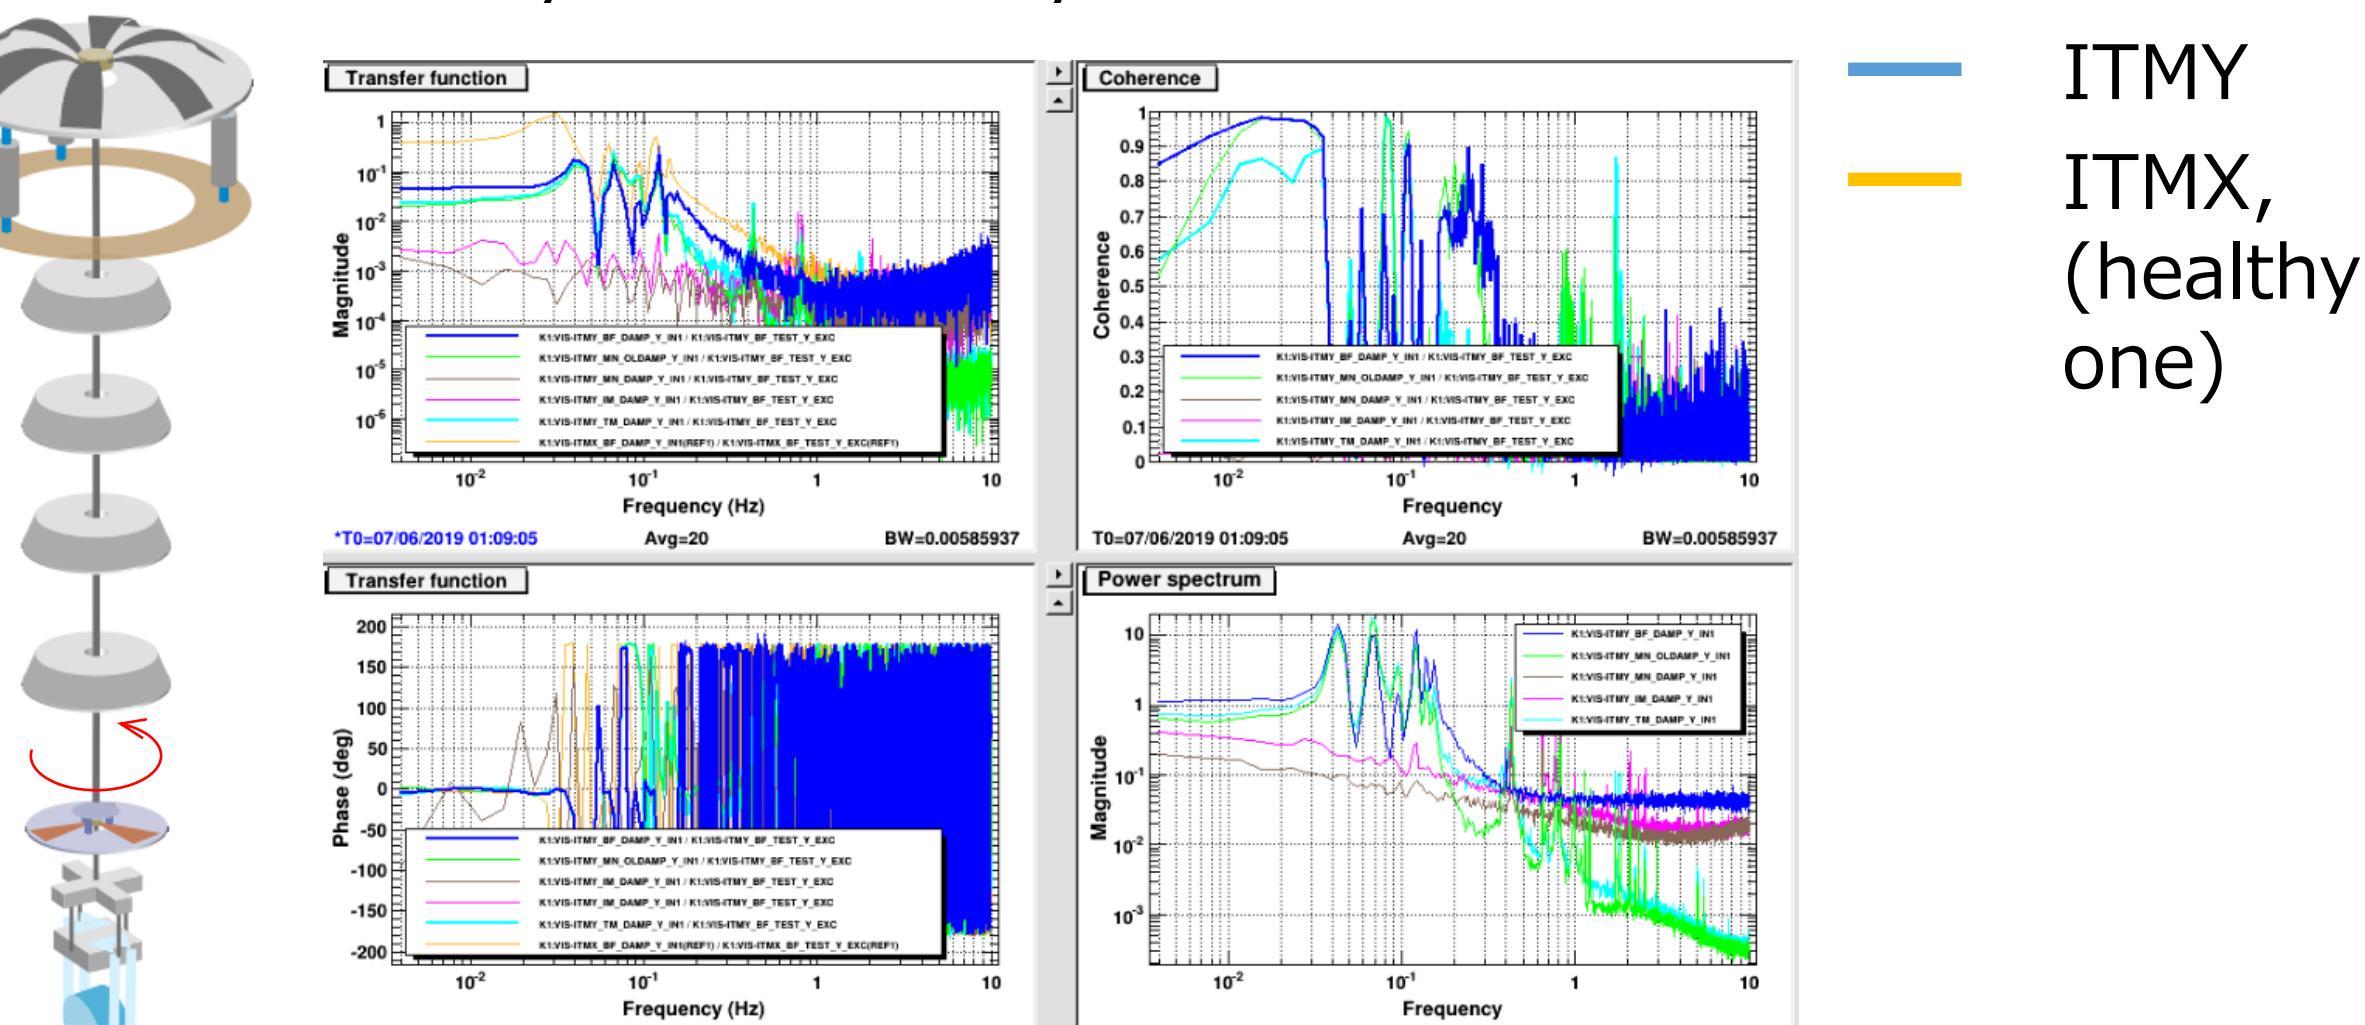
The issue: mechanical transfer functions looked weird.

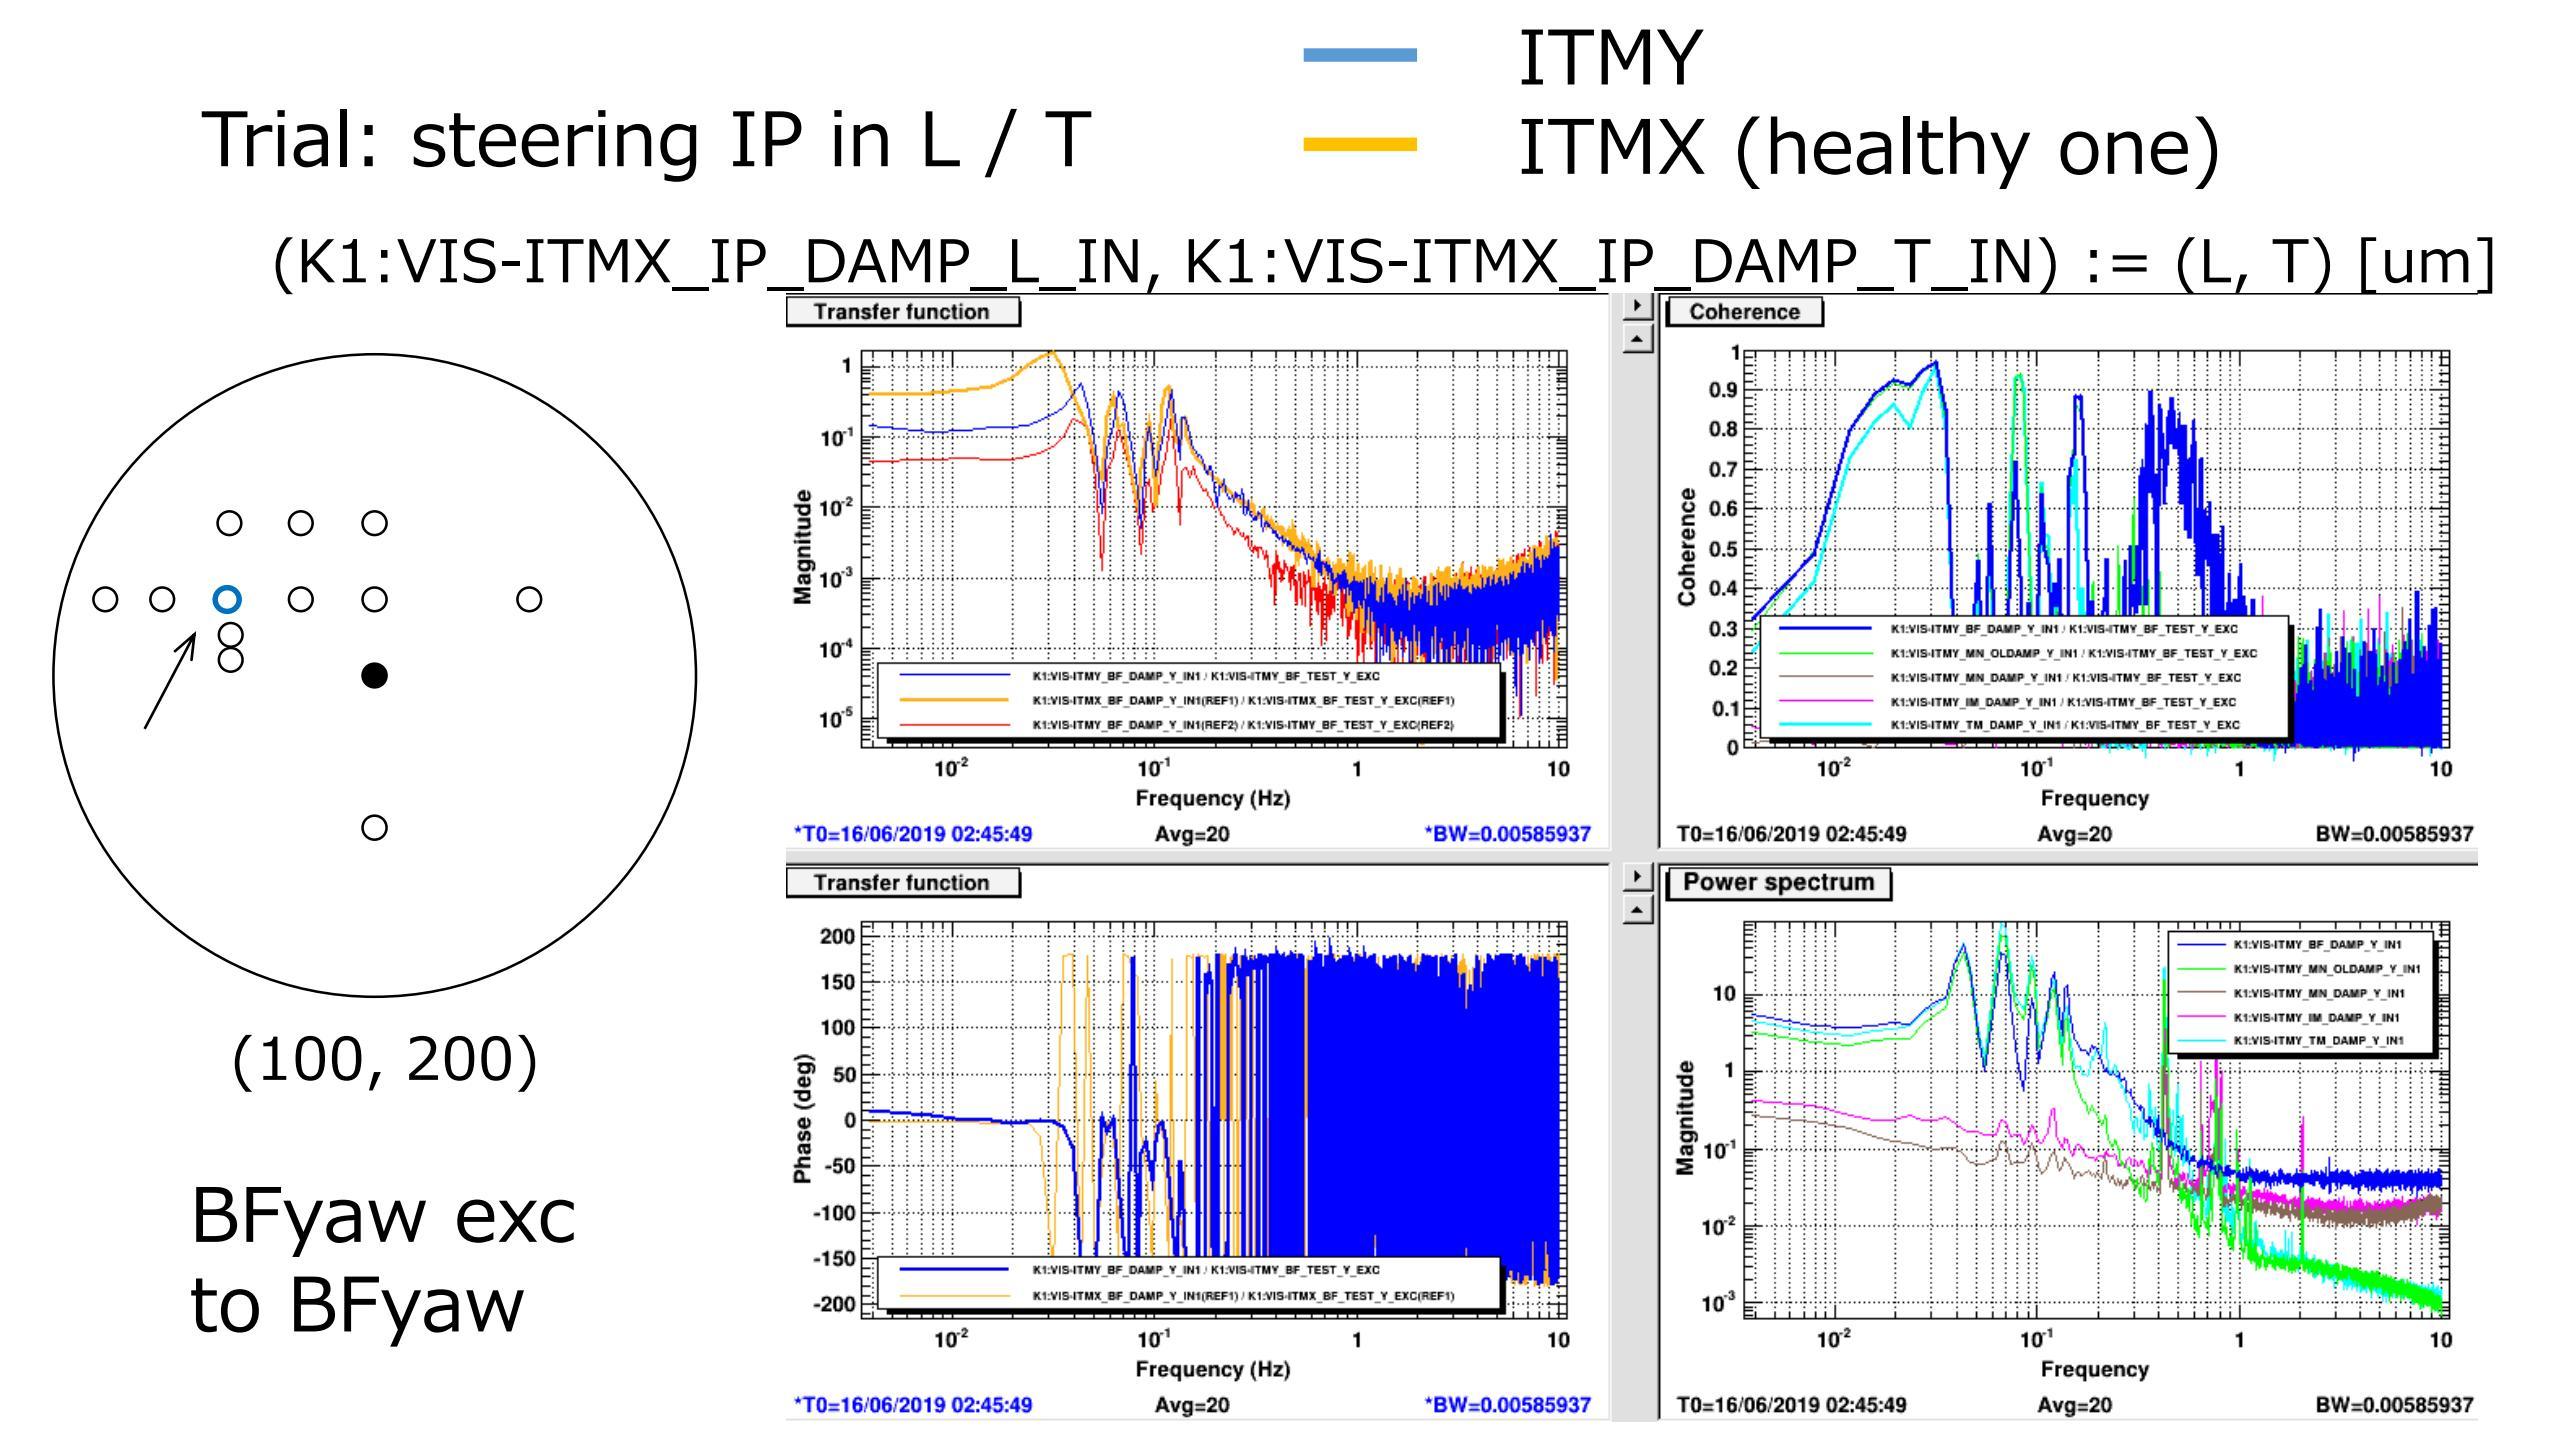
It became improved anyhow.

- TF of IP and BF depends on the position.
 - -- (Current) best position for IP looks at (L, T) = (100, 200).
 - -- still the BFyaw, IPtrans TF looks weird though.
 - \rightarrow Looking for better position might improve this situation.
- Big difference between Feb. and now would be the GAS height adjustment.
 - -- It was already confirmed that all the GAS filters were freely suspended in vertical though, trying to set back the position might be helpful to solve this issue.

- I'm (personally) feeling that something is softly touching to the frame, Softly.
 - -- Although something is happening at ITMY, however, the TFs are not the most terrible ones now and it seems this issue is not so effective to the commissioning work.
 - -- It would be okay to open the chamber when it is found that this issue affect to the commissioning work.
 - -- There is no reason to open it ASAP I think.
 - -- Meanwhile, better position might be found w/o opening the chamber.
