Installing Advanced LIGO: problems, challenges and some solutions M. Landry LIGO Hanford Observatory/Caltech KAGRA Collaboration Meeting

Toyama University 2 August 2013 LIGO-G1300759

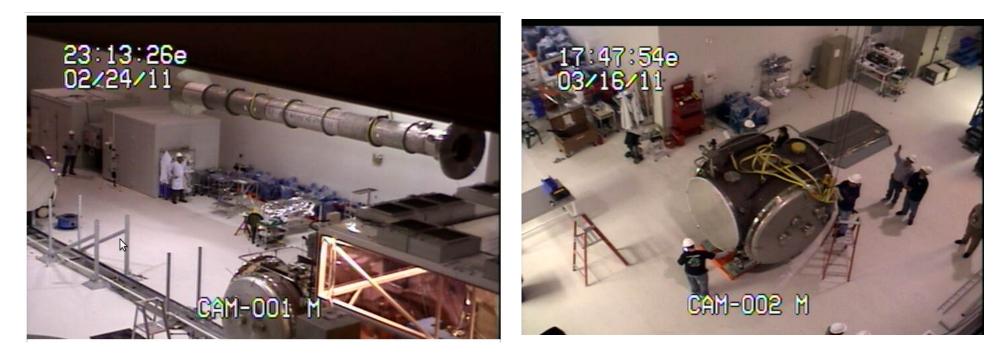
Vacuum mod highlights

- Major L1 and H2 vacuum modifications in halls: input and output tubes removed, recycled. Two HAMs chambers moved
- Degrouting underneath HAMs: dusty operations in the main hall: next year, deinstallation of H1 will be difficult alongside H2 INS

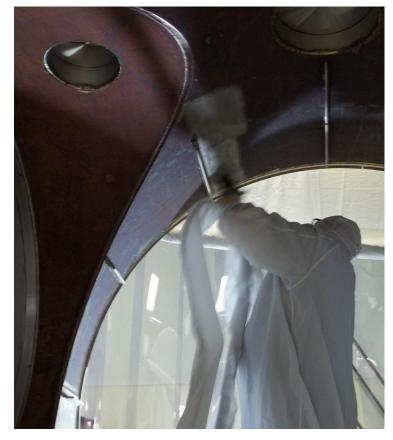
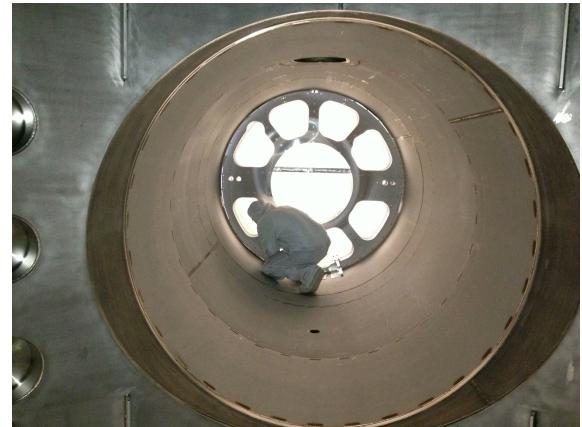
In-chamber cleaning

- Was an ongoing R&D effort at LHO since early December 2010
- Tools, brushing/vacuum/wipedown procedures, FTIR (Fouriertransform infrared spectroscopy) assays finalized
- Completed successfully at both sites

- High in-chamber particulate levels have been observed in Initial LIGO (metal oxides from steel treatment, dusts, Al foil etc)
- Removing oxide layer from interior heat-treated surfaces. Employ
 - » rotary-wire brush with HEPA vacuum assist
 - » dams and barriers
 - » solvent wipedown
 - » i) Fourier transform infrared spectroscopy (FTIR) assessment of hydrocarbon contamination, ii) swipe tests for particle density assessment
- Pneumatic tools used, all lubricants removed (contamination risk; tool failure rates thus high)

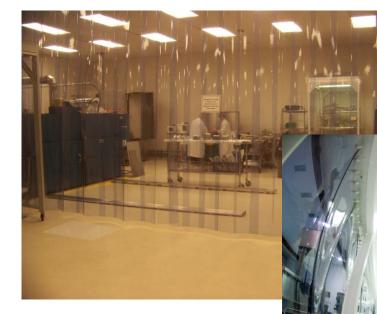
Clean and Bake for Ultra-High Vacuum (UHV) Service

- » Initially underestimated effort hired more staff
- » Procured additional vacuum bake ovens required to minimize downtime & meet throughput required
- » Cleanliness certification (by FTIR testing)

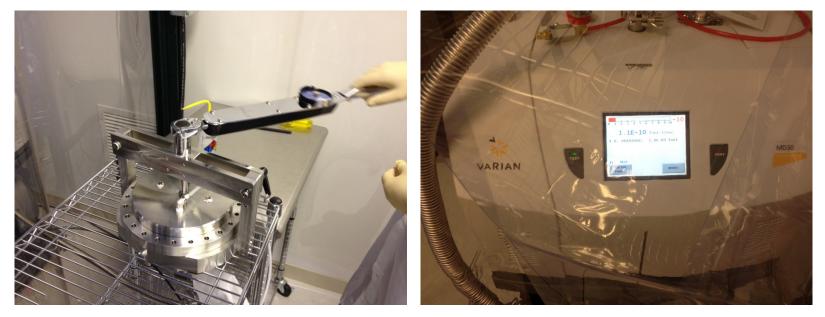
Viewport and feedthrough testing

QAME: Every viewport in the LIGO vacuum system at each observatory is visually inspected then proof and leak tested. Electrical feedthroughs are also 100% leak tested.

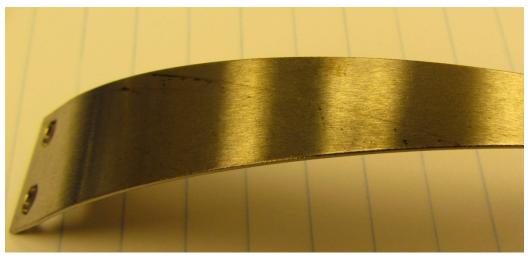
Blade spring corrosion

QAME: Cantilever Blade Springs were received from an overseas vendor with some spotting/light corrosion marks. There was insufficient time to remake the springs so QAME developed a mechanical and chemical process to remove the corrosion before Ni coating.

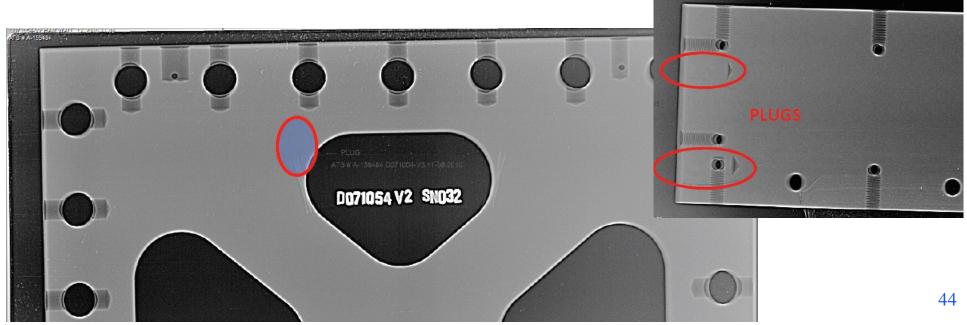
Weld repairs

- Unauthorized weld repairs detected visually in some seismic plates
- Investigated with contractor and x-rays
- At issue is trapped volumes and virtual leaks
- Concluded new parts were required

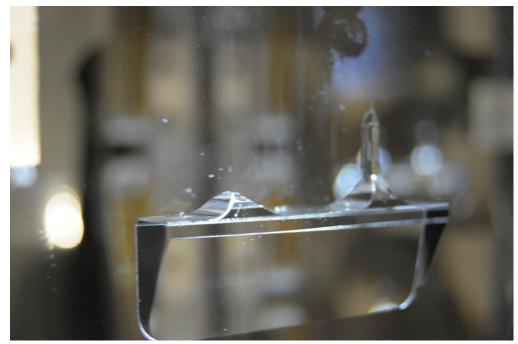
2nd ITMY (in-chamber) fiber break

- ITMY fibers broken in shaking incident induced by code bug
- Stop work called; code fixed/reviewed, testing restarted
- Implemented wire hang of ITMY

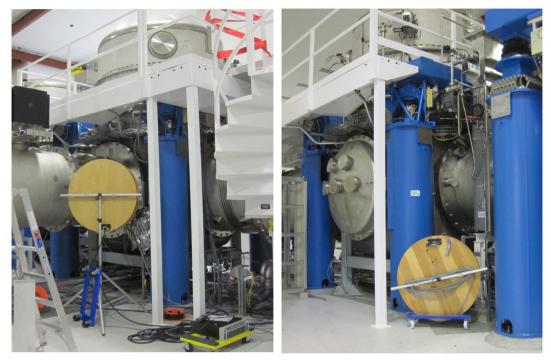
Magnetic coupling

- Suspensions: Excess magnetic coupling observed to test mass motion
 - » Test mass SUS magnetic coupling assessment continues
 - » Ruled out damper magnets and OSEM un-slitted parts as culprit
 - » Investigating reaction masses (cold-worked steel)
 - » Lab and in situ measurements ongoing: next tests at Livingston Aug/Sep

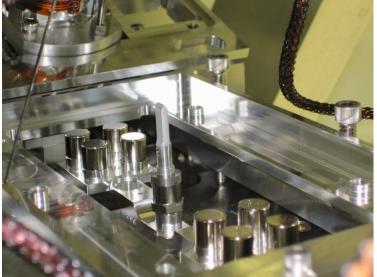
Magnetic coupling, contd.

Damping magnets (now vindicated as coupling site)

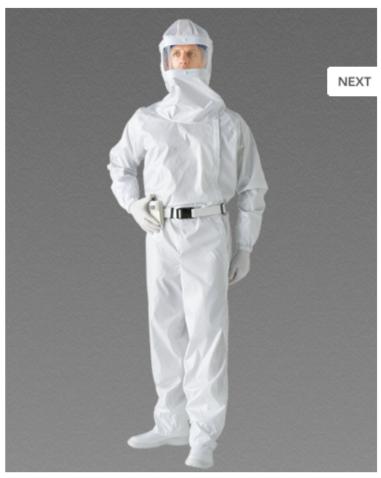
Clean Coverall with Integrated Hood (downflow type)

Below is is the particulate count comparison with the HEPA suit mentioned above (left on the plot) and two other types without HEPA (middle and right) when the worker was walking.

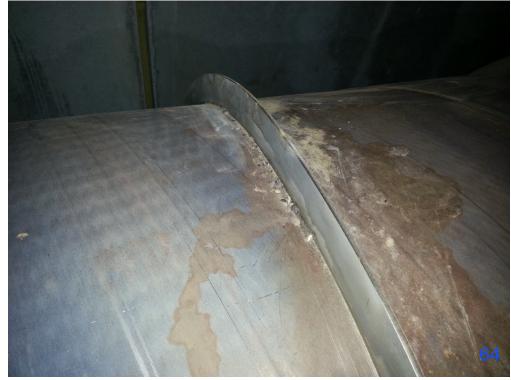
Beamtube leak at LLO

- Not specifically an Advanced LIGO problem, but worth mentioning
- LLO y-beamtube has developed several small leaks
- Associated with rodents living (and urinating) in the beamtube insulation
- Several fixes made
- Will strip insulation at both sites
- New insulation required
