My work in 2016

Hiroki Tanaka

First calibration test(previous)

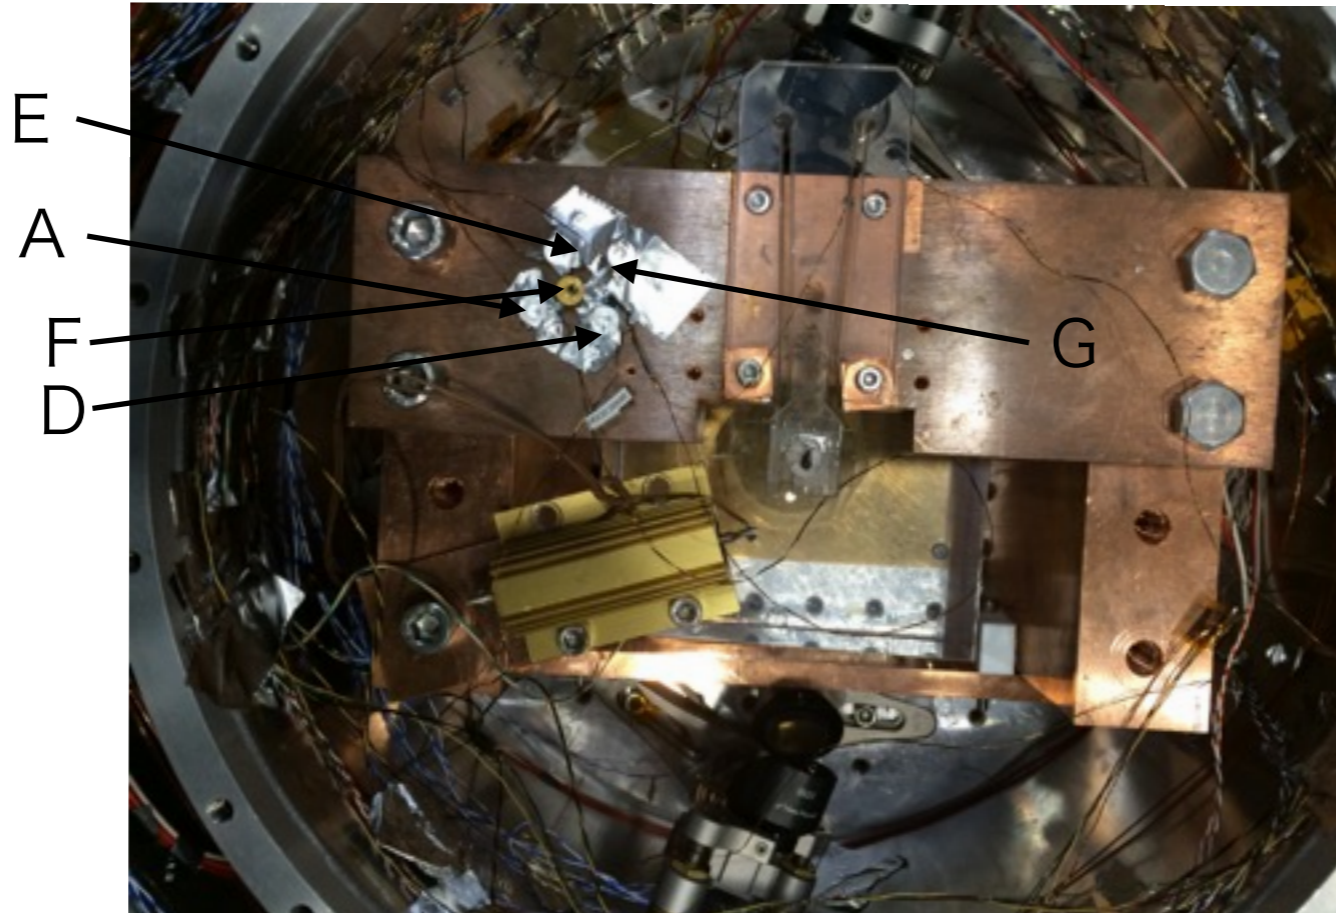
We cooled down the cryostat.

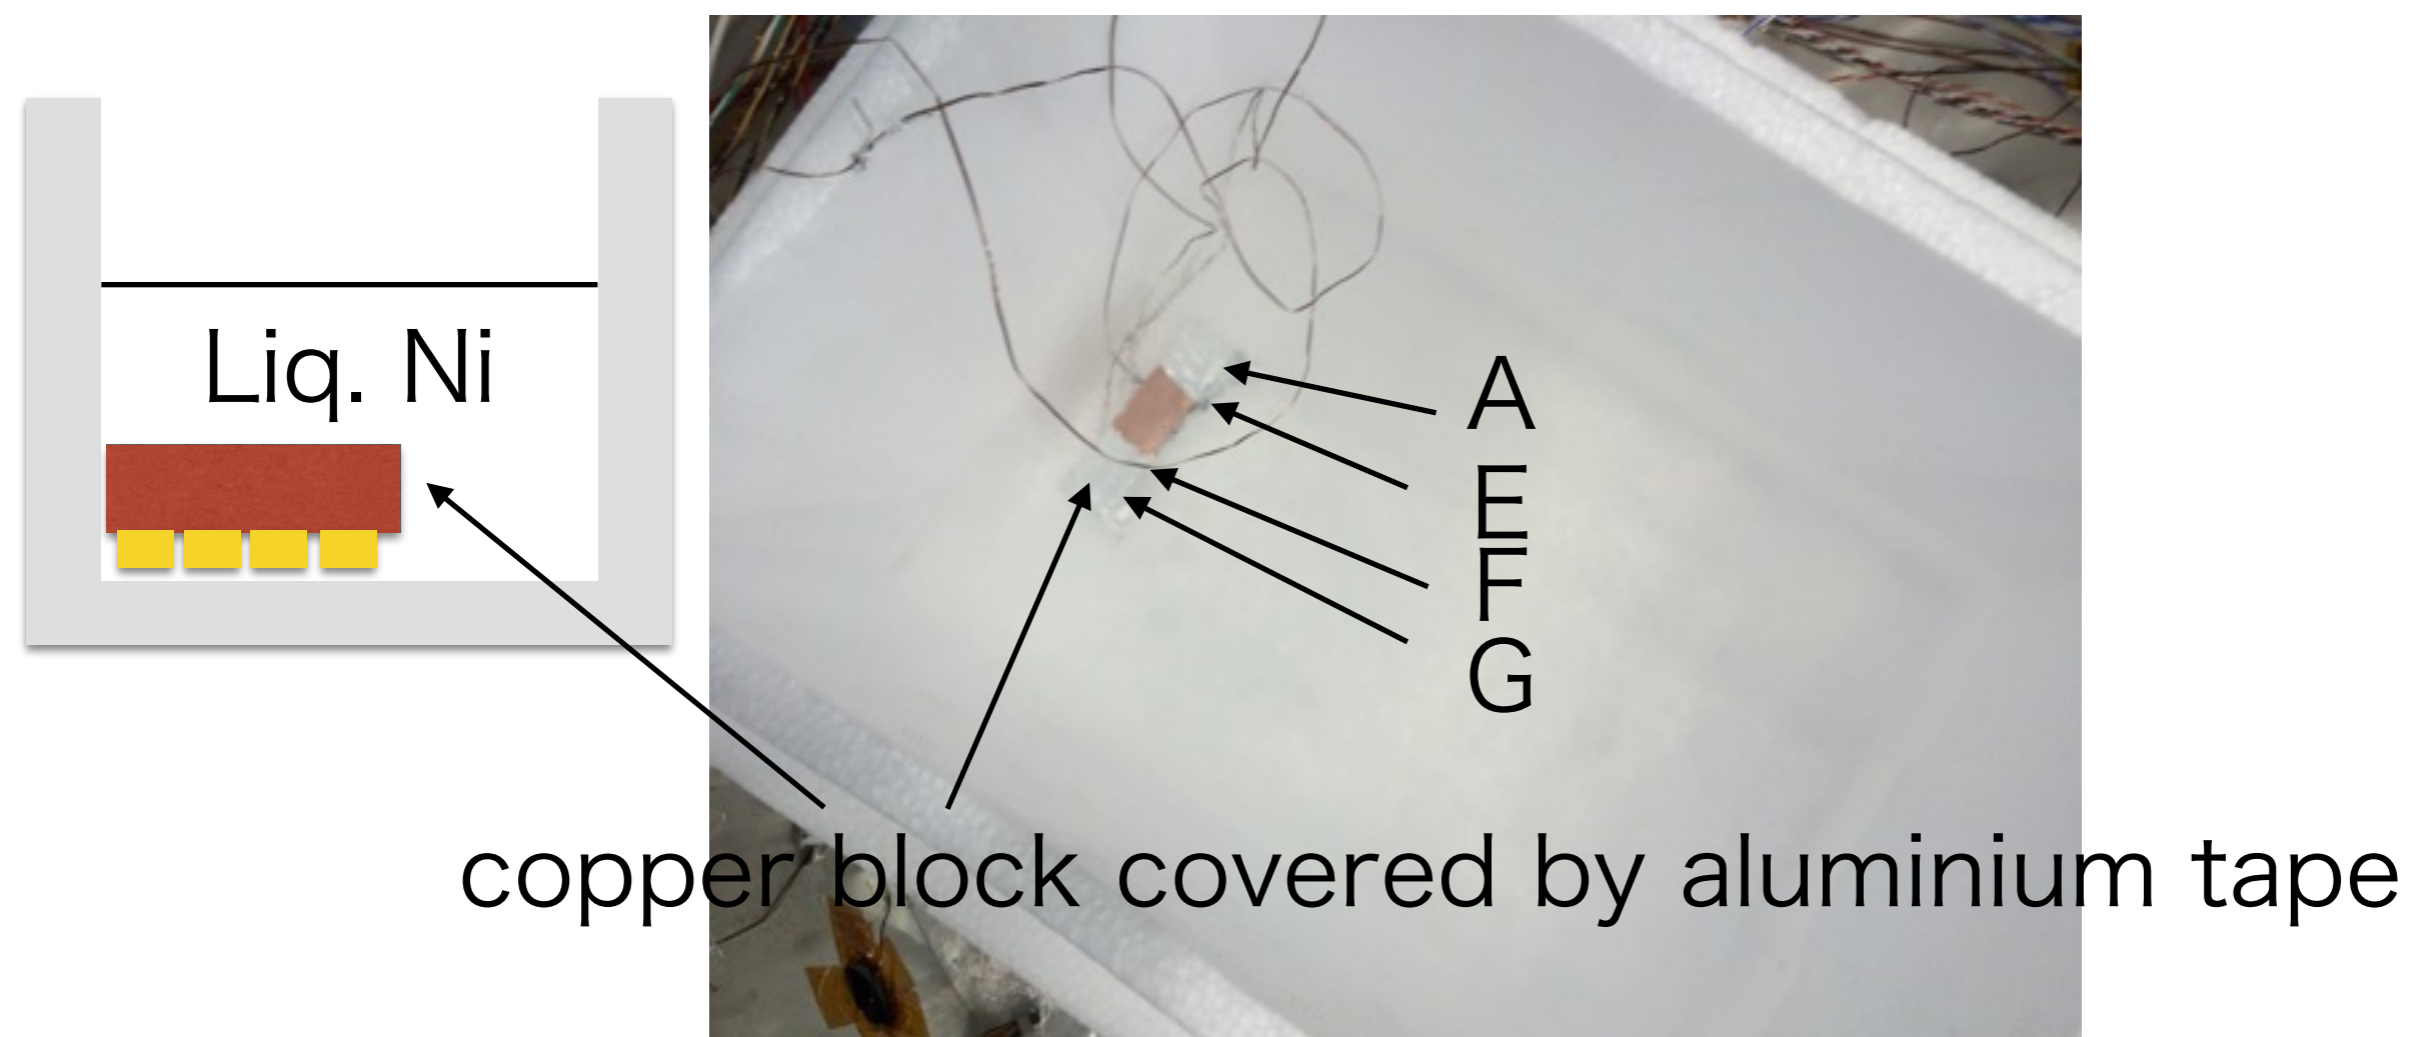
Calibration by liquid nitrogen

I attached the sensors on the small copper block by varnish. Then I installed the liquid nitrogen into the box.

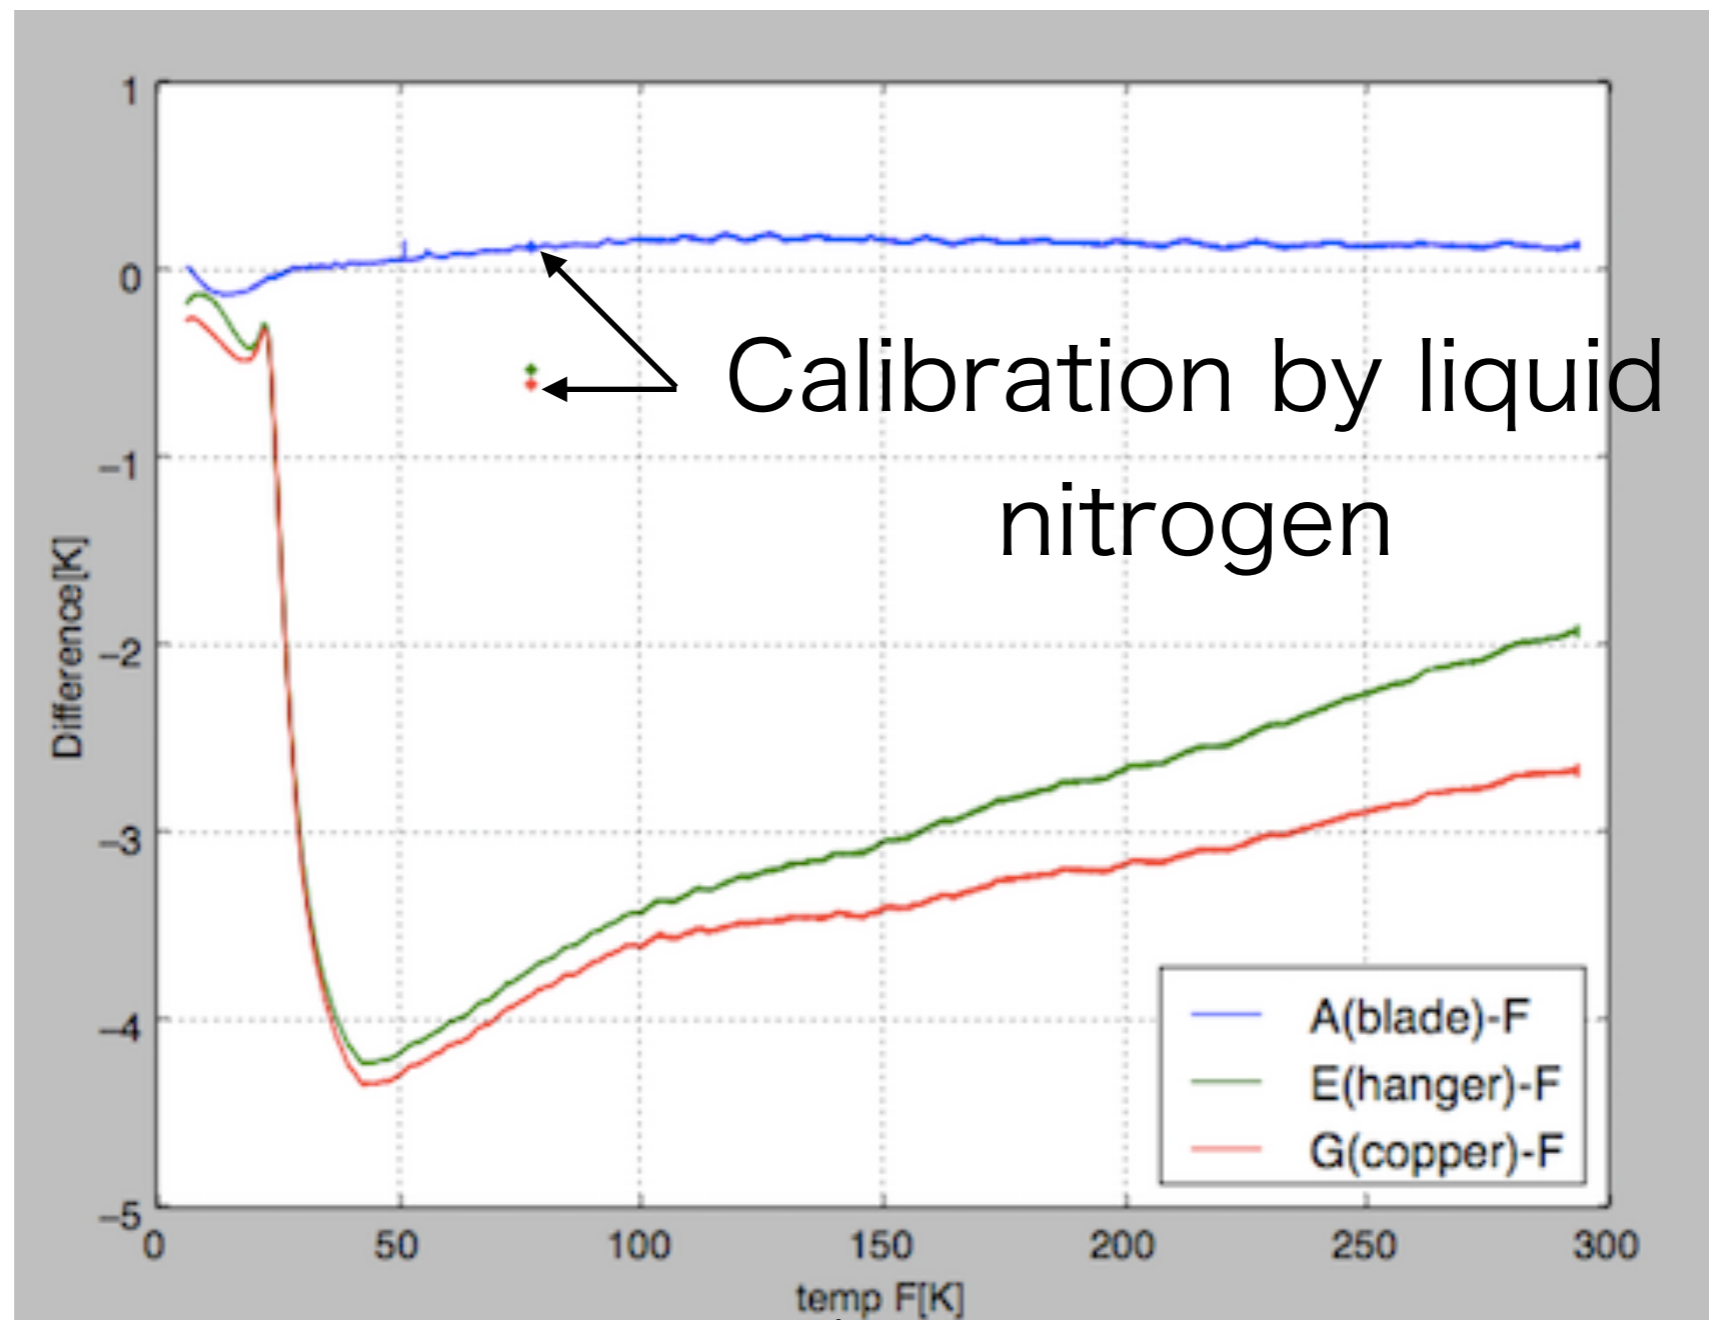
Comparing two calibration

The graph...last calibration

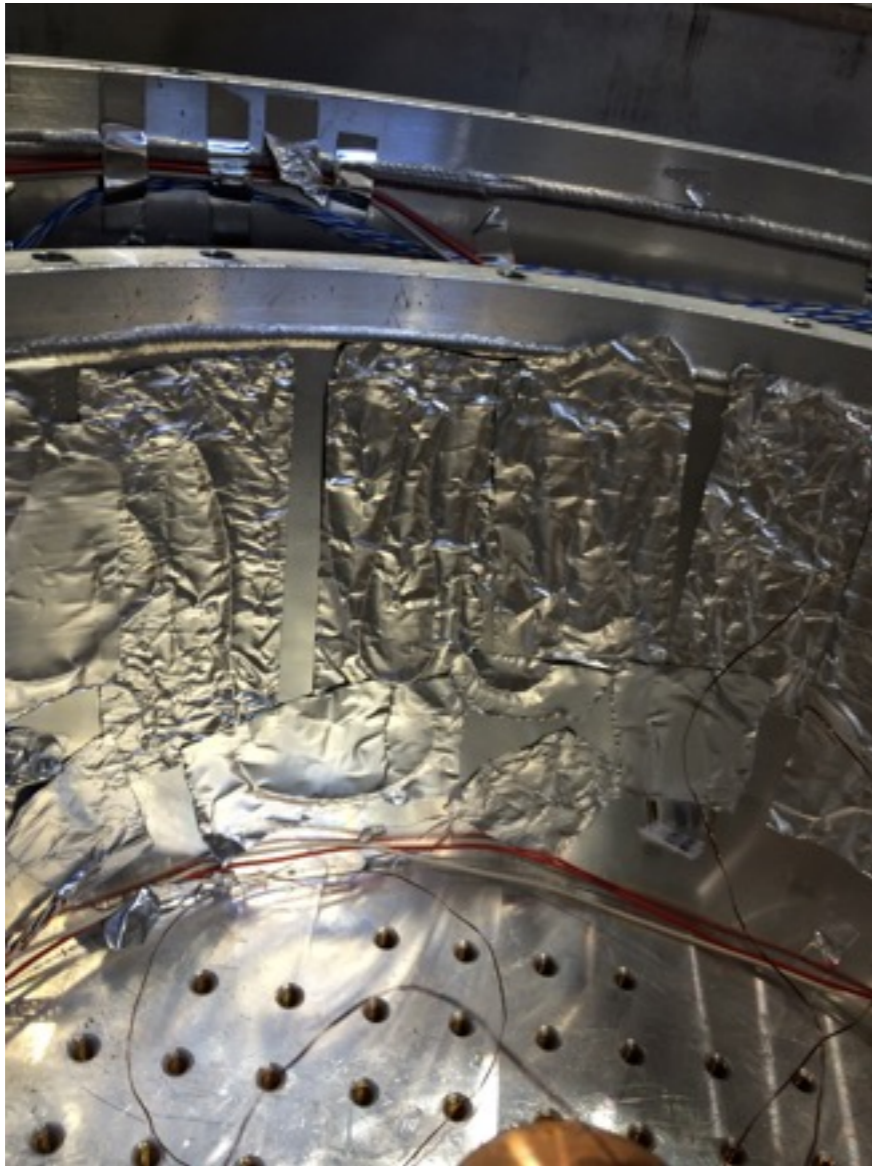
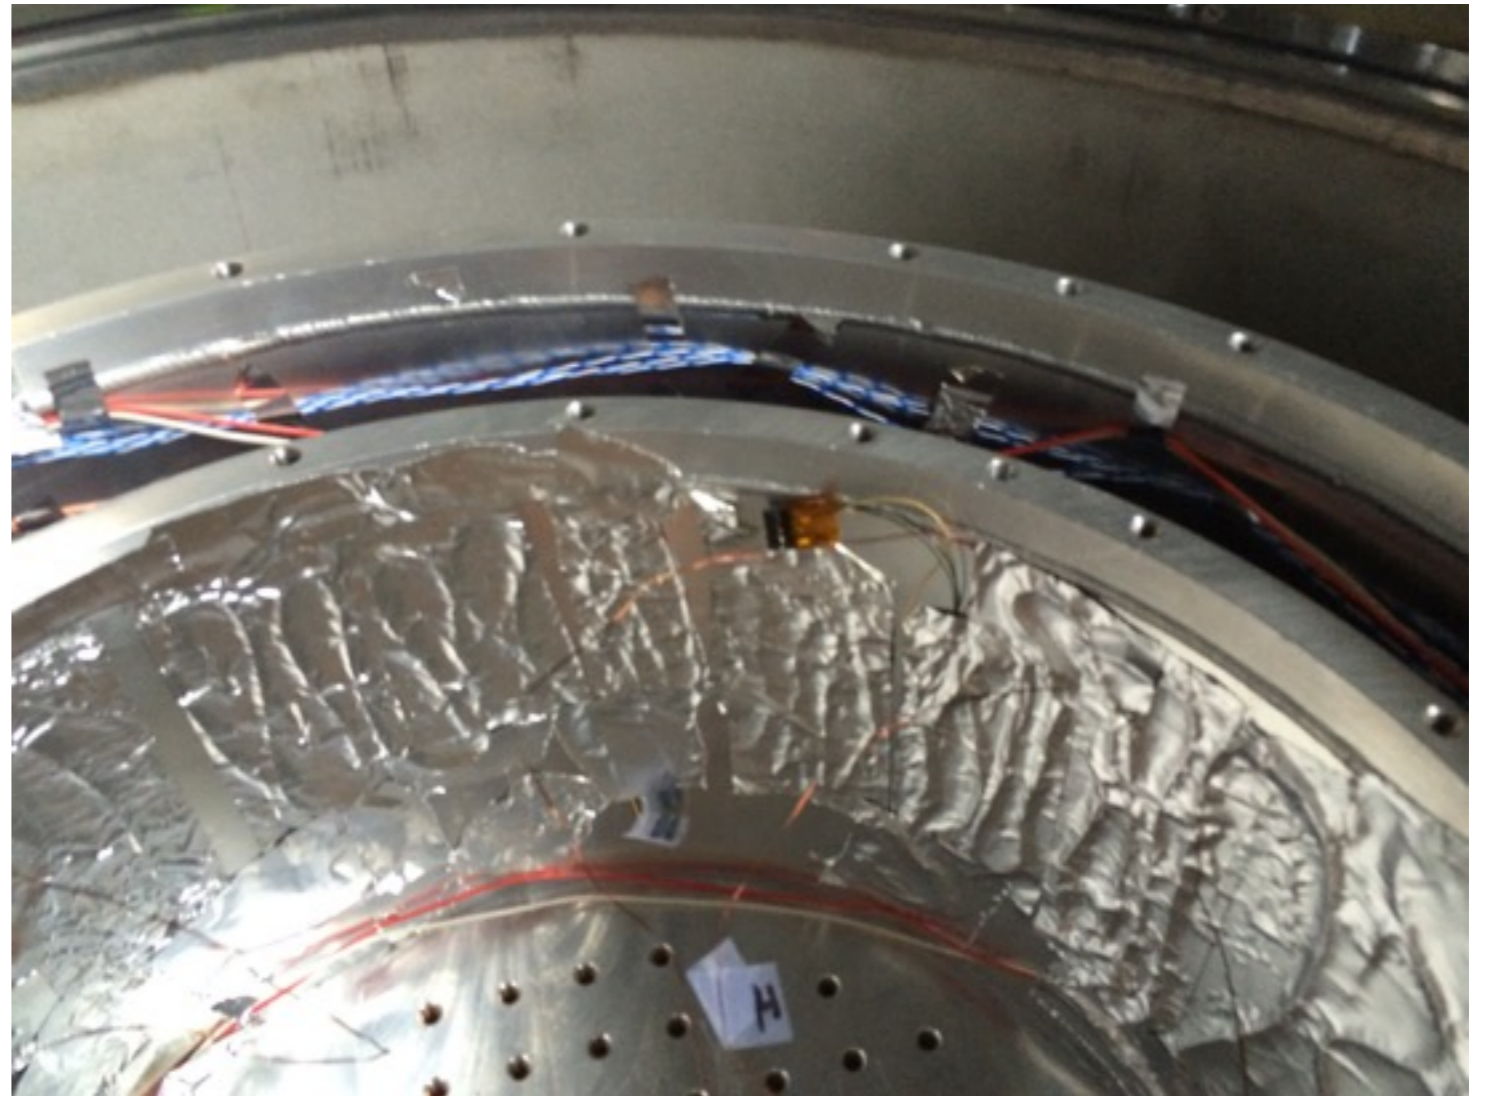
Heat sink

I arranged the heat sink.

- However the difference of the temperature between sensor G and sensor F remained about 2.5K.

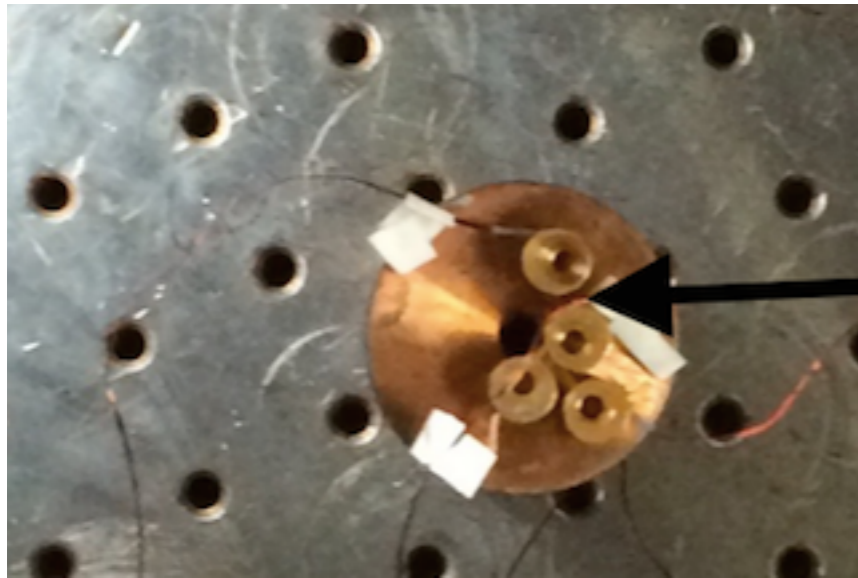
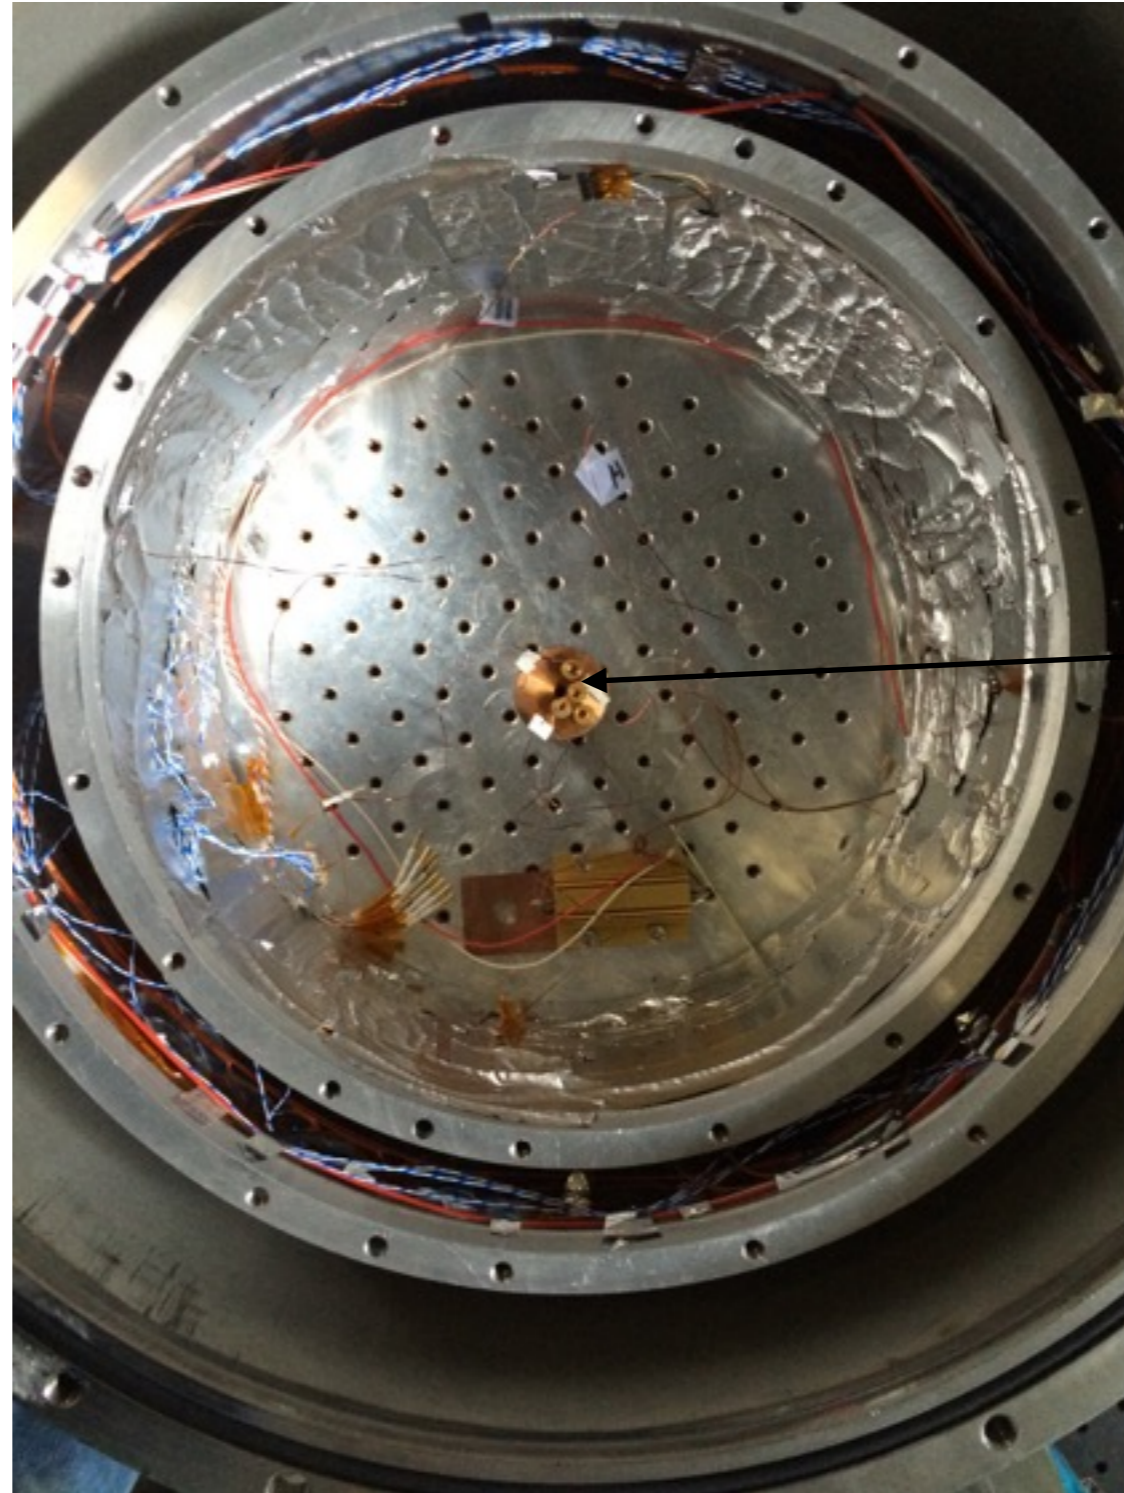
Calibration test

I started to cool down the cryostat.

sensors
A,F,H,J

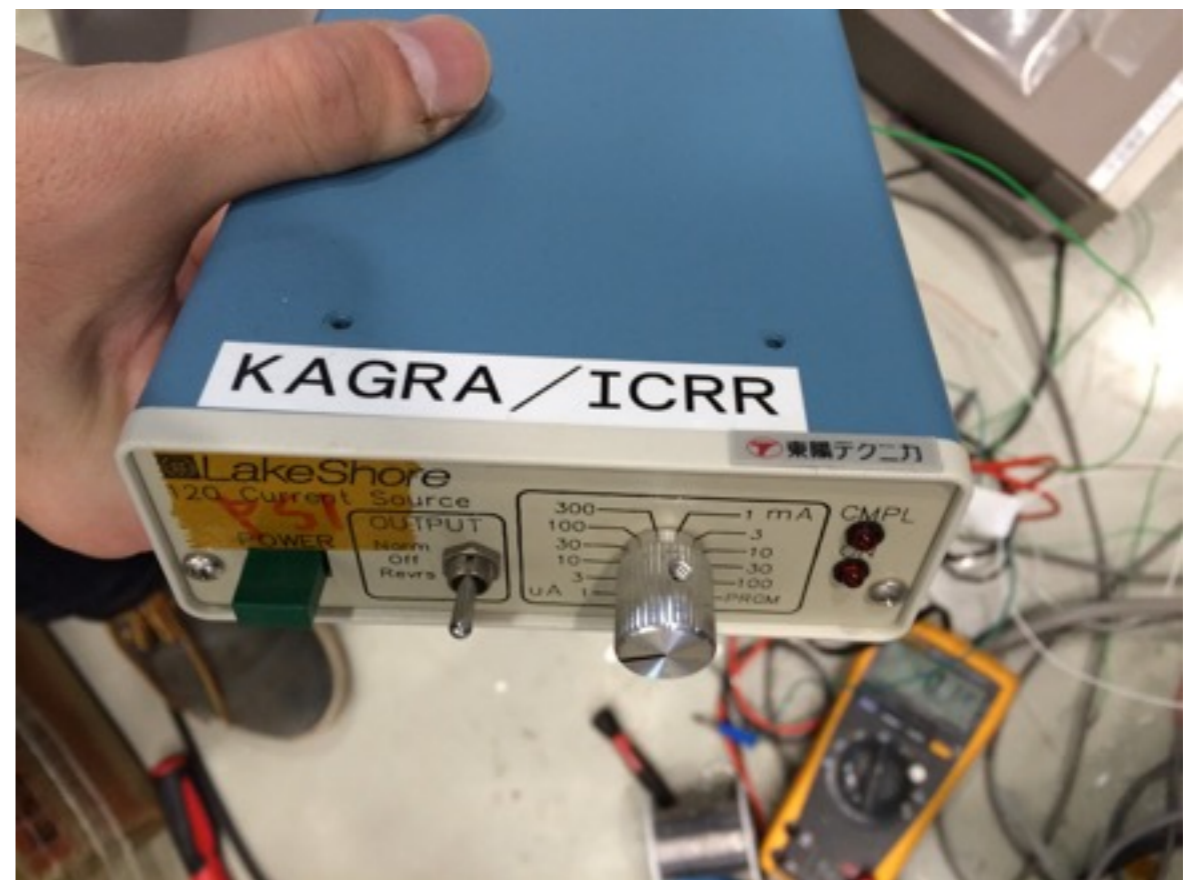
- In order to check LS218, I gave the current ($10\mu A$) to the sensors by this machine and measured their voltage.

The results were exactly equal to the voltage shown on LS218.

So LS218 doesn't have problem.

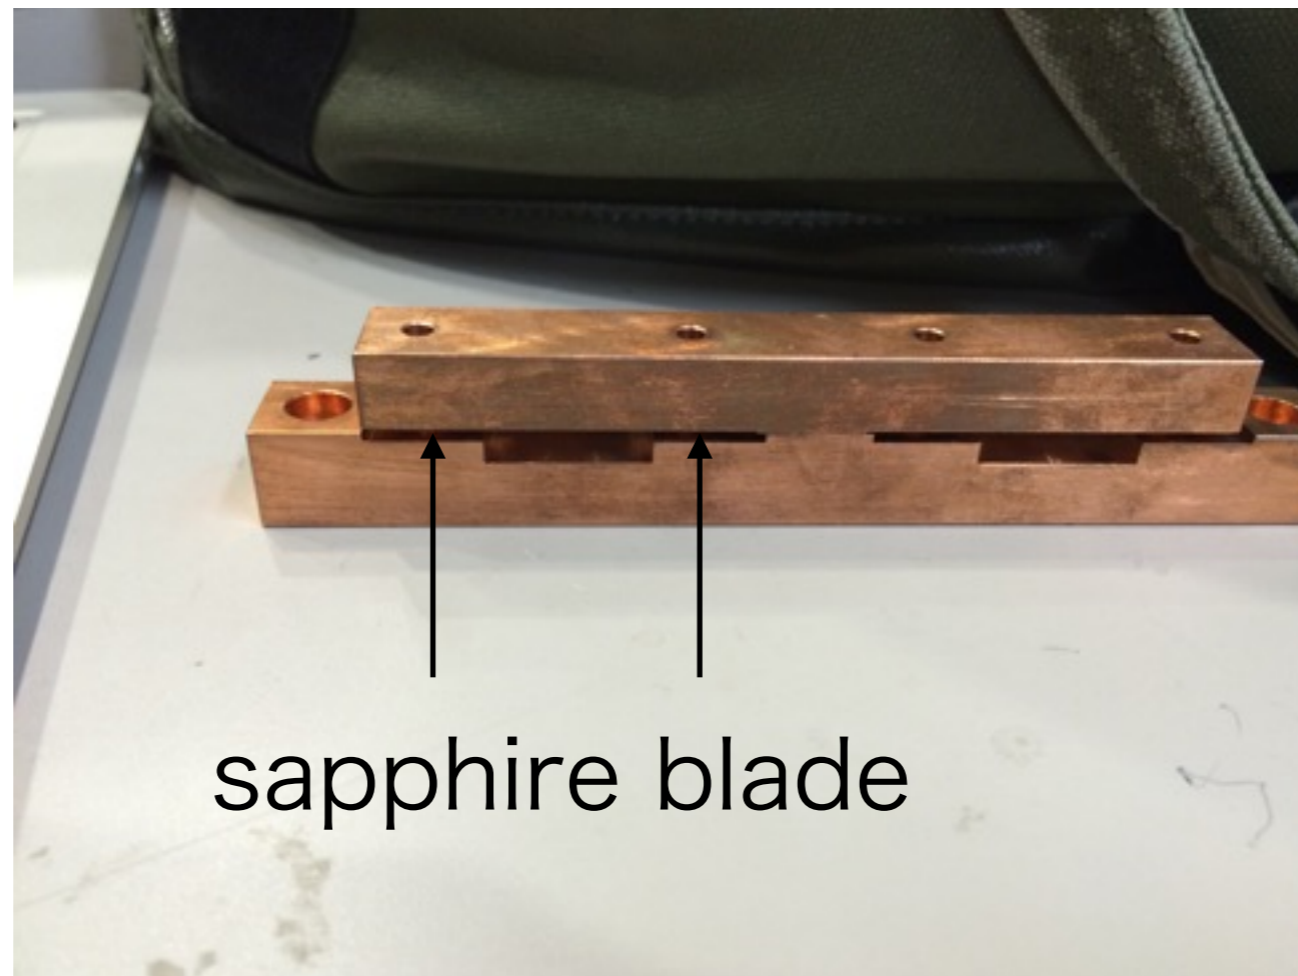
- This time, we will use the clamp below.

- After calibration, we will do the heat load test again.
- Now we know that the difference of the temperature between the blade and the copper support is too large.
