Mode Cleaner suspension installation

Naoko Ohishi^A, T. Saito^B, K. Doi^C,
M. Nakano^C, K. Shiga^B, T. Narita^C, K. Hirai^B,
R. Takahashi^A, T. Sato^B, M. Ohkawa^B,
S. Kawamura^C, T. Uchiyama^C, Y. Aso^A, and E. Hirose^C
A: NAOJ, B: Niigata Univ., C: ICRR

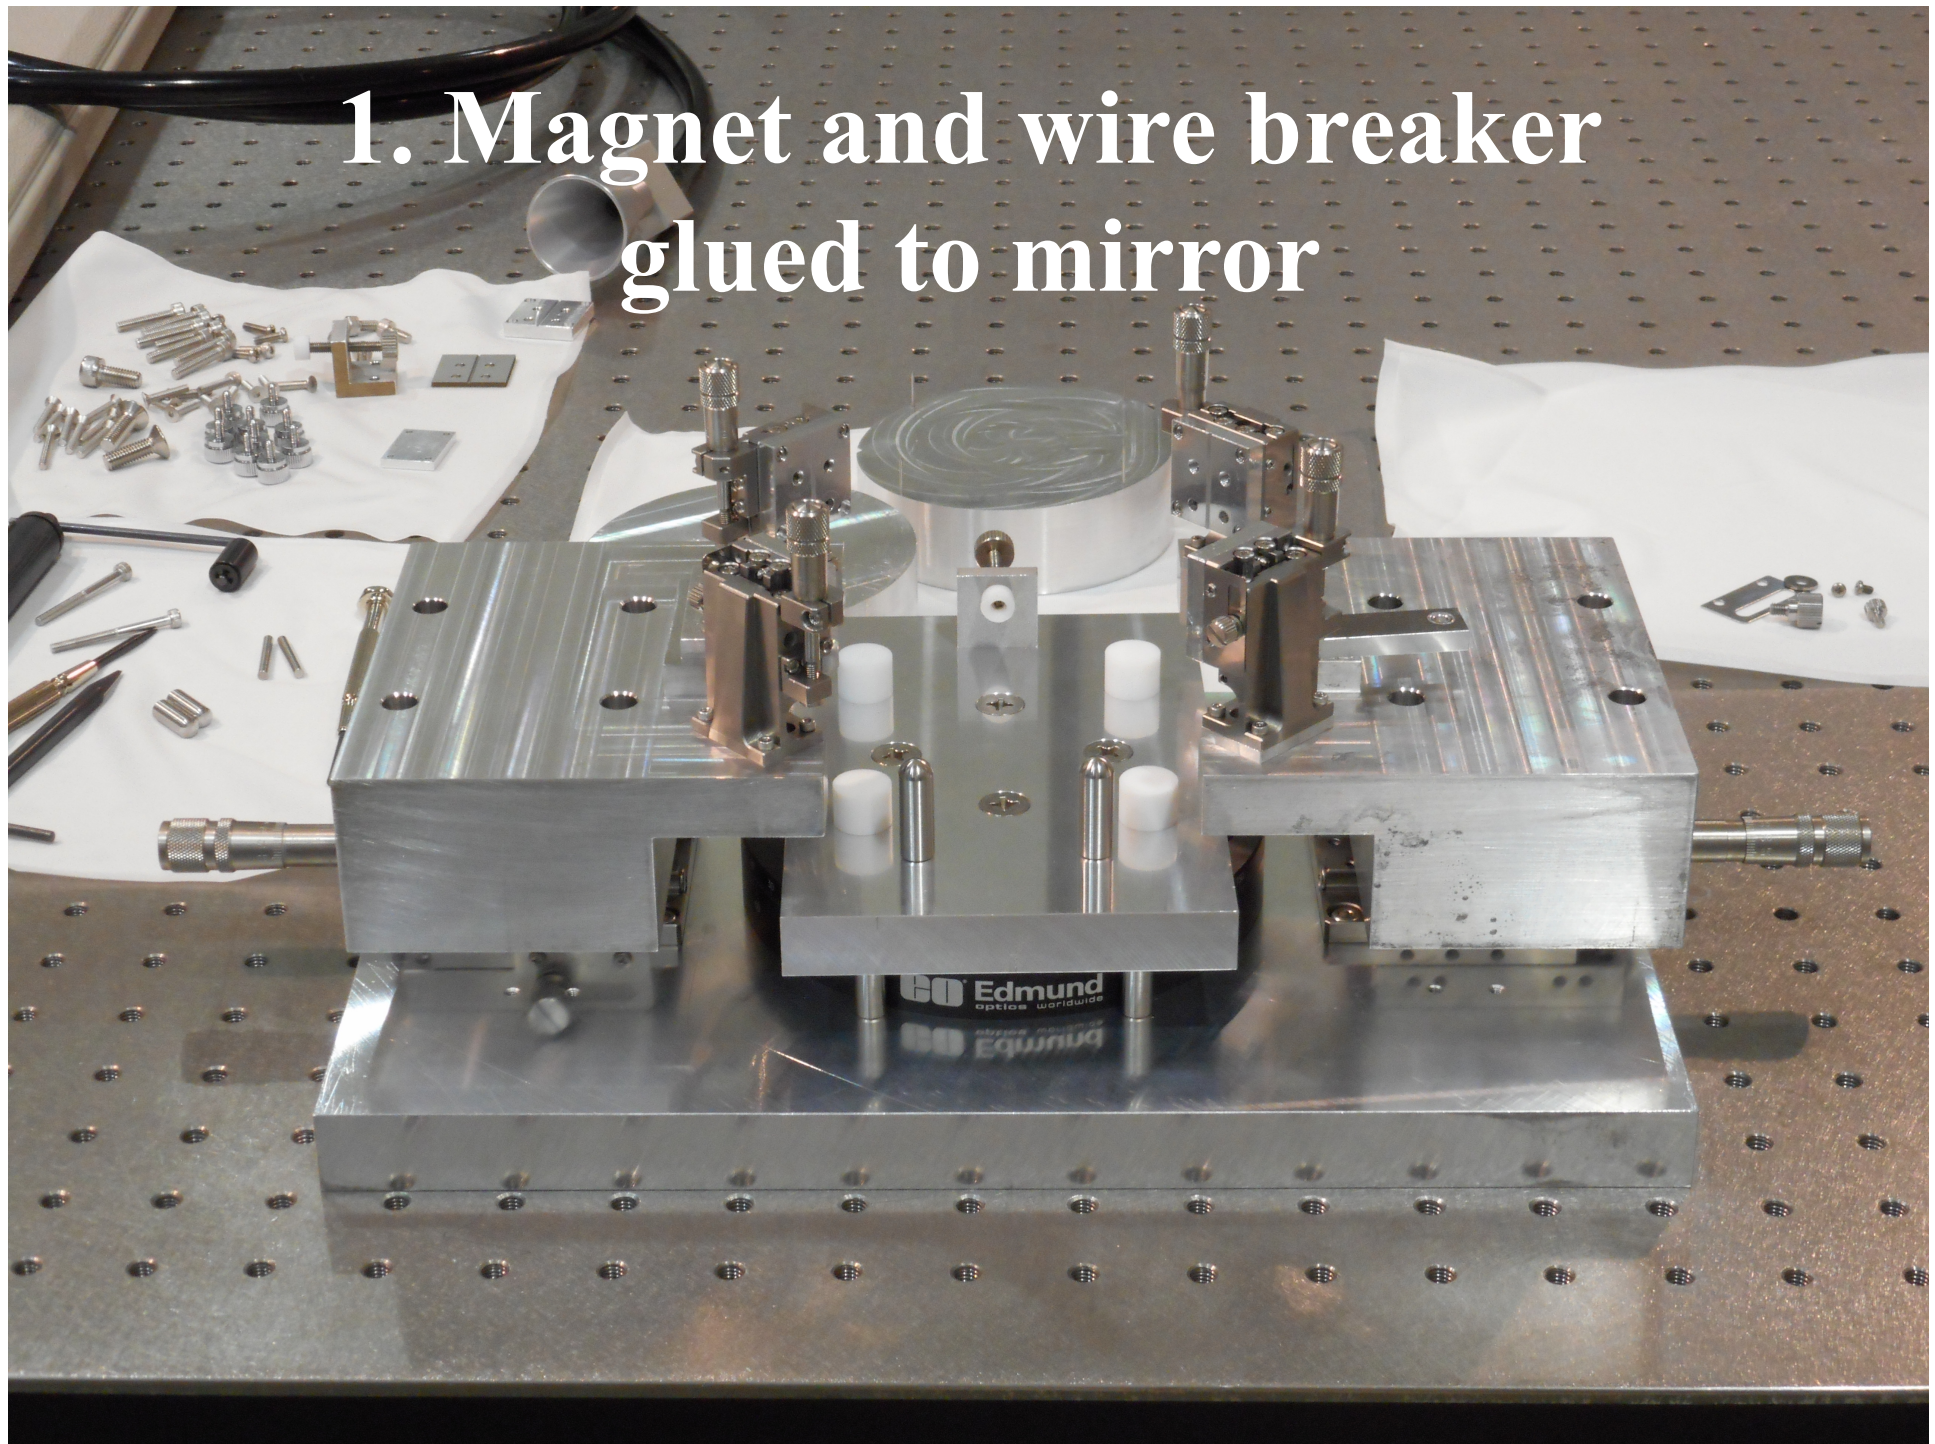
1. Magnet and wire breaker glued to mirror

Glued a magnet in the wrong direction

We used magnetometer for MCI and MCo but didn't for MCE

- **Evaluation of magnetic field** (Michimura-san)
 - **NNNS is Permissible** in terms of displacement noise
 $5\text{e-}15\text{m/rHz}$ (NSNS) \rightarrow $3\text{e-}13\text{m/rHz}$ (NNNS)
 $< 1\text{e-}11\text{m/rHz @}10\text{Hz}$ requirement for
- **Adhesive removal test** (Hirose-san)
 - (Two Liquid Mixture Type Epoxy Resin Adhesive)
 - Adhesive can be removed by heating
 - Re-glueing test is necessary
 - There still remains the fear of damaging AR coating
- **Decision** about to repair/or not to repair the polarity
will be made at the next IOO meeting (Aug 31th)

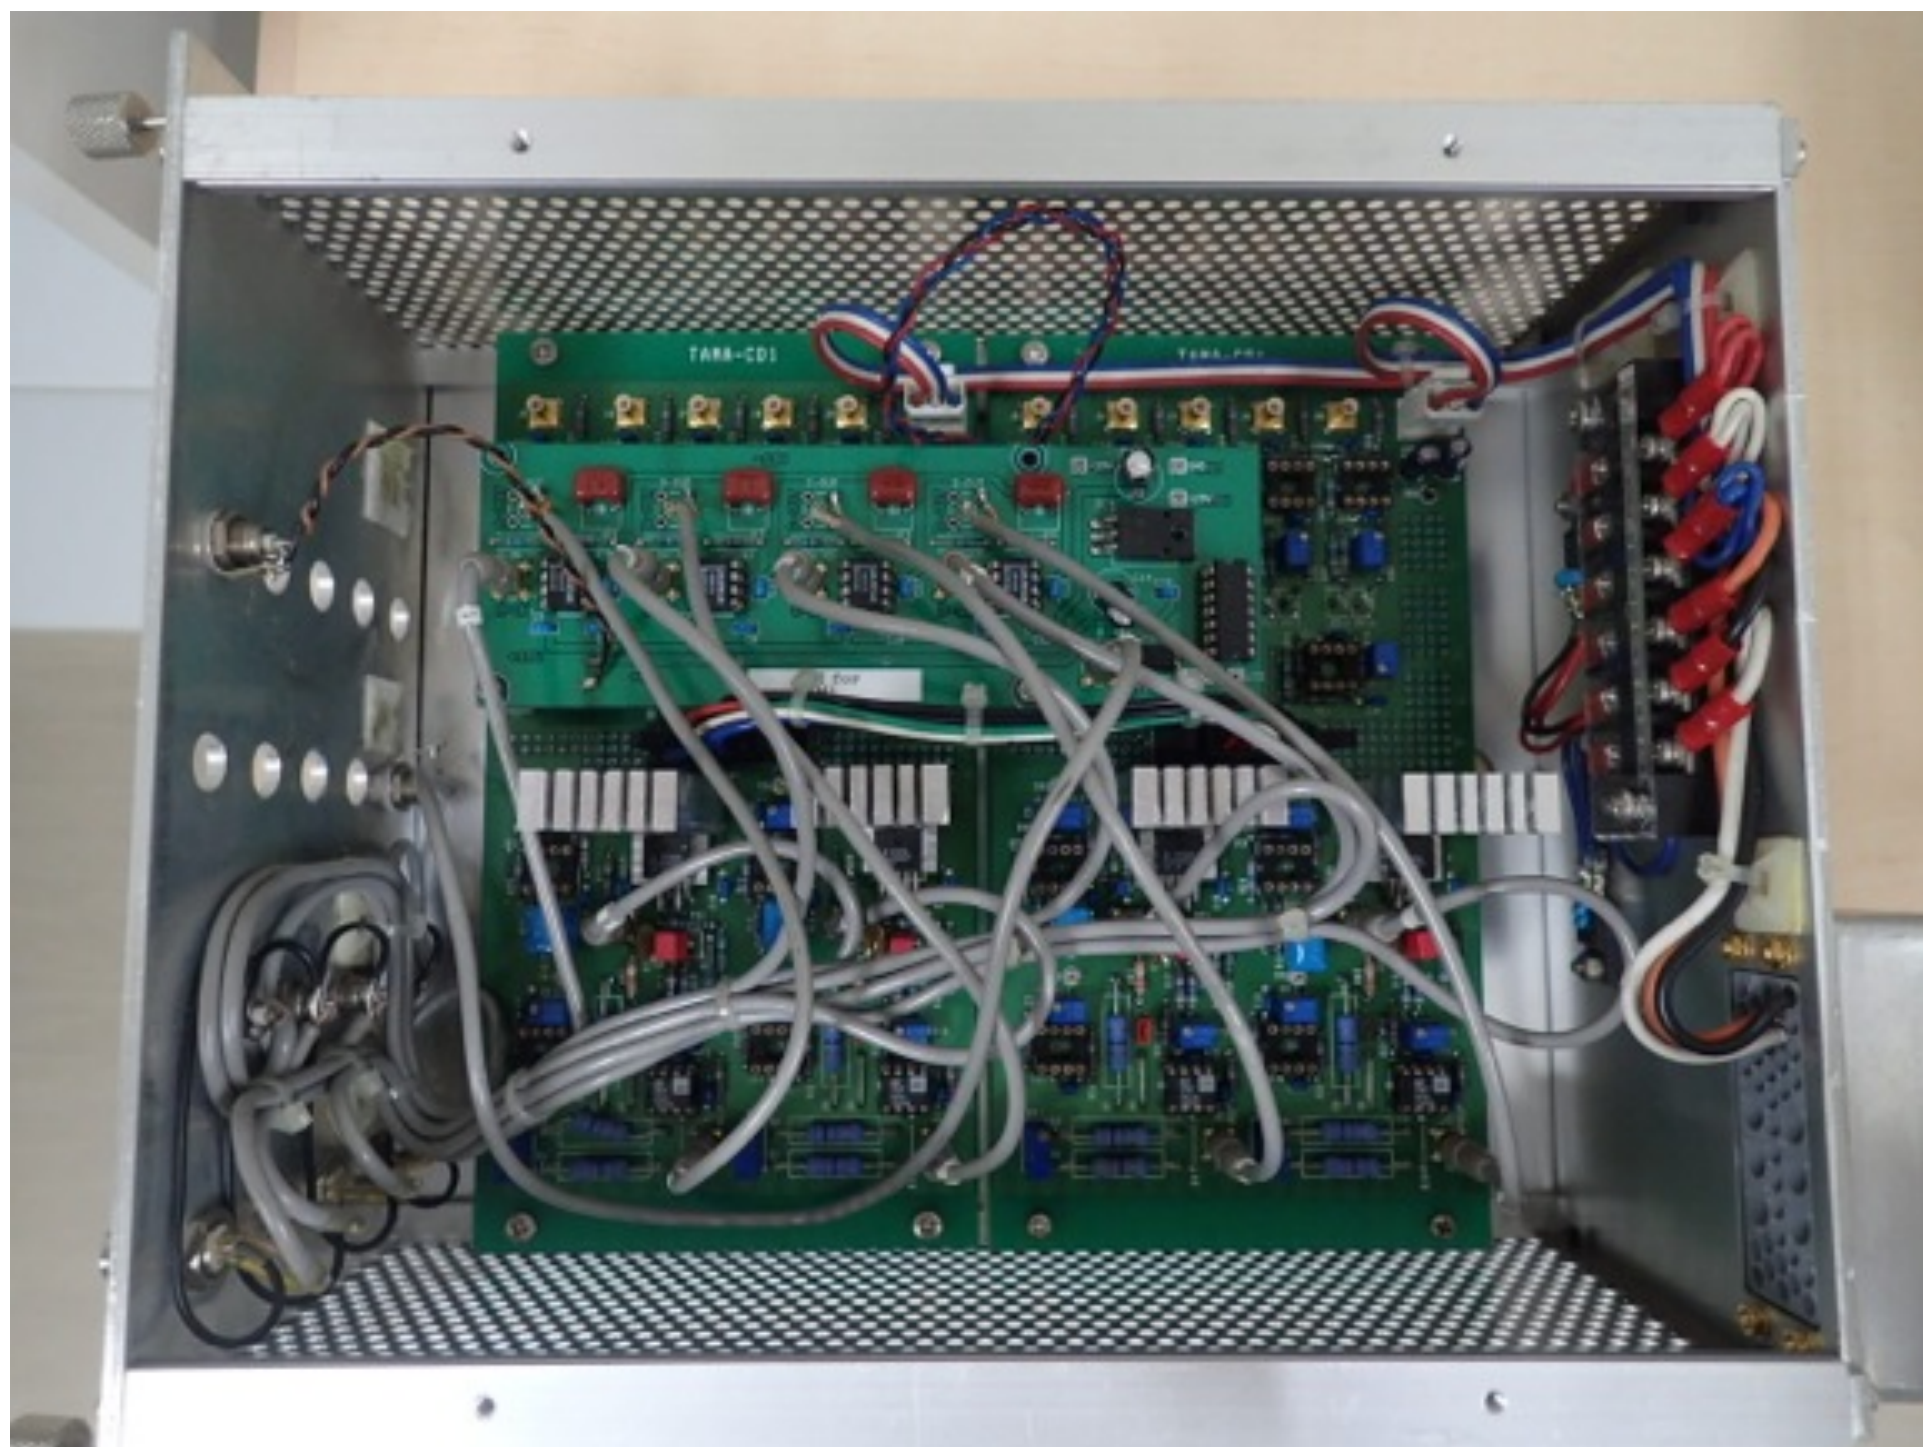
NM1: circuit board burned

- **Coil driver problem**
 - We found TAMA Coil Driver didn't work properly
 - Measures need to be discussed at the next IOO meeting
 - **In either case, it takes a few weeks**
 - Replace of tungsten wires (a few days; 2persons)
- **Wrong direction of a magnet on MCE**
 - To be determined at the next IOO meeting
- **Preparation of plates under suspension**
 - A few days
- **Reassembling of some parts**
 - half a day

Measure

- Need to be discussed at the next IOO meeting.
- **Repair TAMA coil driver**
 - Current OP amp is already obsolete
 - OP amp replacement seem to be not enough
- **Use KAGRA coil driver**
 - KAGRA coil driver are already made (under test)
 - A kind of converter is necessary for handling differential signal output of KAGRA coil driver
- In either case, it takes a few weeks, I think.
