Mode Cleaner suspension installation

Naoko Ohishi^A, T. Saito^B, K. Doi^C,
M. Nakano^C, K. Shiga^B, T. Narita^C, K. Hirai^B,
R. Takahashi^A, T. Sato^B, M. Ohkawa^B,
S. Kawamura^C, T. Uchiyama^C, Y. Aso^A, and E. Hirose^C
A: NAOJ, B: Niigata Univ., C: ICRR

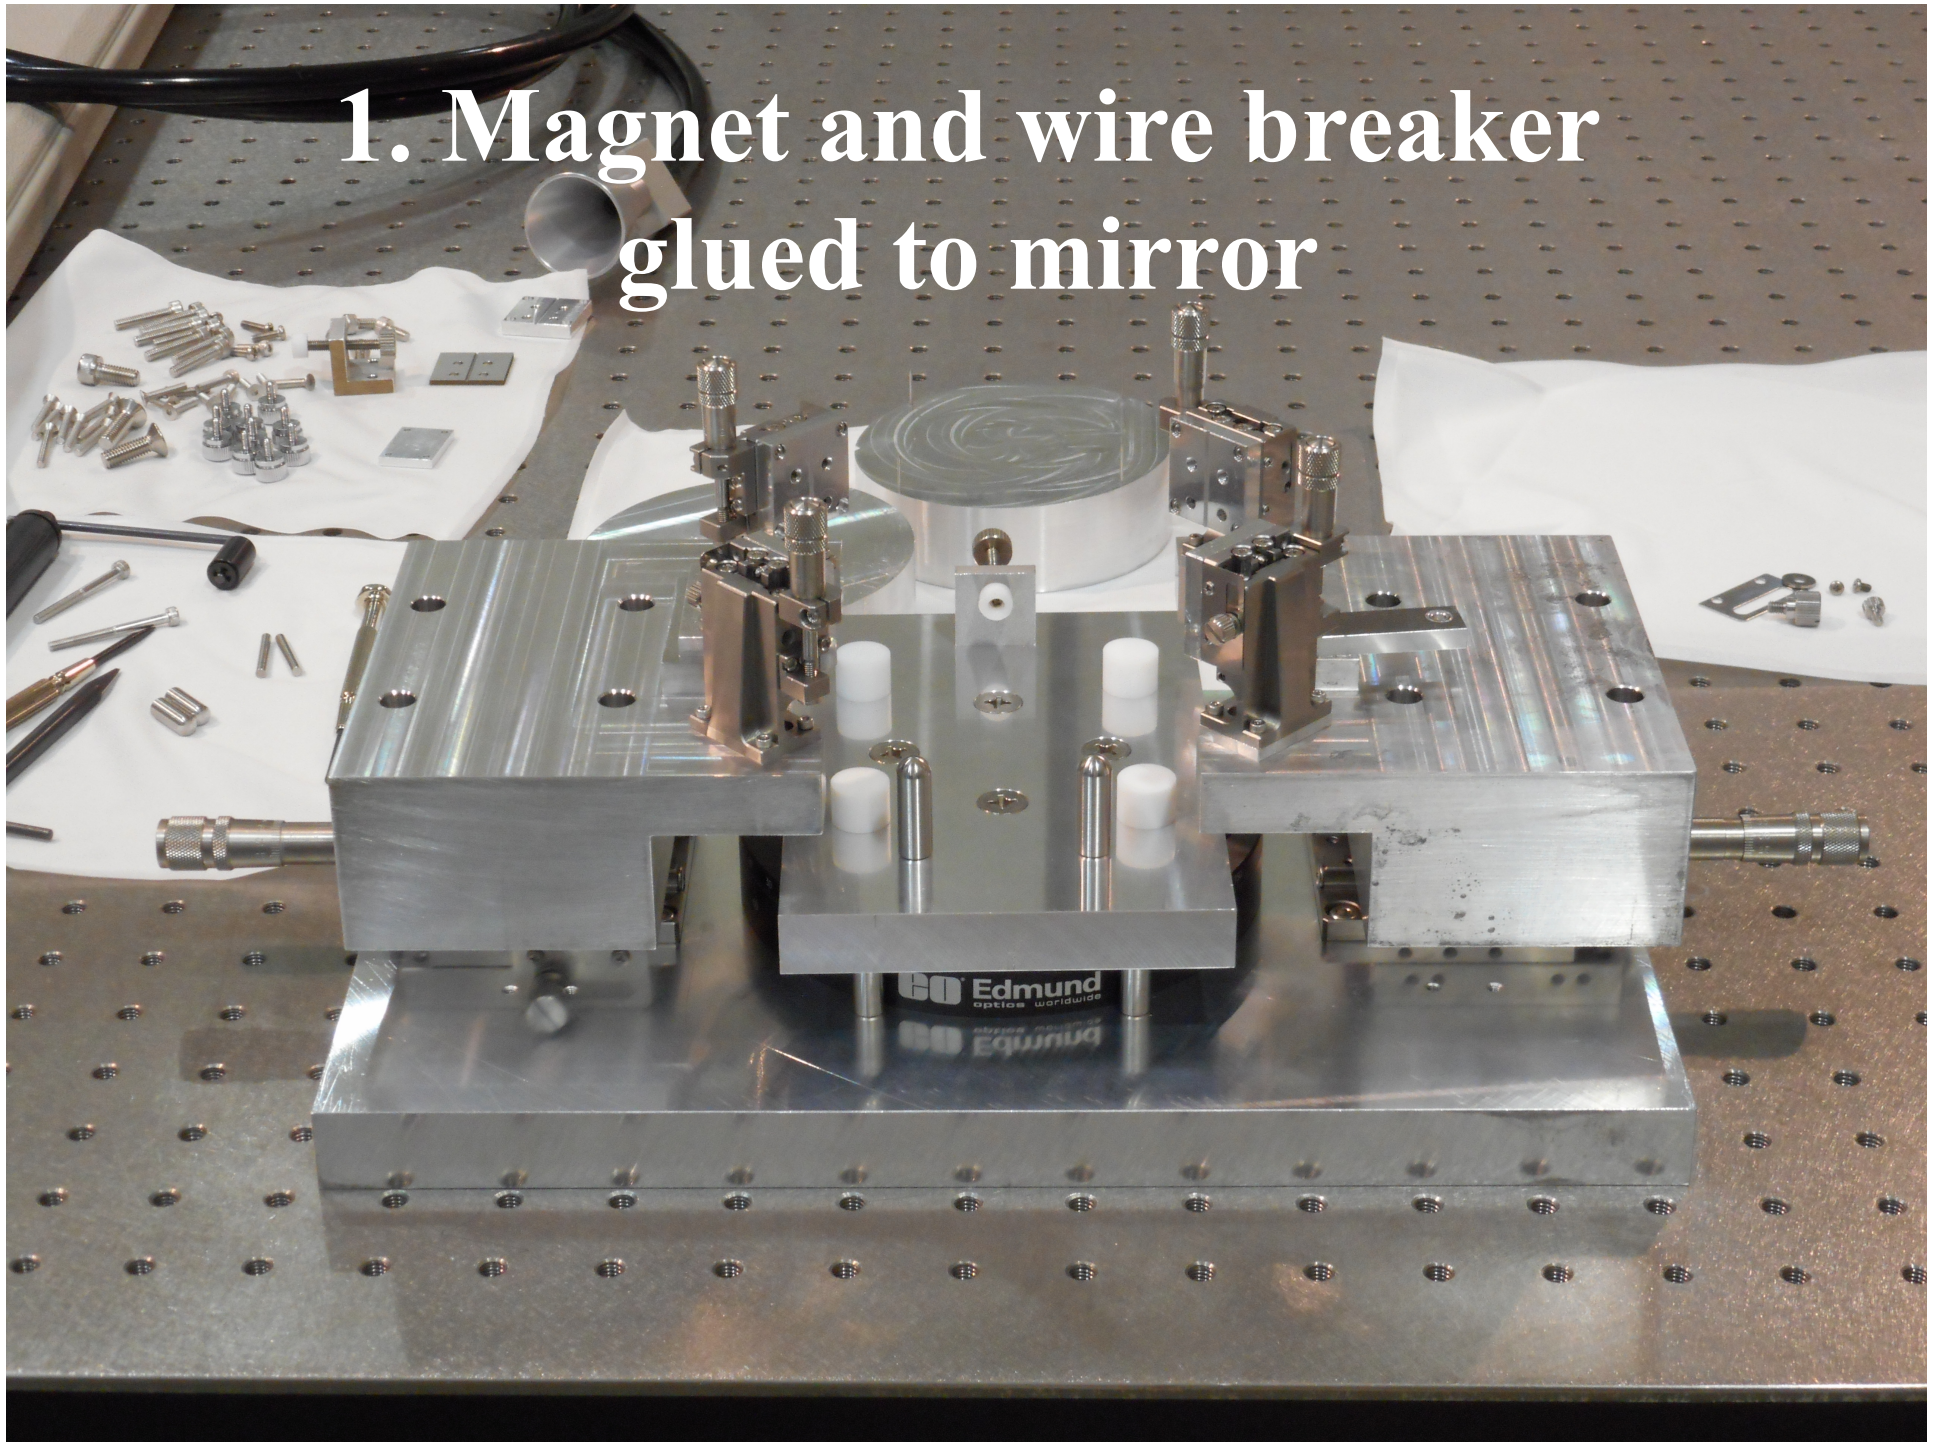
1. Magnet and wire breaker glued to mirror

Glued a magnet in the wrong direction

We used magnetometer for MCI and MCo but didn't for MCE

- **Evaluation of magnetic field (Michimura-san)**
 - **NNNS is Permissible** in terms of displacement noise
 $5e-15\text{m/rHz}$ (NSNS) \rightarrow $3e-13\text{m/rHz}$ (NNNS)
 $< 1e-11\text{m/rHz @10Hz}$ requirement for
- **Adhesive removal test (Hirose-san)**
(Two Liquid Mixture Type Epoxy Resin Adhesive)
 - Adhesive can be removed by heating
 - Re-glueing test is necessary
 - There still remains the fear of damaging AR coating
- **Decision** about to repair/or not to repair the polarity will be made at the next IOO meeting (Aug 31th)

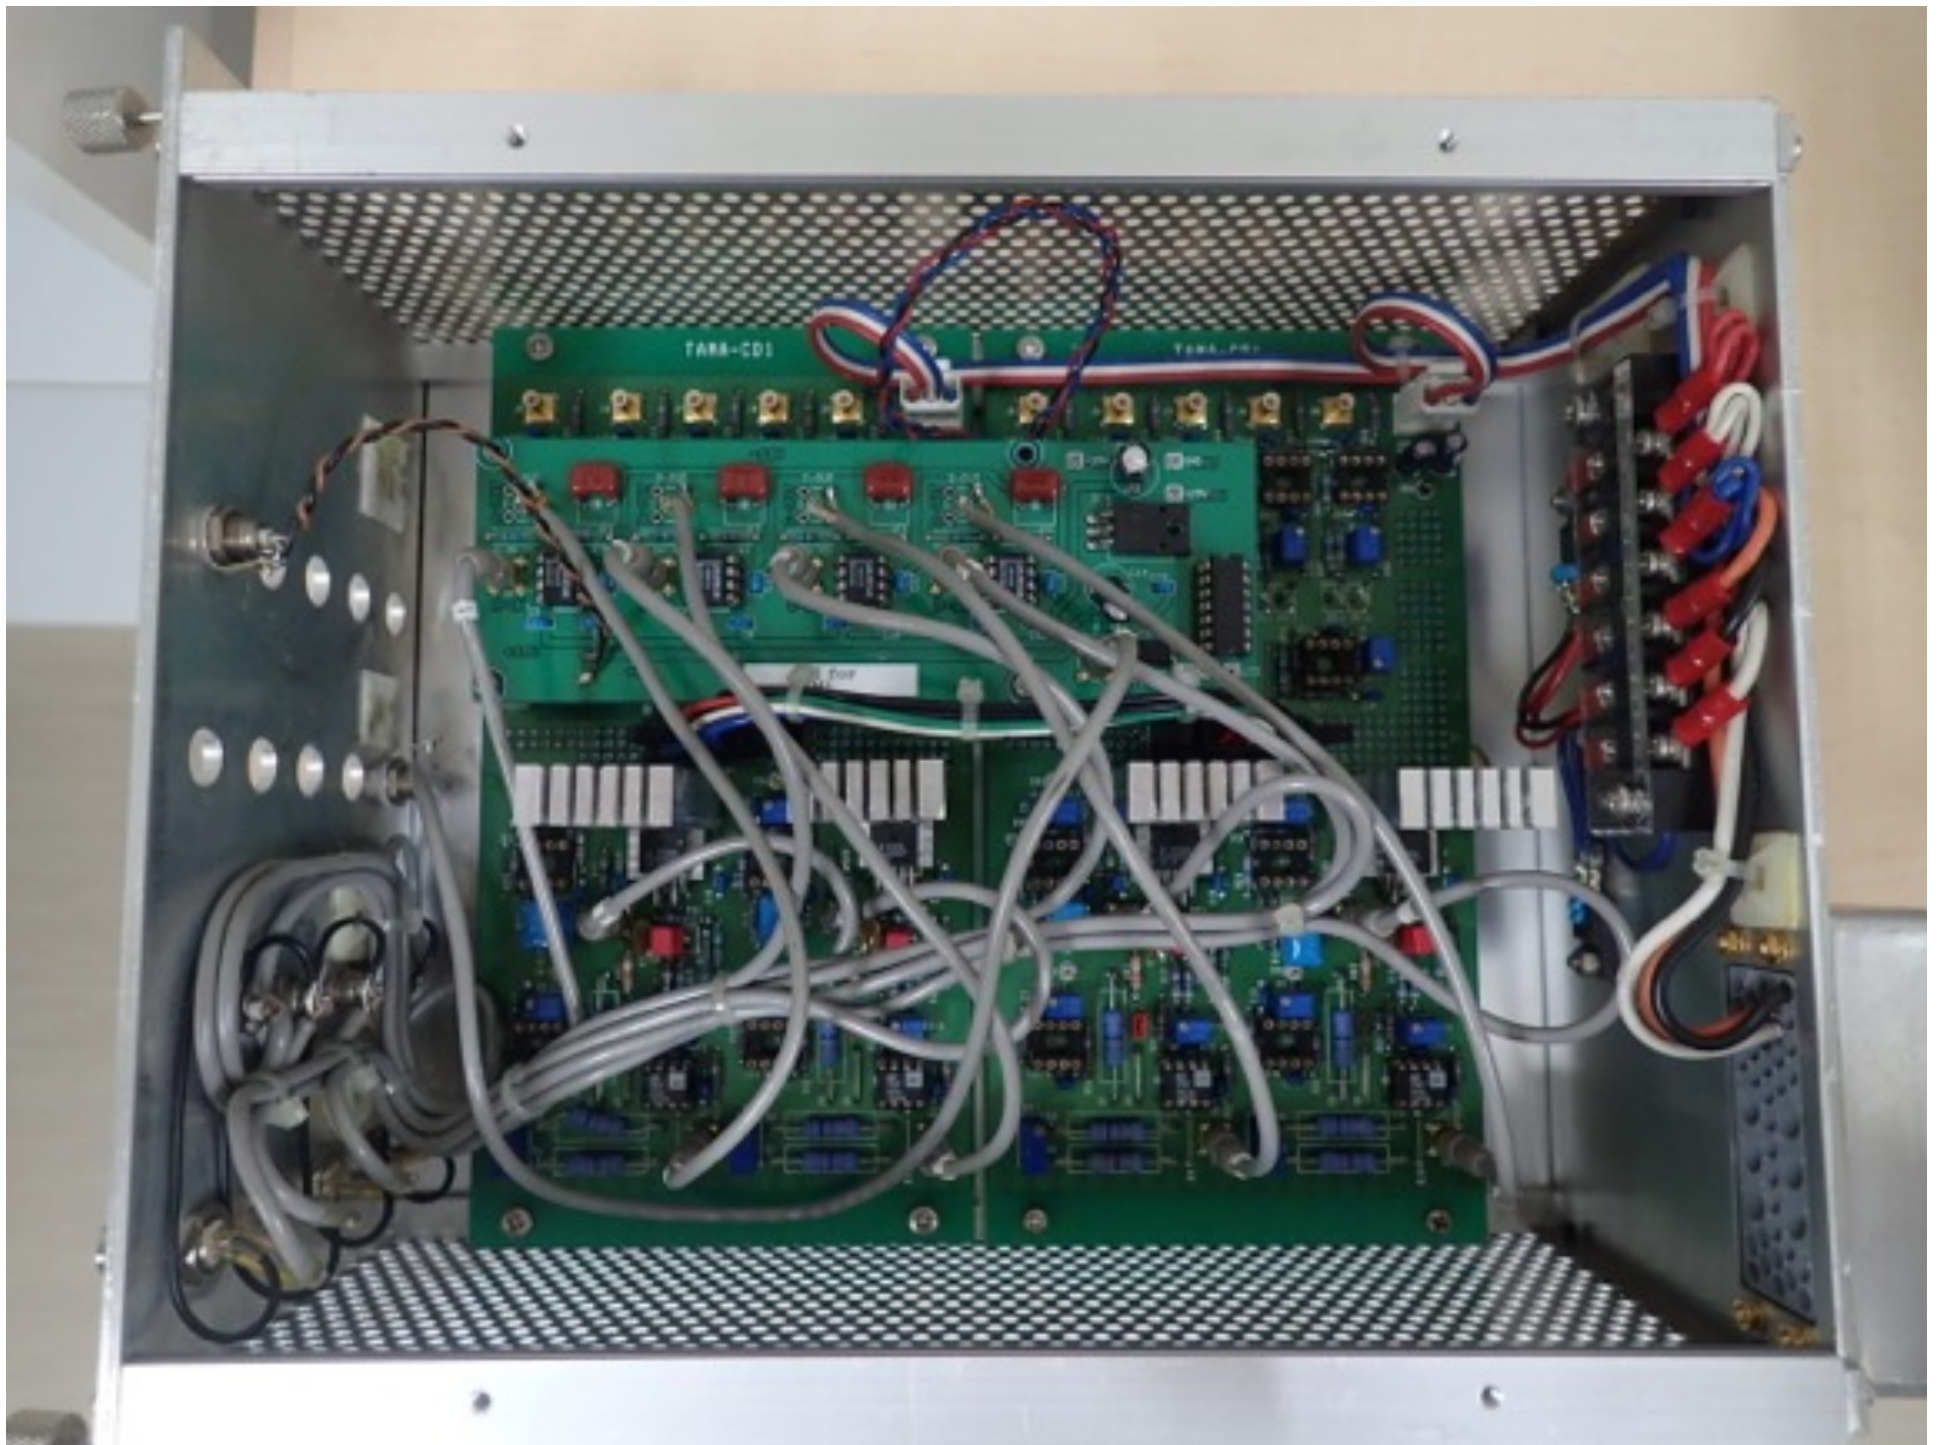
NM1: circuit board burned

- **Coil driver problem**
 - We found TAMA Coil Driver didn't work properly
 - Measures need to be discussed at the next IOO meeting
 - **In either case, it takes a few weeks**
 - Replace of tungsten wires (a few days; 2persons)
- **Wrong direction of a magnet on MCE**
 - To be determined at the next IOO meeting
- **Preparation of plates under suspension**
 - A few days
- **Reassembling of some parts**
 - half a day

- Need to be discussed at the next IOO meeting.
- **Repair TAMA coil driver**
 - Current OP amp is already obsolete
 - OP amp replacement seem to be not enough
- **Use KAGRA coil driver**
 - KAGRA coil driver are already made (under test)
 - A kind of converter is necessary for handling differential signal output of KAGRA coil driver
- In either case, it takes a few weeks, I think.
