Mode Cleaner suspension installation

Naoko Ohishi^A, T. Saito^B, K. Doi^C, M. Nakano^C, K. Shiga^B, T. Narita^C, K. Hirai^B, R. Takahashi^A, T. Sato^B, M. Ohkawa^B, S. Kawamura^C, T. Uchiyama^C, Y. Aso^A, and E. Hirose^C A: NAOJ, B: Niigata Univ., C: ICRR

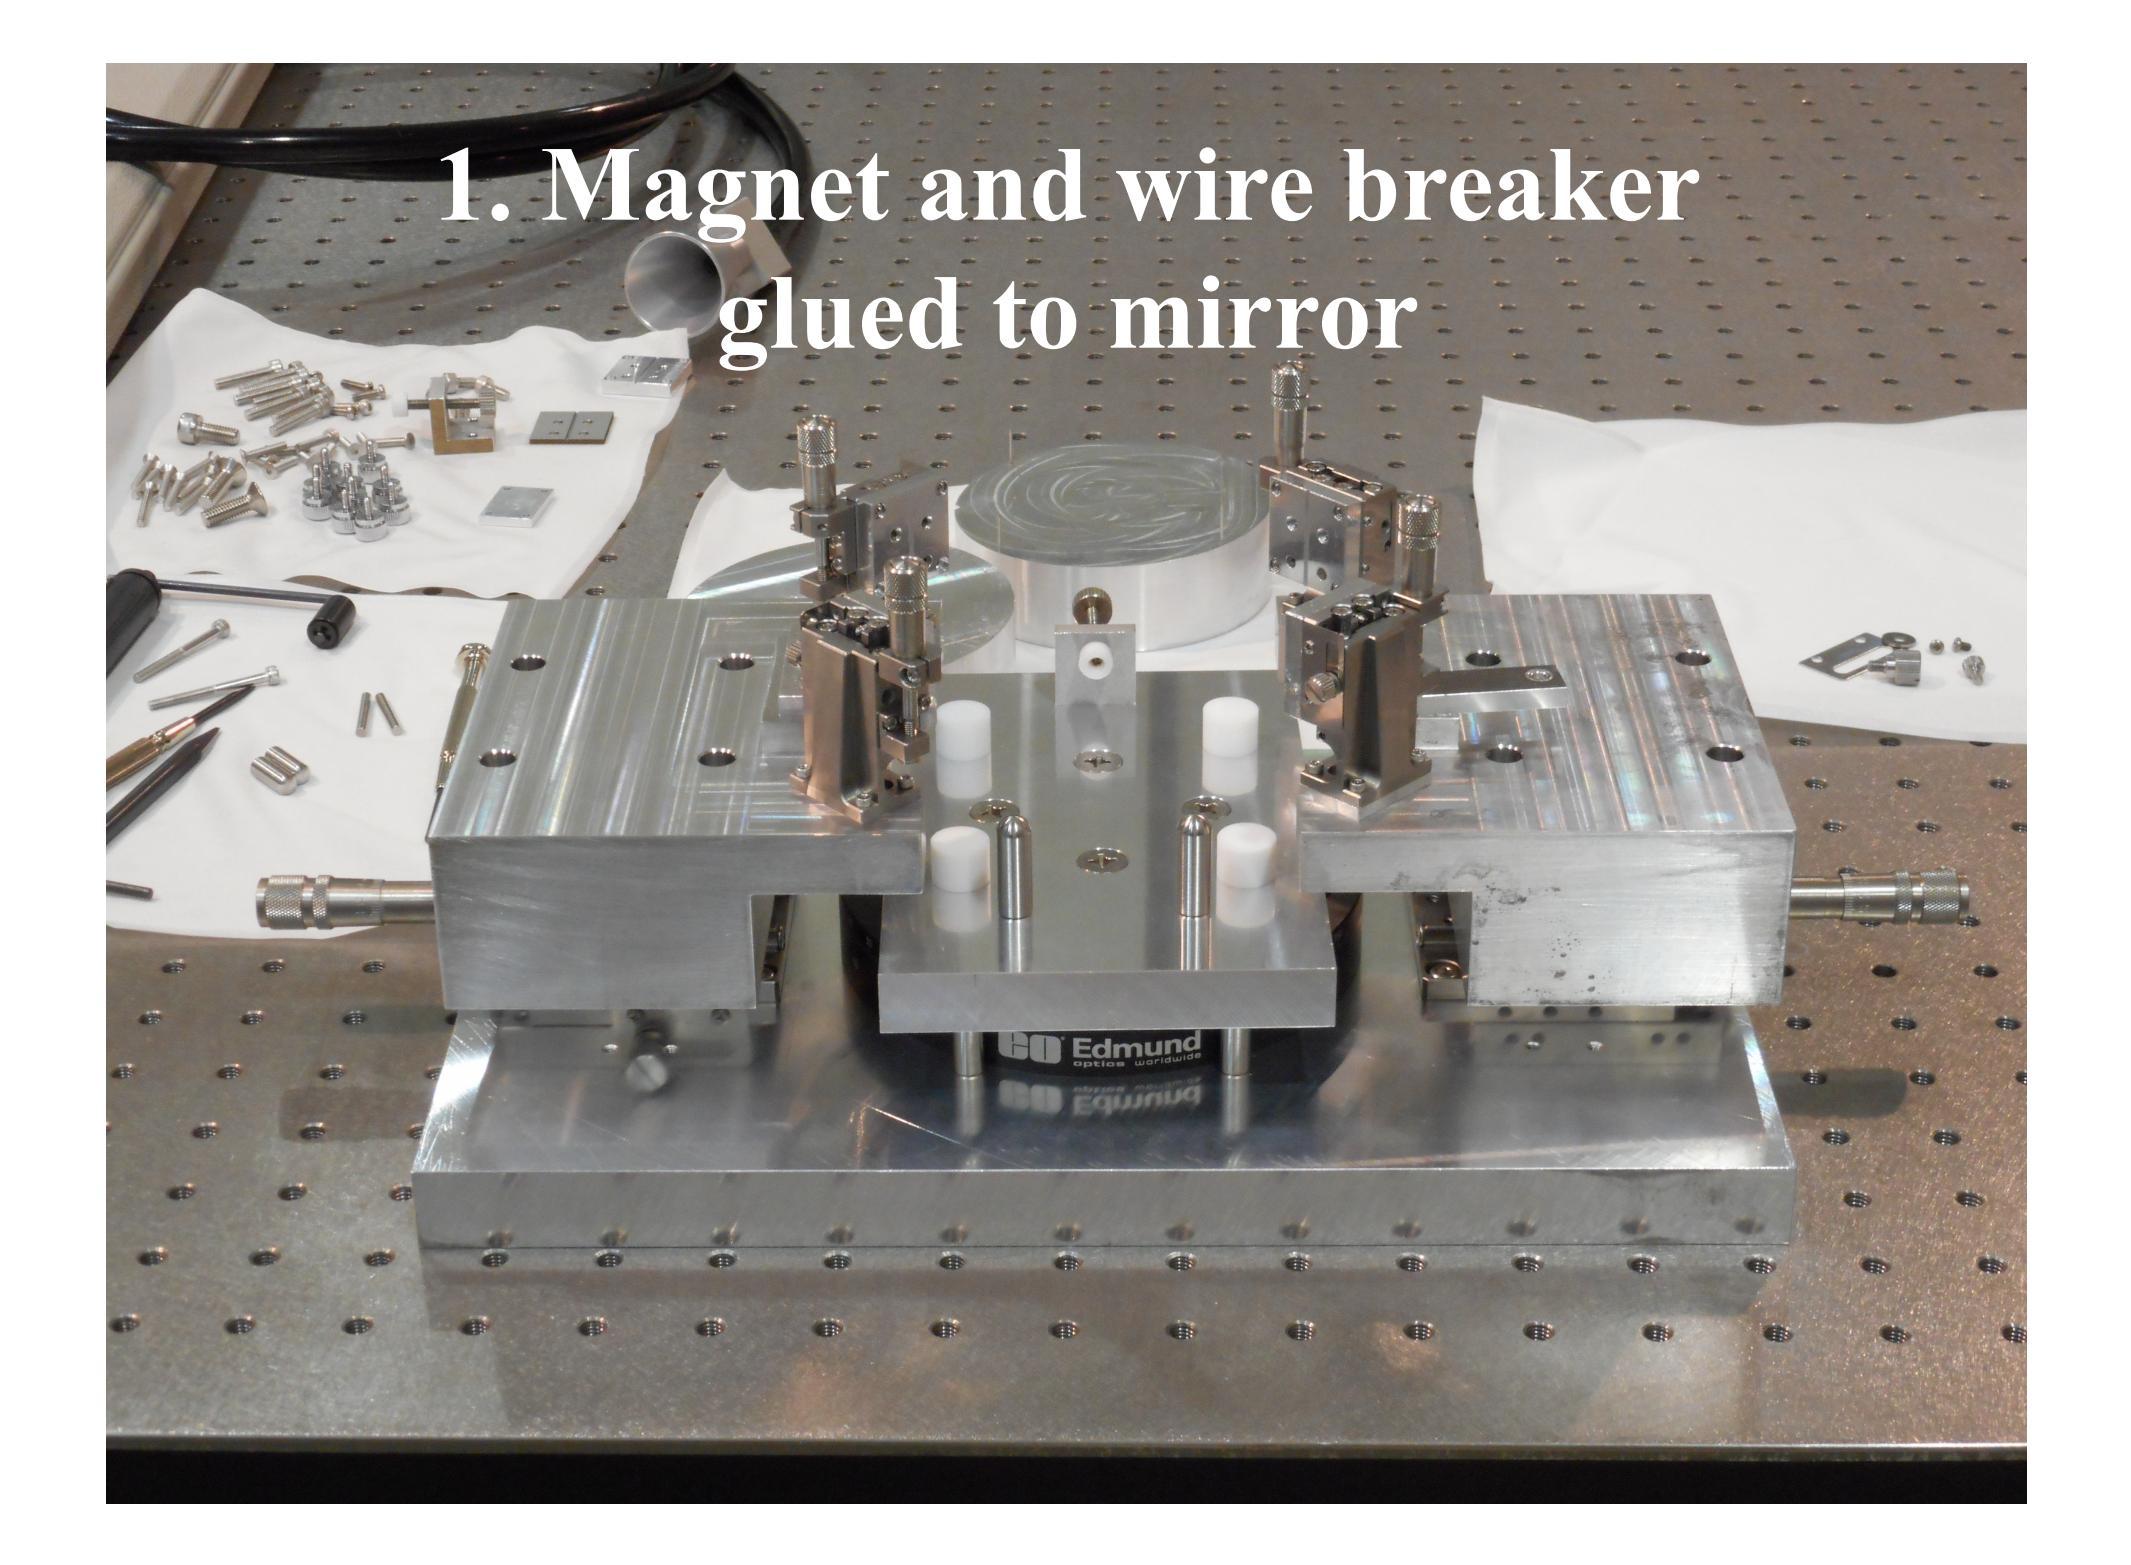
Glued a magnet in the wrong direction

We used magnetometer for MCi and MCo but didn't for MCe

- Evaluation of magnetic field (Michimura-san)
 - NNNS is Permissible in terms of displacement noise
 5e-15m/rHz (NSNS) → 3e-13m/rHz (NNNS)
 < 1e-11m/rHz @10Hz requirement for
- Adhesive removal test (Hirose-san)
 - (Two Liquid Mixture Type Epoxy Resin Adhesive)
 - Adhesive can be removed by heating
 - Re-glueing test is necessary
 - There still remains the fear of damaging AR coating
- **Decision** about to repair/or not to repair the polarity will be made at the next IOO meeting (Aug 31th)

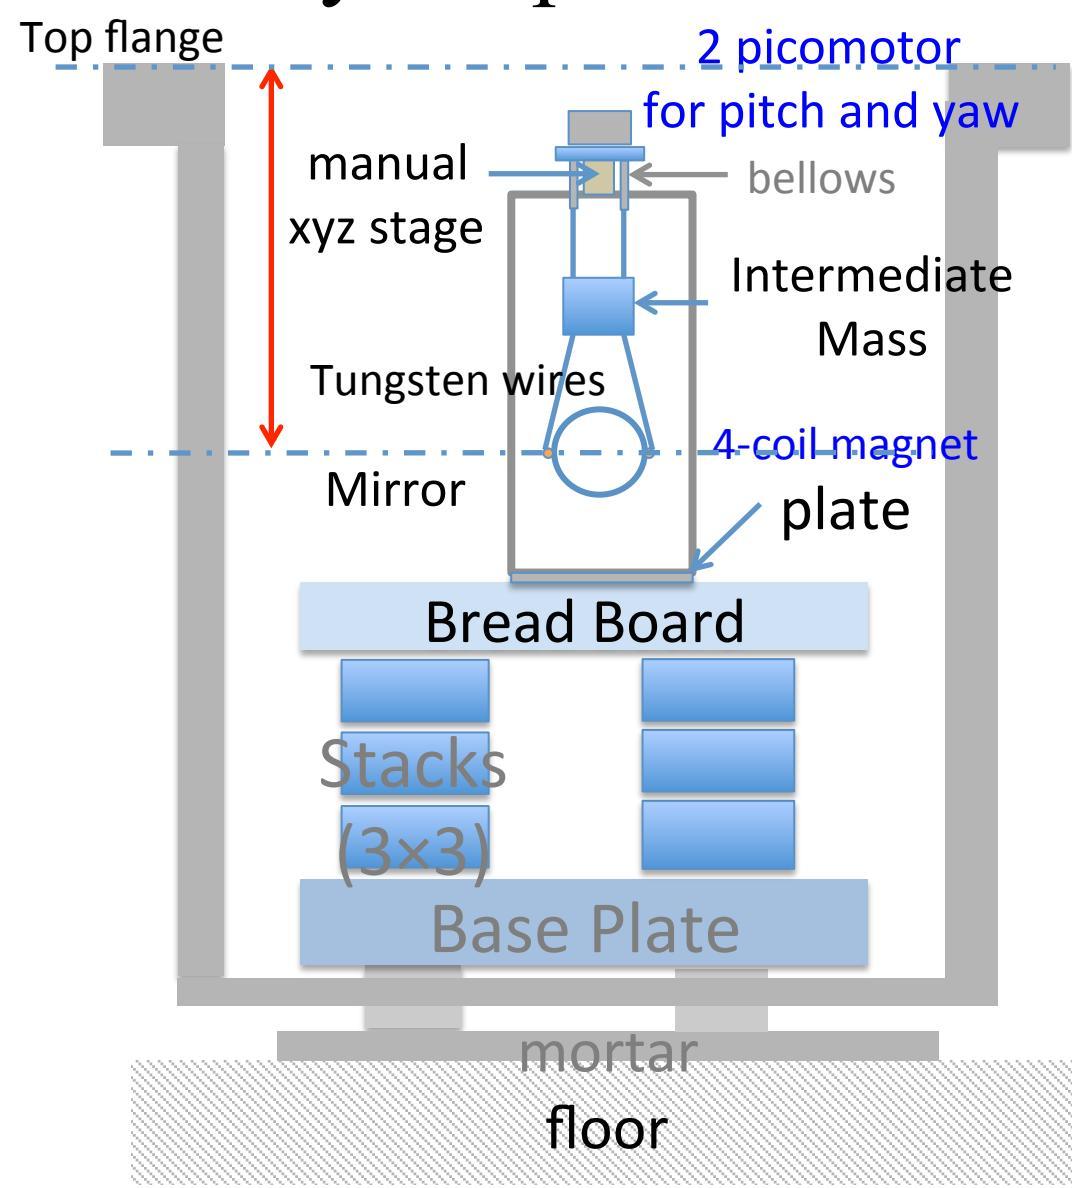
Position deviation of Breadboard

+2mm in x-direction, +1mm in y-direction Orientation error is less than 0.1 deg

-2mm in x-direction, 4mm in y-direction Orientation error is about 0.5 deg

Position and orientation deviation will be compensated by the plate under suspension

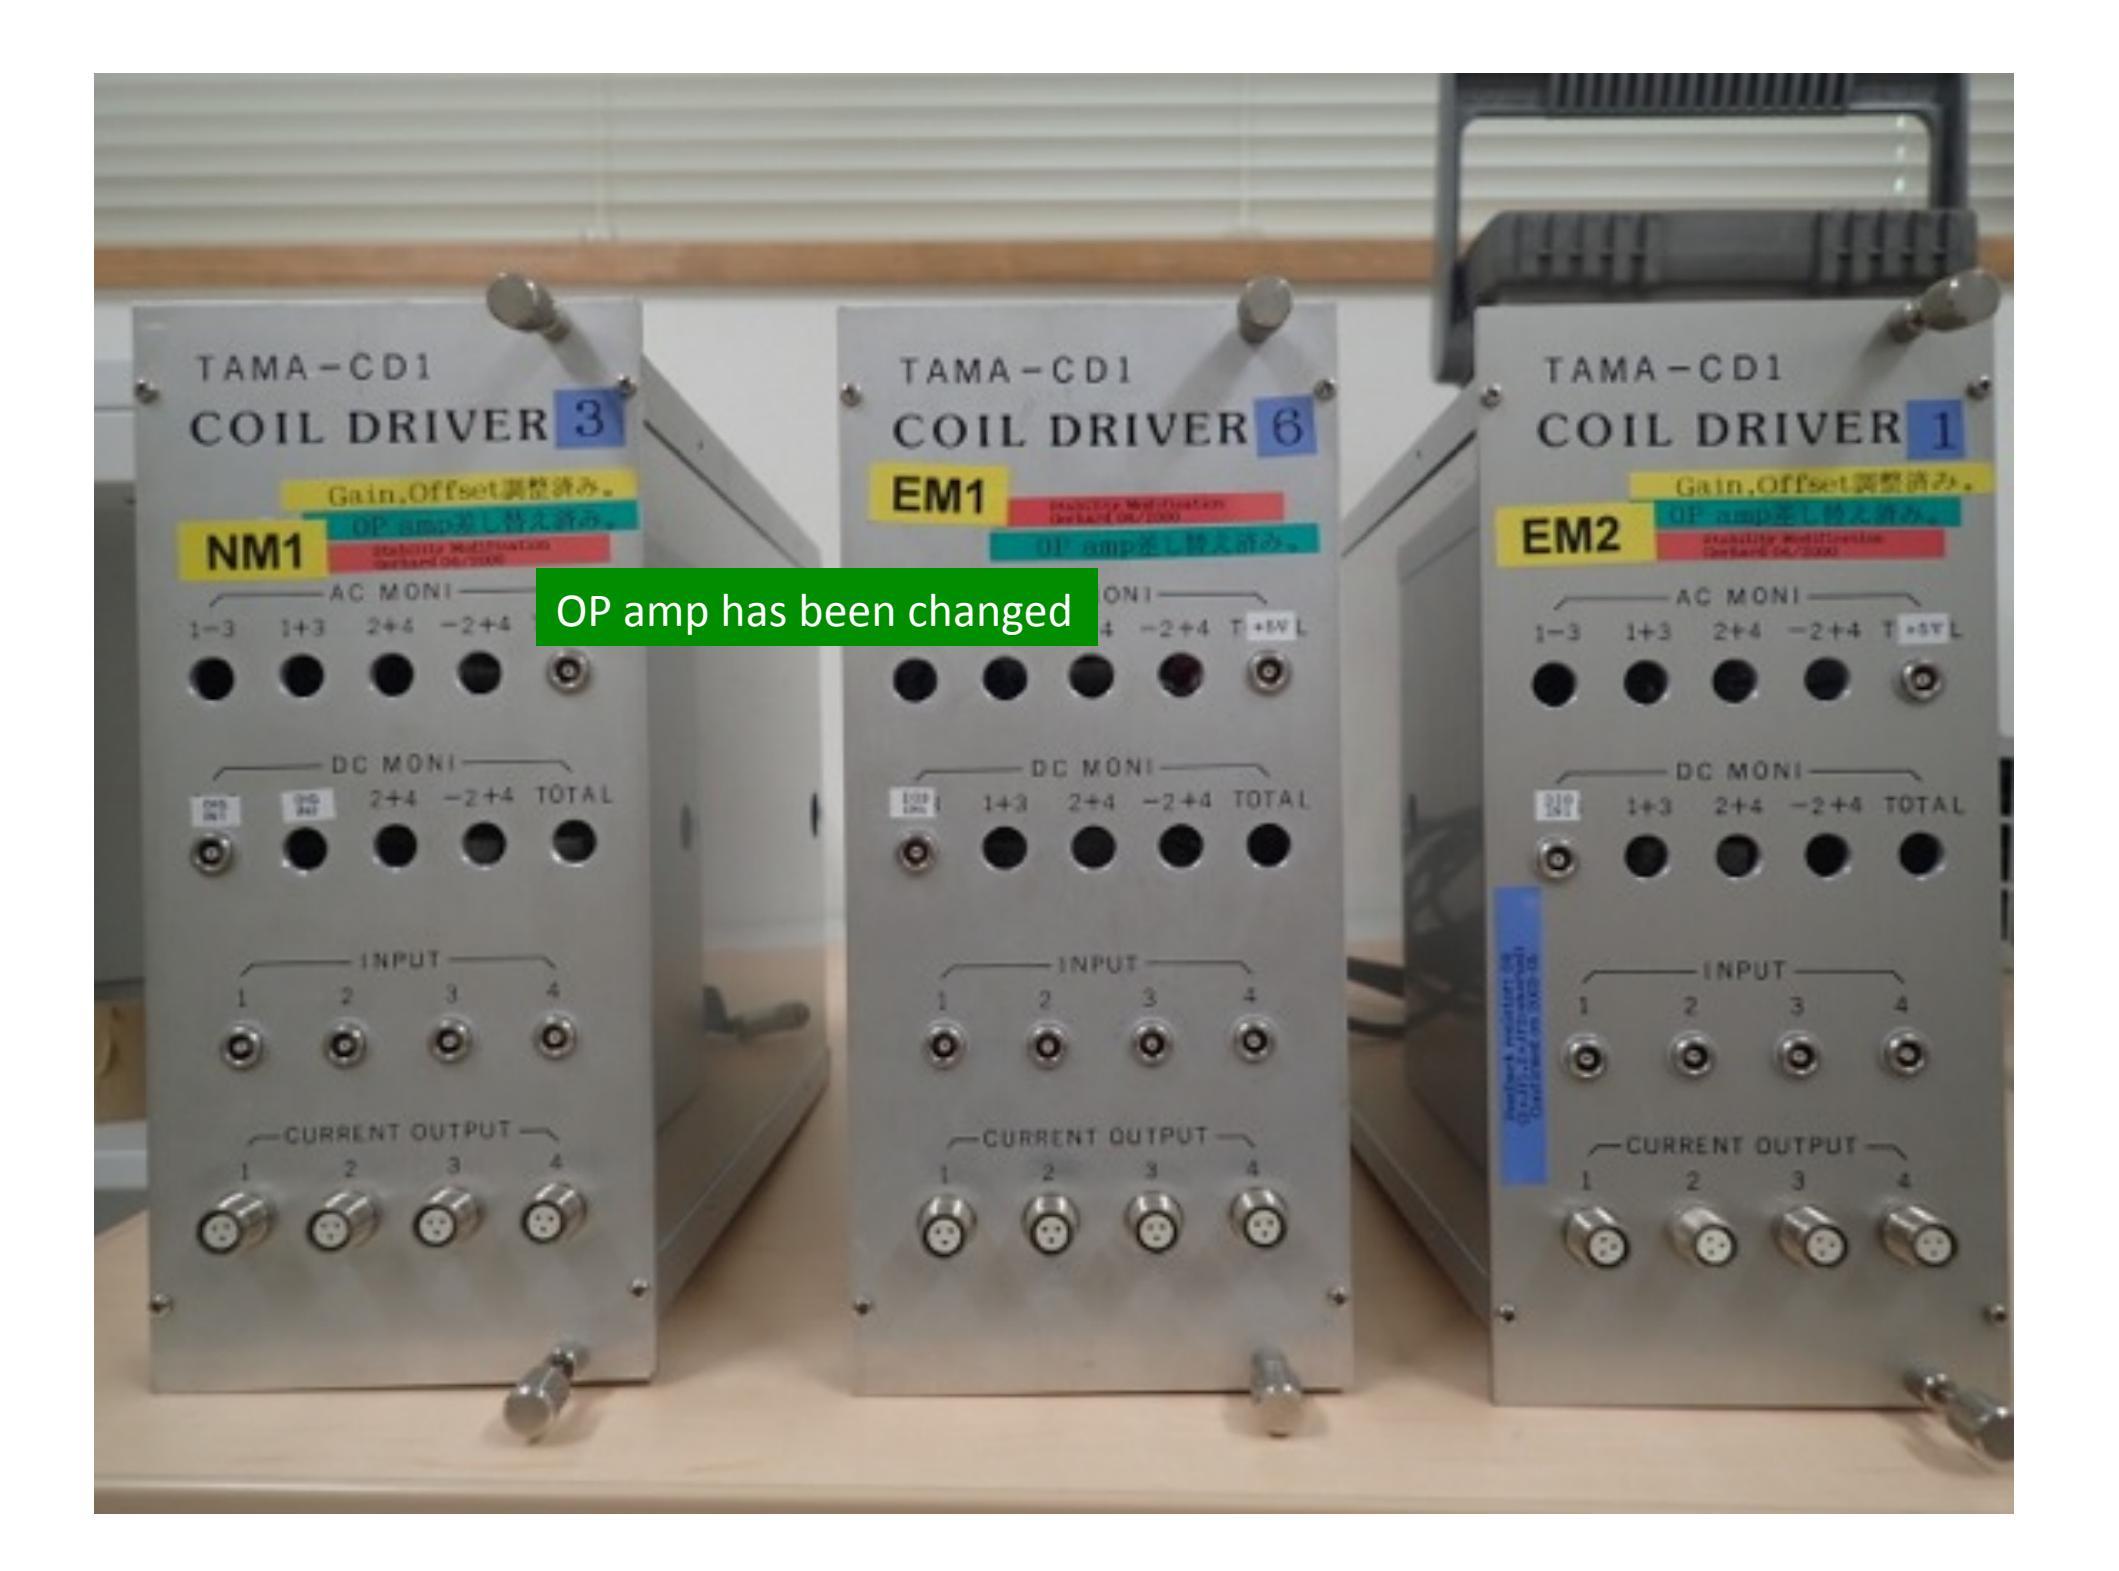
- Transfer function of the suspension was measured by Saito-san at NAOJ
 - Resonant frequencies and Q-values seems OK
 - Absolute value was smaller than expected
- Coil driver performance seems to be strange

EM1: ch4 is strange

- Need to be discussed at the next IOO meeting.
- Repair TAMA coil driver
 - Current OP amp is already obsolete
 - OP amp replacement seem to be not enough
- Use KAGRA coil driver
 - KAGRA coil driver are already made (under test)
 - A kind of converter is necessary for handling differential signal output of KAGRA coil driver
- In either case, it takes a few weeks, I think.

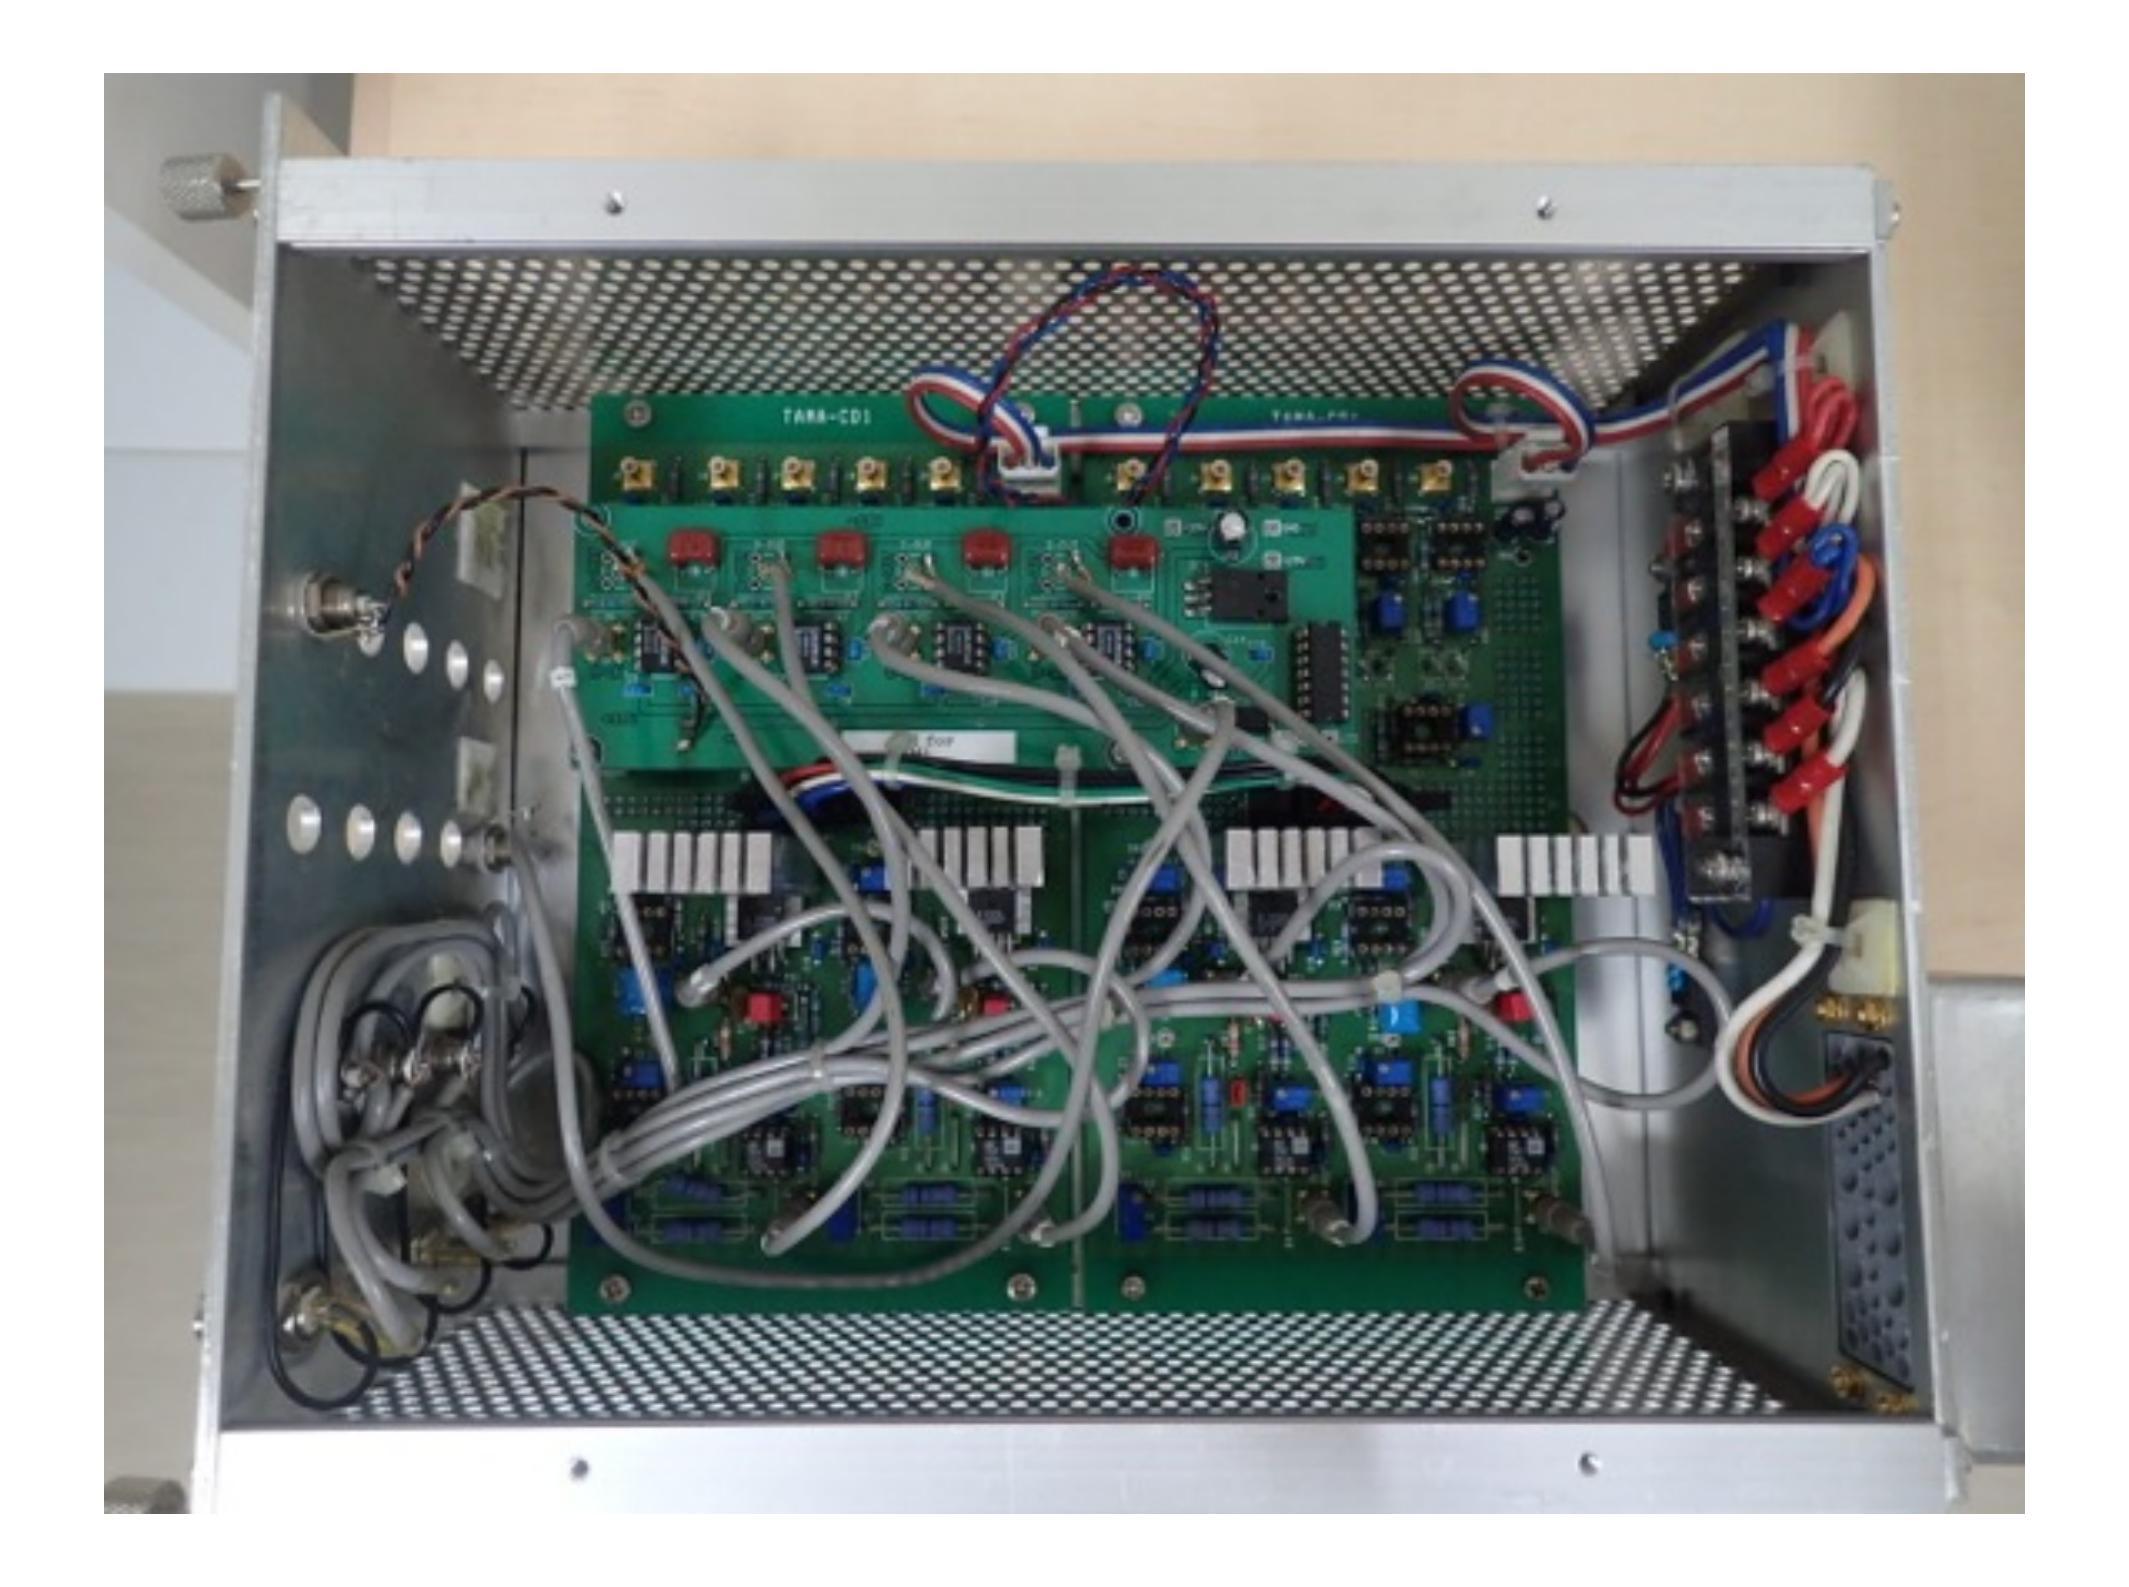
NM1: circuit board burned
