Session: errors not to be made again  
*The beauty of hindsight:* a discussion of mis-steps in

# KAGRA

**Tomo Akutsu**

For the KAGRA collaboration

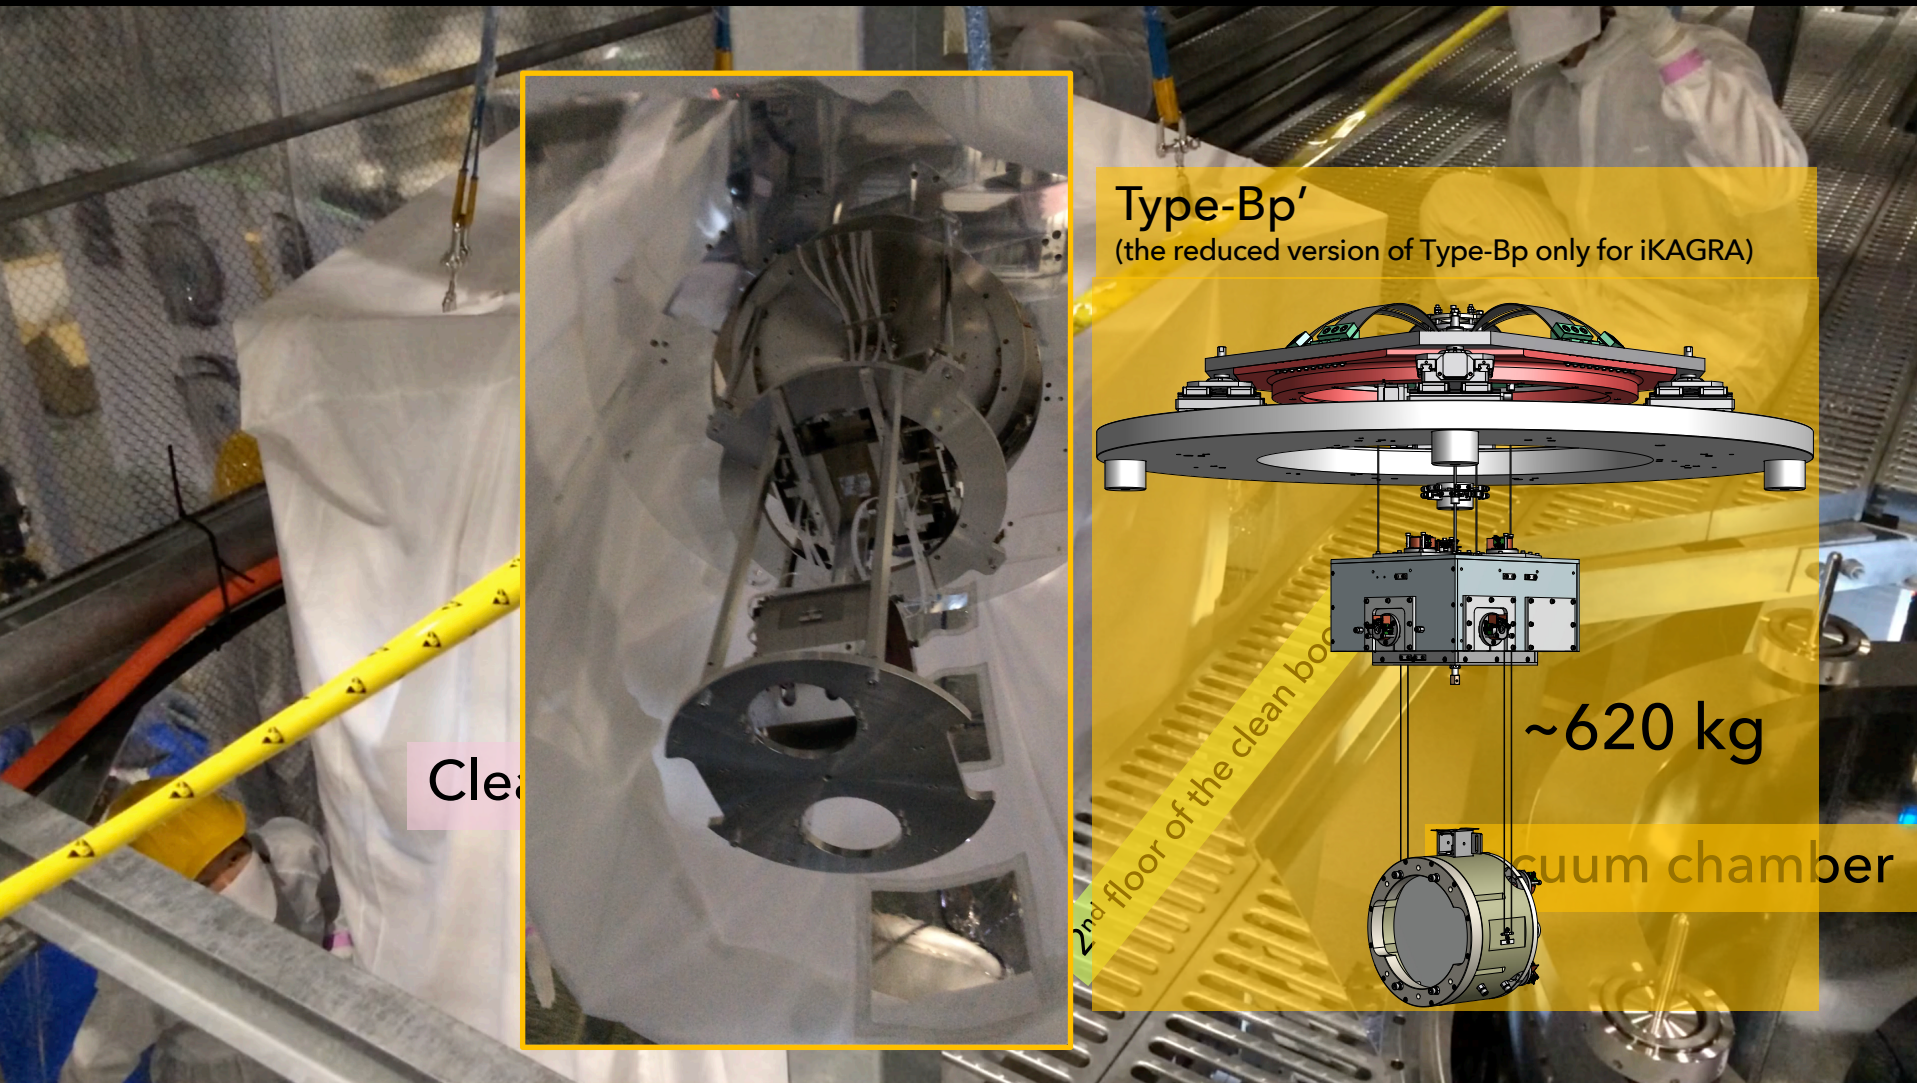
At the installation test of a suspension with a spare mirror for PR3 on 10<sup>th</sup> Dec 2015

- One of the four turnbuckles (to balance the load) suddenly unhooked during the crane work.
- The load fell ~ 1 cm and arrived (crashed!) onto the target position!

- **Mystery:** neither the turnbuckle nor the shackle seemed broken; a bad hooking from the first!?
- If so, the clean cover hid the bad hooking?? → Now we don't use such turnbuckles for these works.
- Plus, actually a pair of hook points were connected by a single sling. If the turnbuckle would have unhooked at the higher position, the paired point would lose the tension at once, and the load would swing, and caused severe injuries... again, we were so lucky. → "One hook for one sling".

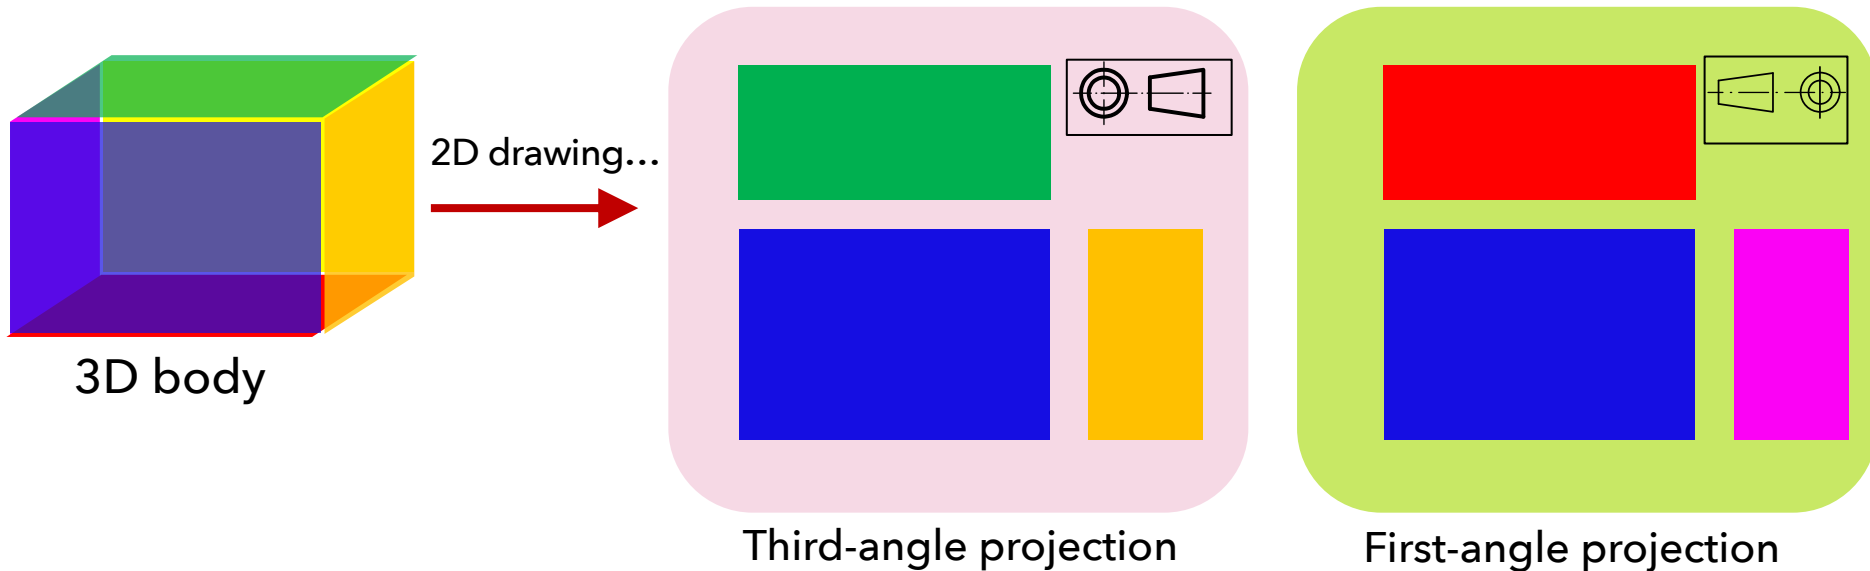
- Local manufactures (and we) *might* miss imported 2D drawings.
- We elaborated the translations for avoiding errors, but sometimes failed.

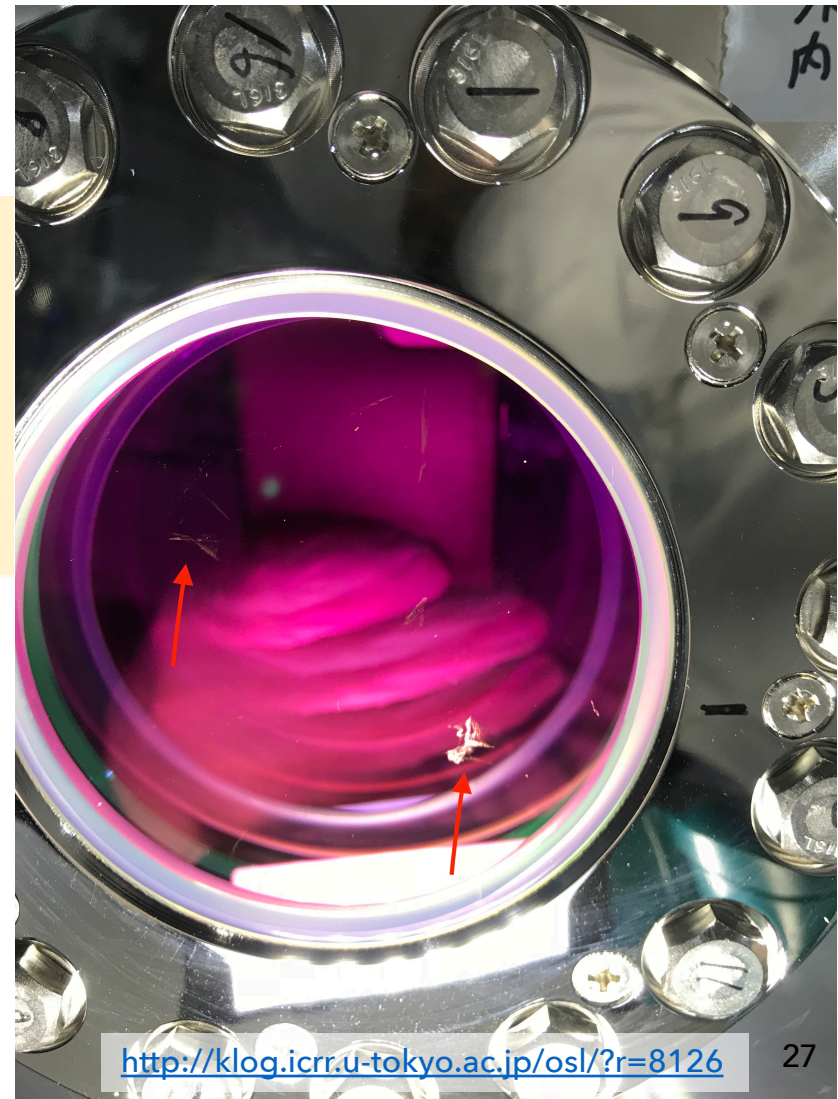
- Worked in a clean booth without wearing clean wears.
- Went outside of the clean booth with clean wears, and then came back to the inside.
- Touched an oplev during closing vacuum tanks; the oplev was a reference for the alignment of the mirrors.
- Touched a viewport windows by a metal nozzle during the leak check.
- (?) Left dirt or finger prints on an expensive viewport window.
