# Current status of DGS group

KAGRA f2f meeting

Shoichi Oshino

On behalf of DGS subgroup

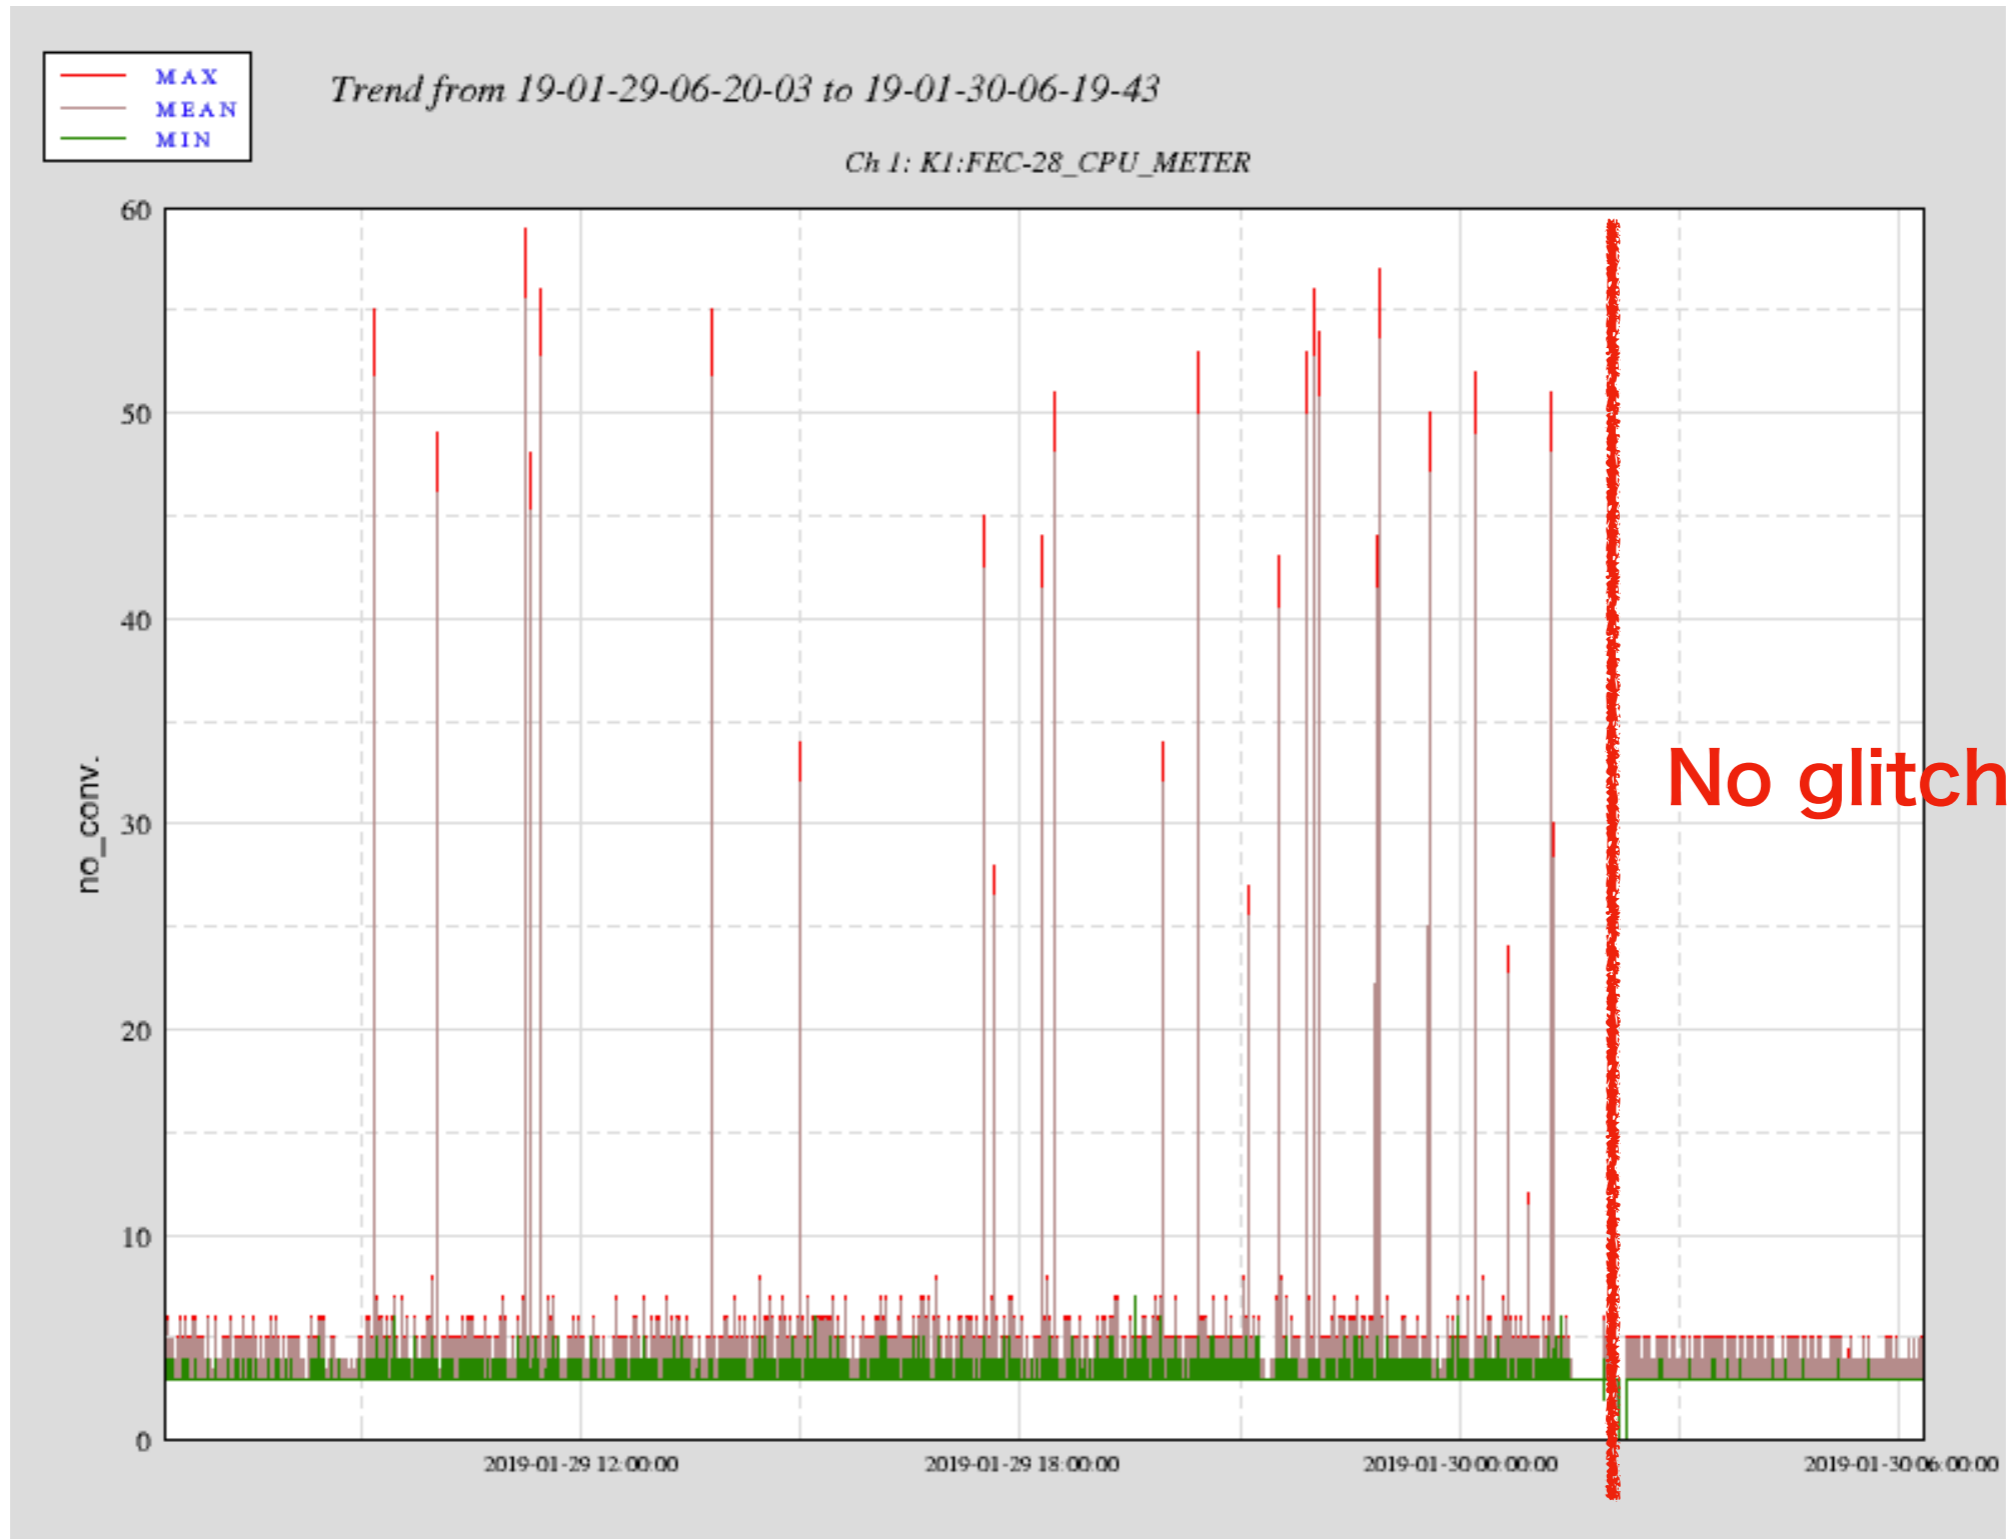
# DAC glitch issue

## DAC glitches caused by CPU load

## Exchange to faster CPUs

We also replace k1ix1, k1iy1, k1ex1, k1ey1 and k1bs
